13 March 2023

Shrewsbury Public Schools Pre-K-12
Capital Inventory & Improvement Study

TABLE OF CONTENTS

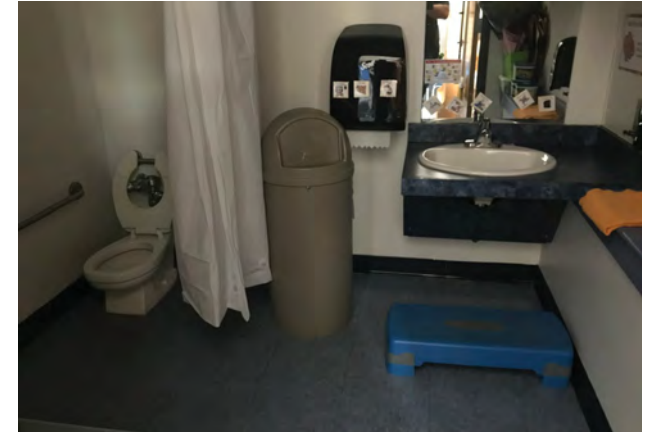
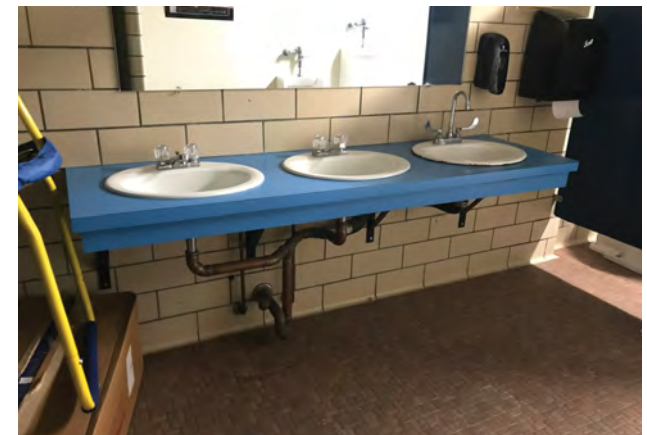
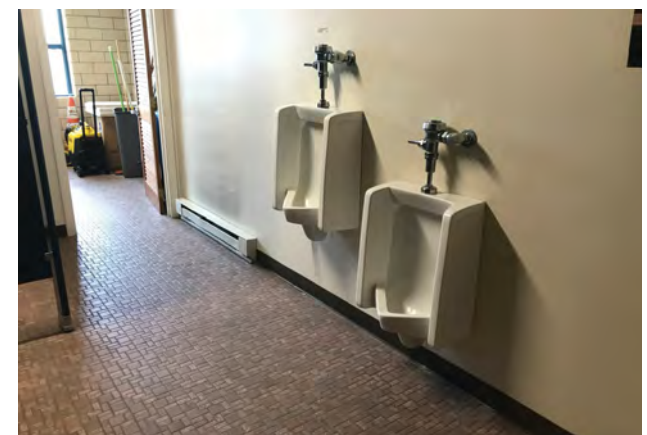
Public lavatory faucets vary, from metered (self-closing) to most being non-metered two-handle style. Public should be of the metered style to automatically shut off after use as required by current code. However, due to the occupant age, spring type self-closing fixtures should be avoided as they can be difficult to operate. The fixtures do not have limit stops or tempering valves to ensure hot water does not exceed 110°F for scald prevention. We suspect hot water to entire building may be reduced for scald preventing. Some lavatories which appeared to be ADA-compliant were missing protective insulation on the piping below.

At least one floor-mounted style janitor's sink was observed in the building.

As renovations occur, the following items should be considered: replace all flushometers/faucets with automatic low flow flushometers/faucets.

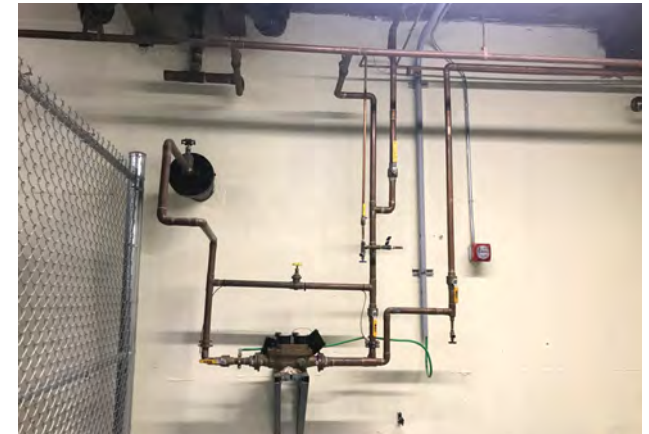
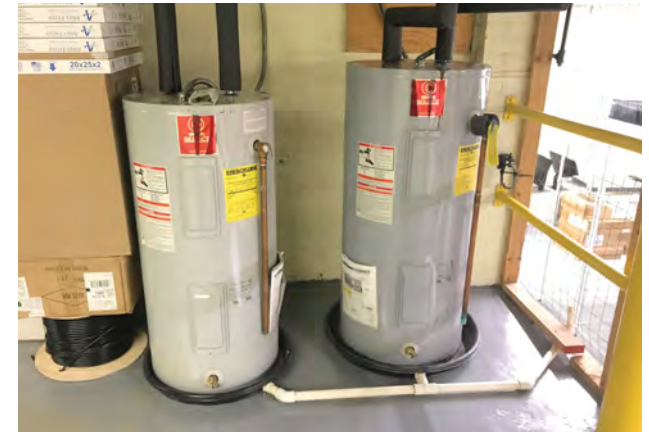
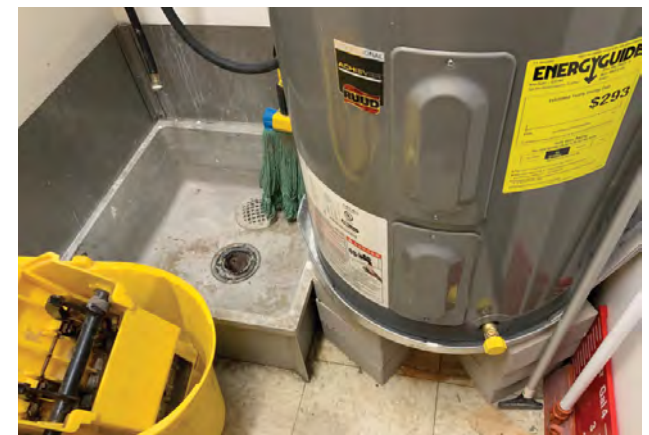
There is no backflow preventer on the main incoming water service. In facilities such as this where there could be various potential sources of cross contamination, a backflow preventer may be required to protect the municipal water supply. Local vacuum breaker backflow prevention on a janitor's sink was also noted.

The water heaters have no active signs of leakage with the exception of some water staining at one of the pipes at the top of the 50-gallon water heater. At 15 years old, the 40 and 50-gallon water heaters are well past their useful service life of 10 years and are prime candidates for replacement.

We did not notice mixing valve stations on the building's domestic hot water supply. Current code would require differing water temperatures at different types of fixtures. Lavatory sinks and showers must not discharge hot water at a temperature exceeding 110–112°F for safety reasons, whereas service fixtures (janitor's sinks, kitchen sinks, etc.) are required to have hot water temperatures in excess of 120°F for sanitation reasons. In addition, domestic hot water storage tanks should be kept at approximately 140°F to prevent the possibility of bacteria growth within the tanks. It is recommended that the central mixing valve should be replaced with an electronic type.

There was no recirculation pump on the domestic hot water systems, which may be required as some fixtures appear to be located beyond 100 feet of the hot water source. The plumbing code requires hot water to be available within 100 feet of any hot water consuming fixture. The domestic hot water heaters should be replaced with high-efficiency condensing gas-fired style.

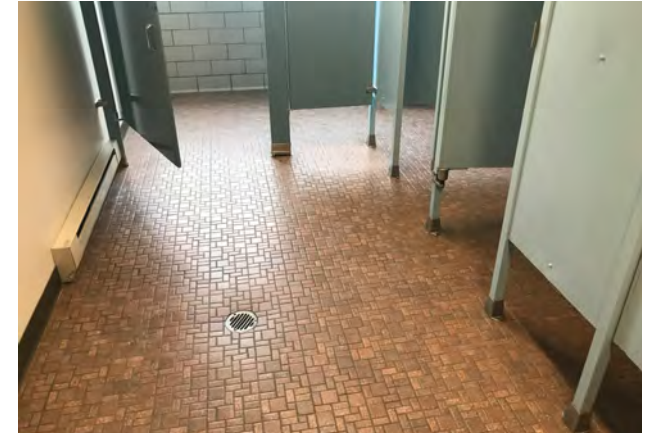
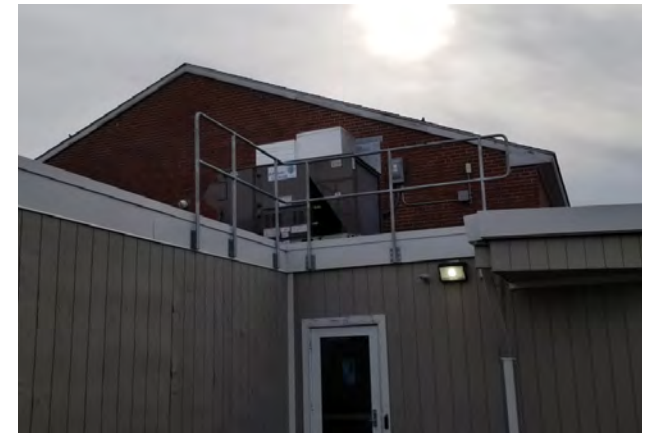
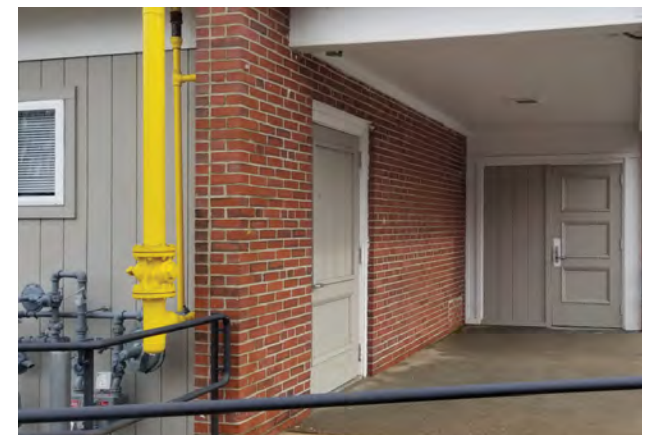
Roof storm water is drained via roof drains connecting to internal leaders. The lines presumably exit to a municipal storm water system. The building does not appear to have any emergency roof overflow drains. These are required by current code as a clogged drain can lead to water build-up on the roof and structural failure due to weight. During any reroofing project or building upgrade, we highly recommend emergency roof drains be added. The emergency drains should be added near the current roof drains and run to discharge to the side of the building. The visible discharge location is required as it gives users an indication of a failed main drain system.

A natural gas service entrance meter is located outside the building along the Parker Road side. The service rises up the outside of the building and feeds multiple gas-fired roof-top units. The gas service to the building is provided by Eversource.

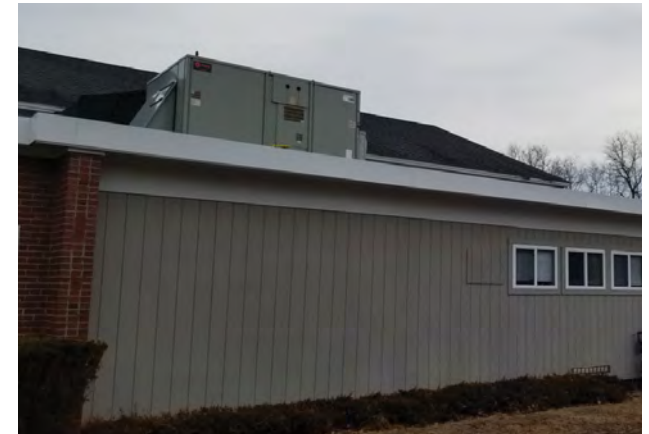
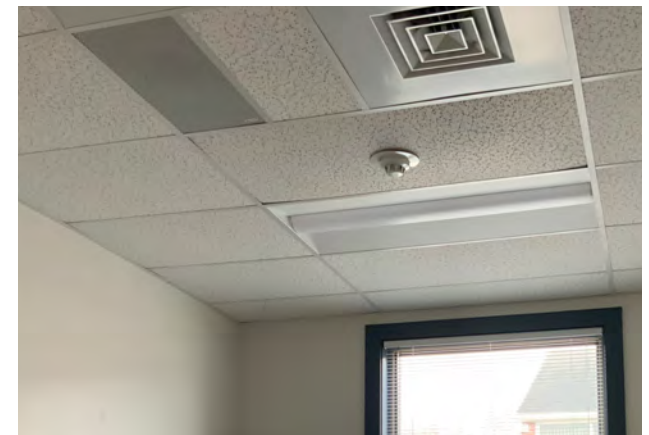
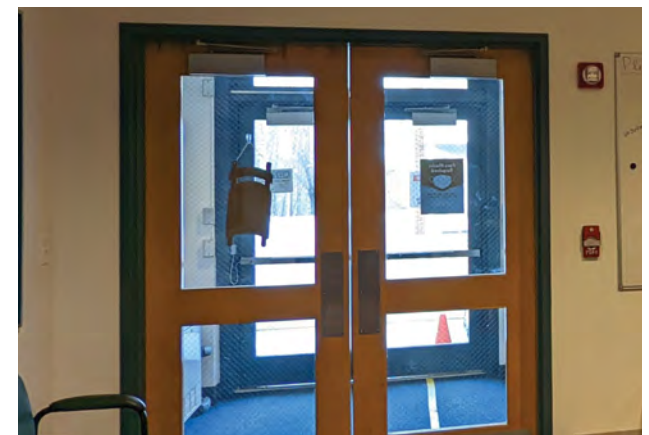
Rooftop units RTU-1 through RTU-8 serving the classroom portion of the building have all been replaced in 2021. RTU-1, 2, 3, 4 & 6 each have a cooling capacity of 3-tons. RTU-5 has a cooling capacity of 5-tons. RTU-8 has a cooling capacity of 10-tons.

The Shrewsbury Electric Company (SELCO) portion of the building is supported by two (2) packaged rooftop units. RTU-9 was recently replaced in 2021 and RTU-10 was replaced within the last few years. RTU-9 has a cooling capacity of 6.5-tons and RTU-10 has a cooling capacity of 12.5-tons. There is also a small 3.5-ton ducted split system which serves a portion of the SELCO administration area. This system appears to have been installed circa 2014.

The building appears to have a hybrid control system with local controls being able to communicate via wifi for remote control energy management system throughout. Besides scheduling, the controls appear to have limited advanced capability.

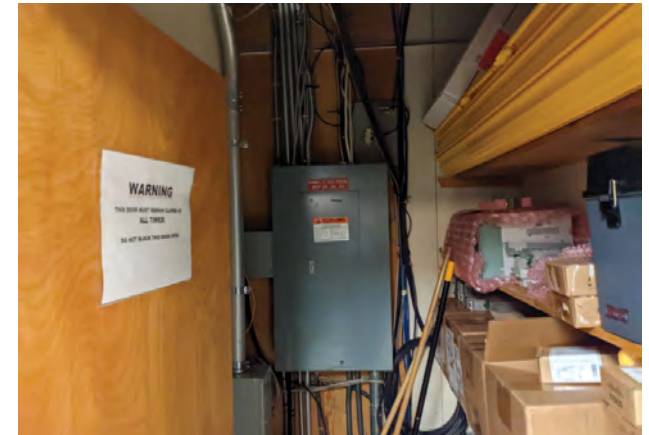
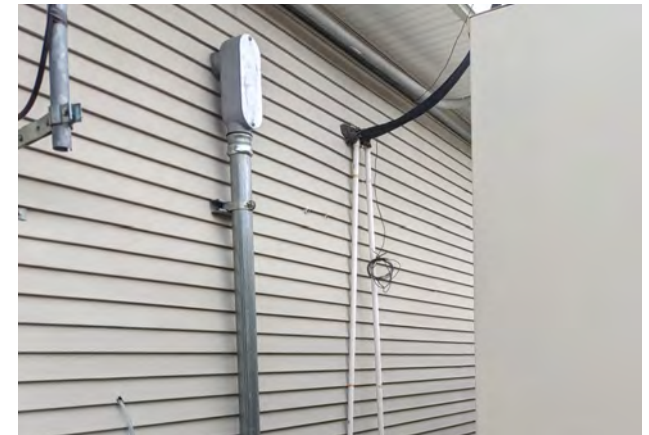
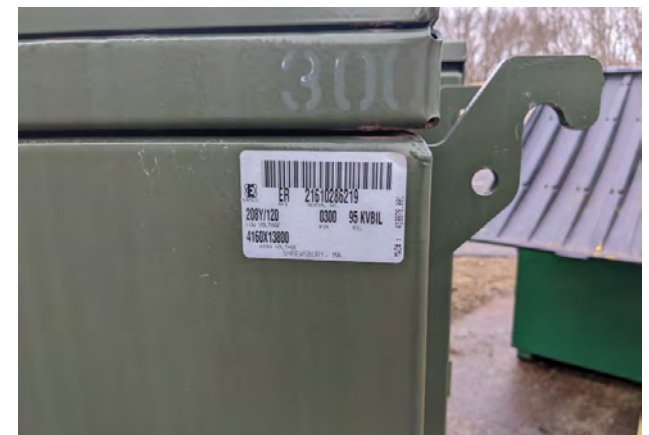
The preschool electrical service is rated 400 Amperes, 208/120V Volt, 3-phase, 4-wire. The preschool is fed from a 1600A, 208/120V, 3-phase, 4-wire main electrical service switchboard in the basement. The main electrical service feeds seven other services for CATV head-ends and public building departments. The service consists of a utility company pad-mount transformer on the exterior of the building and underground feeds to the electrical service equipment. The electrical distribution equipment is by Square D. Maintenance of the switchboard is recommended by the manufacturer and NETA.

The panelboards in the building are by several different manufacturers. The panelboards are located throughout the building in electrical rooms, corridors, etc. and are circuit breaker type. Some panelboards are original to the building and others were added over the years. Several different types of wiring methods were observed: namely, wires in raceway, metal clad (MC) cable, and armored cable (AC). Electrical distribution equipment should be replaced.

The ambient lighting system in the building consists of various types of fixtures (recessed, surface, pendant, etc.) with fluorescent lamps. The lighting system is inefficient and does not meet current energy codes. The lighting throughout the facility is controlled with snap switches. Recommended to provide ambient lighting system consisting of LED light fixtures. Networking lighting controls including occupancy, vacancy, and daylight sensors should also be provided.

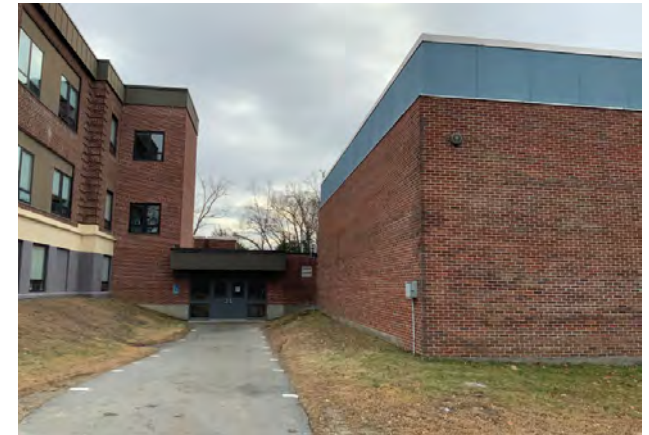
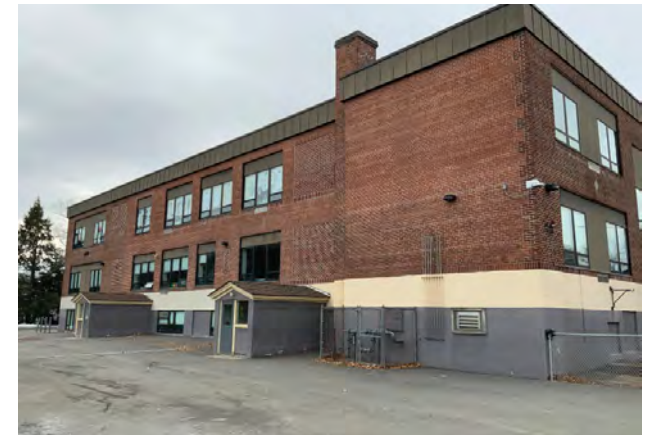
The exterior walls consist of brick masonry, concrete, exterior insulation and finish systems [EIFS], and metal panels. As previously reported, the exterior joints where sealant was used have failed. LPA|A observed some replacement/repairs of these joints, but many still require attention. The brick masonry requires repointing throughout and resetting/re-anchoring/replacement of bricks at several locations to ensure the envelope is watertight. There are also several corroded steel lintels that should be replaced. There are some smaller concrete repairs that are also required to prevent further deterioration.

The roof is comprised of black EPDM over mechanically-fastened insulation. Based on previous reports, the roofing has several deficiencies, including open seams, unadhered membrane, leaking drains, damaged down spots and flashing. These deficiencies are minor in nature but should be addressed before they lead to significant water infiltration. There are smaller, lower roofs that have asphalt shingles on the east side of the building.

The building consists of aluminum-framed windows and hollow metal doors and frames. The doors and windows are in fair condition with the exception of failed sealants, corroded lintels, and failed insulated glazing units. The sealants, lintels, and insulated glazing units should be replaced and maintained through a comprehensive maintenance plan.

The interior walls consist of painted concrete masonry units, plaster finish walls, and ceramic tile. These walls are all in good condition and provide good acoustical separation between spaces. The ceiling primarily consists of acoustical ceiling tiles with some plaster ceilings, all of which are in good condition except where leaks have occurred. The flooring consists of vinyl composite tile, ceramic tile, and carpet, which have been well maintained and/or replaced since the building has opened. The items that have the most amount of wear on them are the doors, frames, and casework, many of which are original to the building. The gymnasium floor is vinyl composite tile.

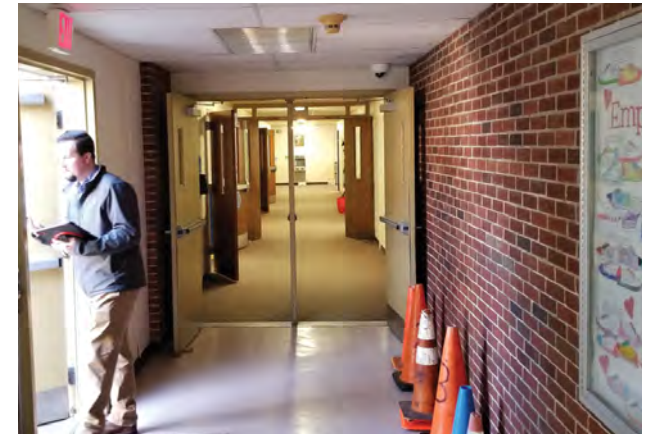
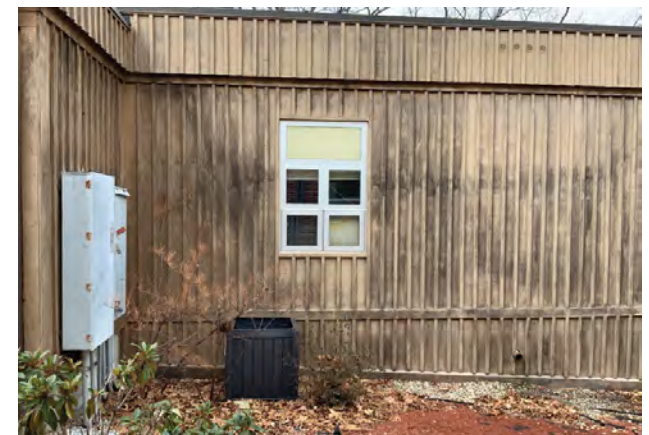
The main structural system consists of a steel frame with concrete floor slabs and frost walls. There appears to have been some settling in certain areas that should be investigated and remediated prior to any masonry repairs. Corroded lintels should also be remediated in conjunction with any masonry repairs.

The modular classrooms have served the district well for many years and are not intended for long-term utilization, as is seen here. We recommend removal of these structures.

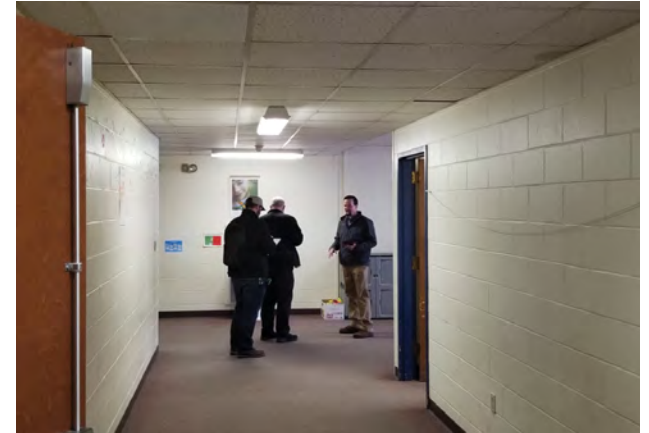
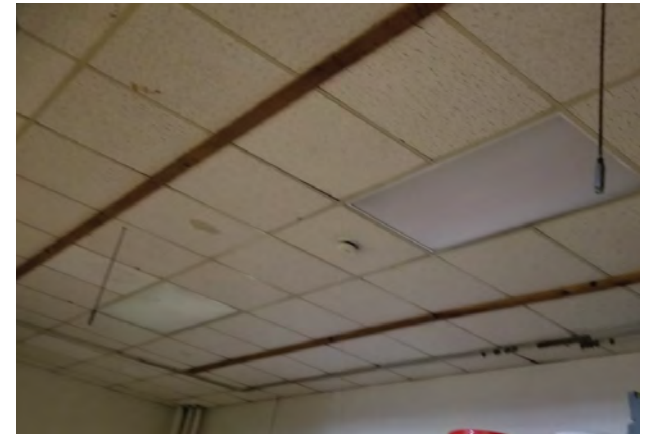
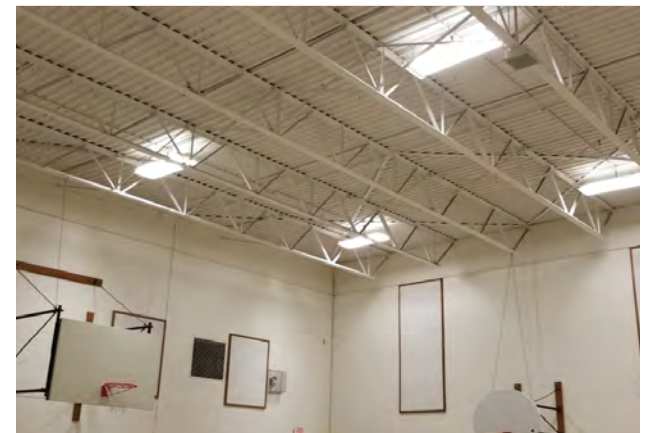
There is currently no fire suppression system serving the building. The kitchen hood also had no chemical-based suppression system; however, the equipment below the hood would not require such a system. If any additions are proposed or any substantial renovations, the code would require a building-wide suppression system be installed.

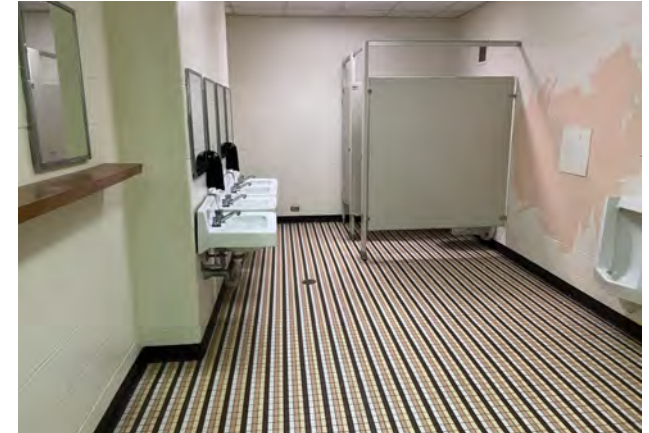
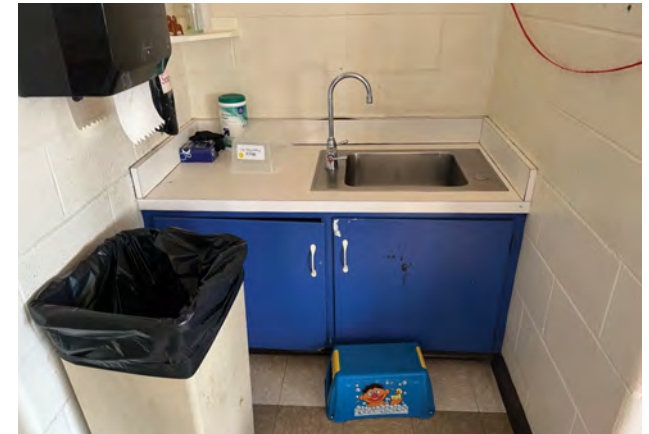
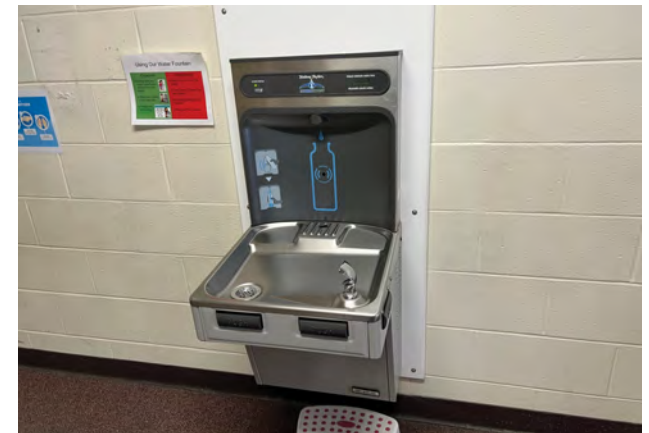
Janitor sinks inspected during our walk-through had faucet trim with vacuum breakers to limit backflow contamination caused by siphonage.

Most fixtures (with limited exception) appear to be operational, and maintenance is routinely performed on faucets, toilet flush valves, etc. as needed

As renovations occur, the following items should be considered: replace all flushometers/faucets with automatic low flow flushometers/faucets.

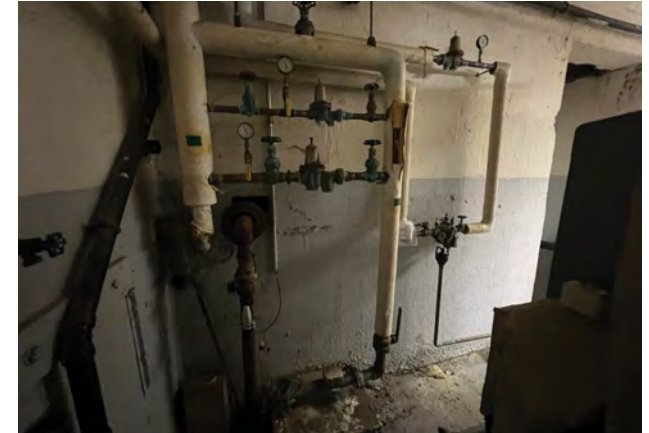
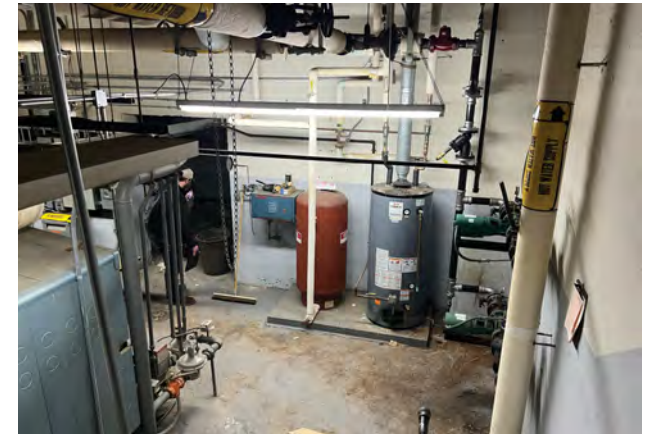
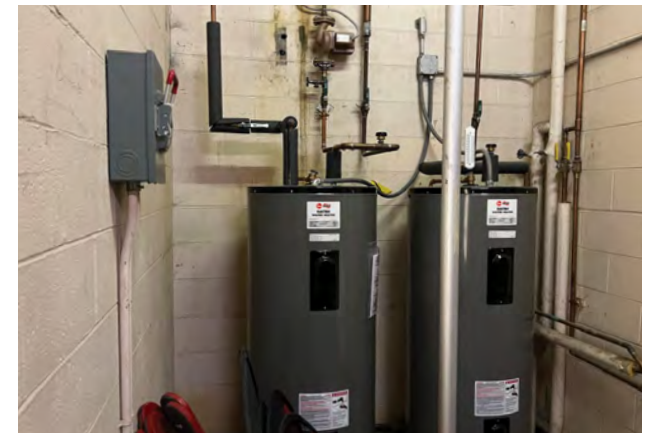
There is no backflow preventer on the main incoming water service. In facilities such as this where there could be various potential sources of cross contamination, a backflow preventer may be required to protect the municipal water supply. We did note localized reduced pressure zone (RPZ) type backflow prevention on the water supply to the boilers as well as vacuum breakers on janitor sinks. Local backflow prevention on hazards such as these is required and outlined in the Commonwealth of Massachusetts Plumbing Code.

Most of the piping in the building appears to be copper however there may be brass piping present as well. Due to the age of the building there is a high probability that the water service could have lead containing solder in the fittings or old brass piping as well as drinking fountains that may have lead containing components. Although not a large source of lead contamination it should be tested and monitored and if found to be a problem, components should be replaced. In general, there were no outward signs of failure during the day of our site inspection. We also recommend a pipe sample from both the cold and hot water system be taken to verify pipe condition.

The water heaters have no active signs of leakage; however, the gas-fired unit is near the end of its useful expected service life at near 10 years of age. There are no mixing valve station on the building's domestic hot water supply.

Current code would require differing water temperatures at different types of fixtures. Lavatory sinks and showers must not discharge hot water at a temperature exceeding 110-112°F for safety reasons, whereas service fixtures (janitor's sinks, kitchen sinks, etc.) are required to have hot water temperatures in excess of 120°F for sanitation reasons. In addition, domestic hot water storage tanks should be kept at approximately 140°F to prevent the possibility of bacteria growth within the tanks. It is recommended that the central mixing valve should be replaced with an electronic type.

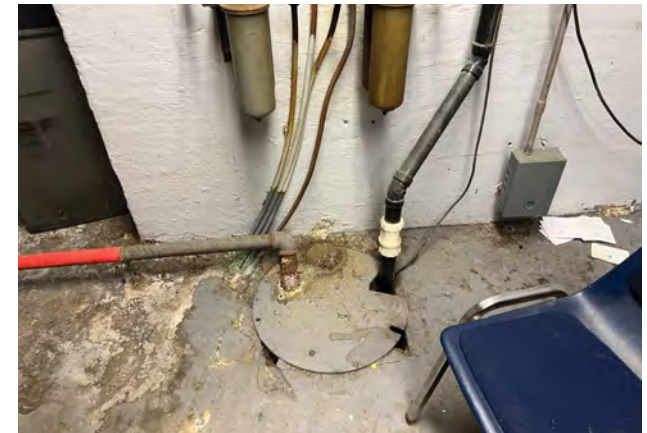
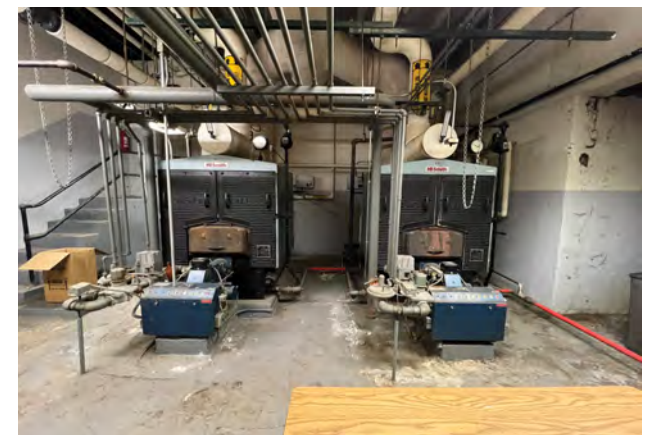
Roof storm water is drained via roof drains connecting to internal leaders. The lines presumably exit to a municipal storm water system. The building does not appear to have any emergency roof overflow drains. These are required by current code as a clogged drain can lead to water build-up on the roof and structural failure due to weight. During any reroofing project or building upgrade we highly recommend emergency roof drains be added. The emergency drains should be added near the current roof drains and run to discharge to the side of the building. The visible discharge location is required as it gives users an indication of a failed main drain system.

A natural gas service enters the building in a lower-level boiler room of the older portion of the building. The gas line enters as a 4" low pressure service and supports the building loads. The service feeds the gas loads in the building, which include the heating boilers and the domestic hot water heater for the older 3-story section of the building.

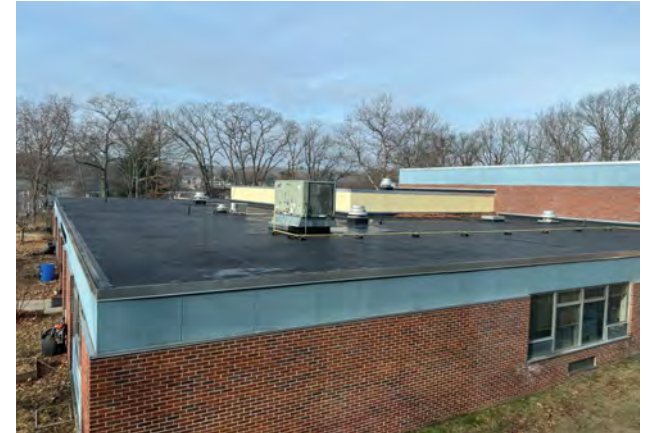
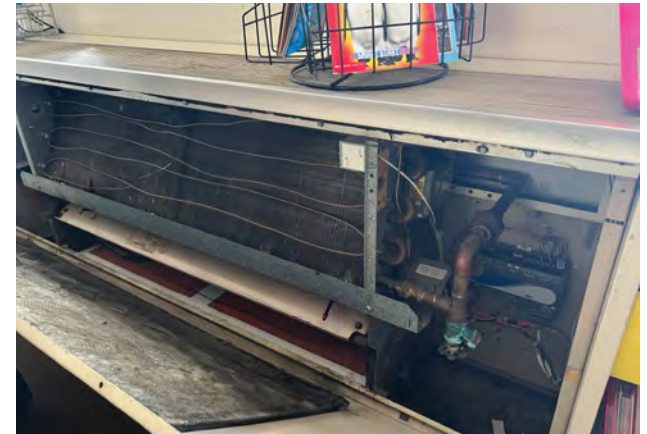
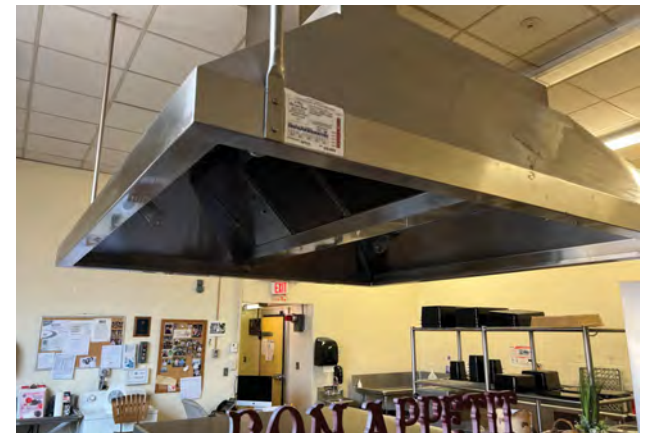
A packaged rooftop gas-electric rooftop unit installed circa 2010 serves the library space and adjoining teacher's room. The unit has a cooling capacity of 6-tons and appears to be in fair condition.

The kitchen hood over the oven equipment appears to miss compliance with current NFPA 96 and IMC standards based on the use of improper style grease filters. However, if the hood is just used for heat capture with no grease producing cooling equipment under it, these type filters are not required. Review of the ductwork above the ceiling as well as the fan on the roof would be required to further review compliance. The hood has no chemical-based suppression system which is not needed with the current cook-line arrangement, but would be required if a range top or other equipment requiring such were installed under the hood.

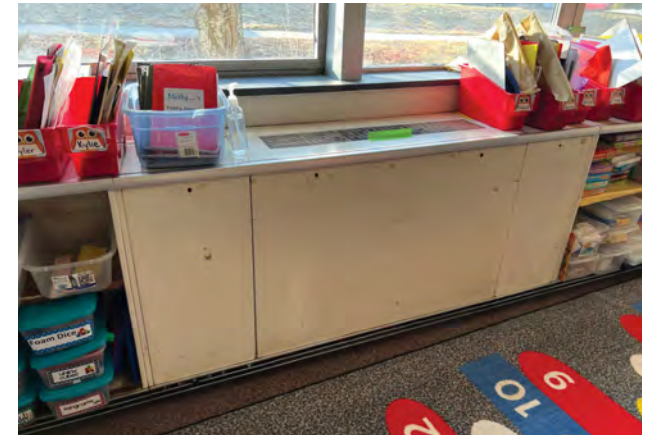
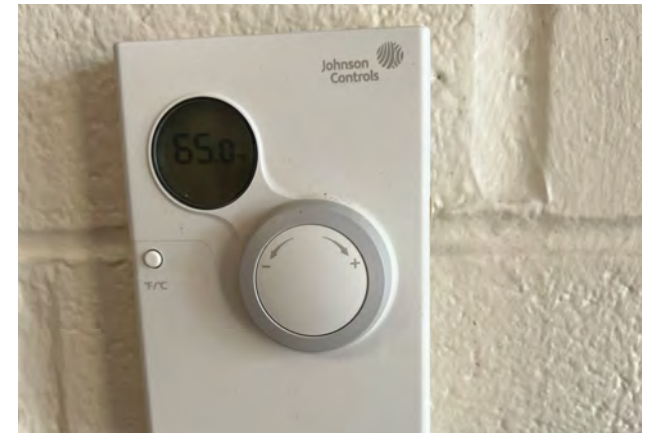
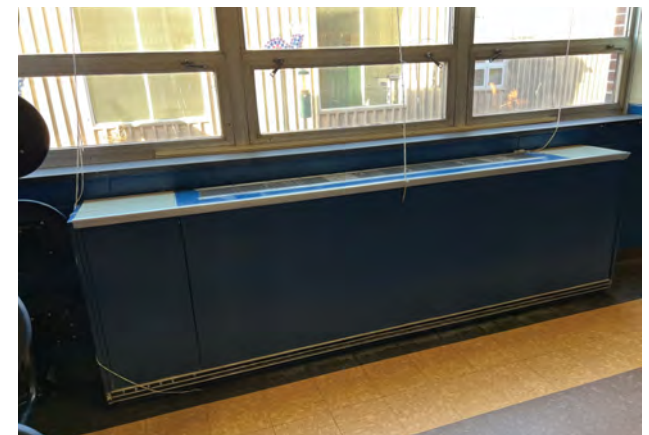
All restrooms appear to have ducted exhaust systems. The systems connect to exhaust fans located on the roof.

The building appears to have a building-wide DDC energy management system throughout. The system is manufactured and supported by Johnson Controls. Sequences should be reviewed further as additional indoor air quality and energy-saving routines may be possible.

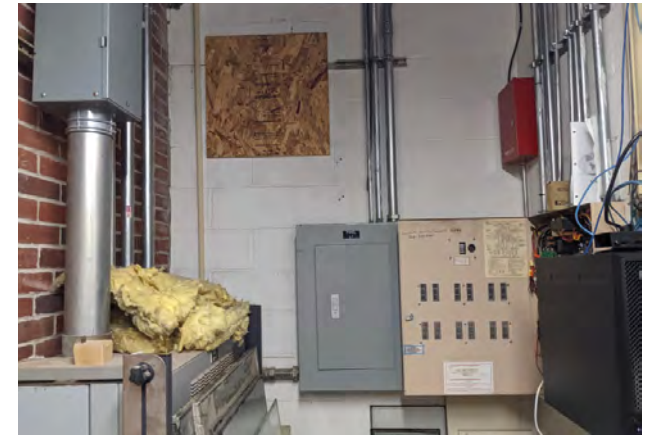
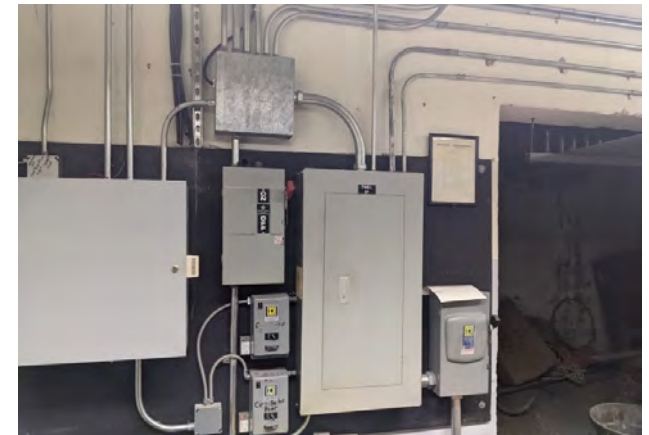
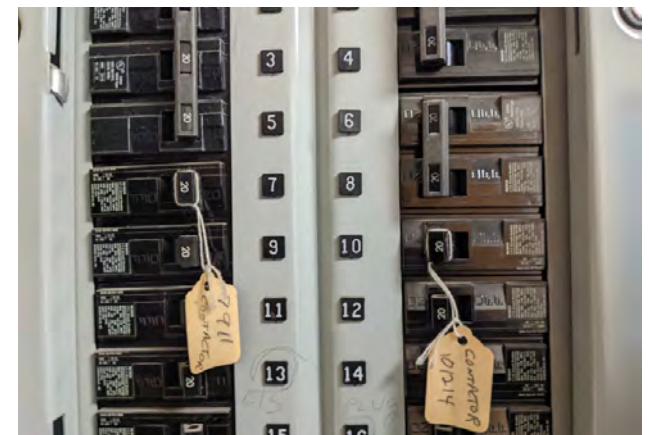
The panelboards in the building are by FPE and ITE. The panelboards are located throughout the building in electrical rooms and are circuit breaker type. The branch circuit panelboards by both are past their useful life, the distribution equipment is no longer being manufactured or supported. Several different types of wiring methods were observed namely wires in raceway, metal clad (MC) cable, and armored cable (AC). Electrical distribution equipment should be replaced.

The egress and exit lighting are through battery-powered exit signs and emergency lighting units. ART observed that emergency lighting was not installed at all the exit discharge leading to a public way. The overall coverage of emergency lighting and exit signs appears to be inadequate. Emergency egress and exist lighting in compliance with 780 CMR should be provided.

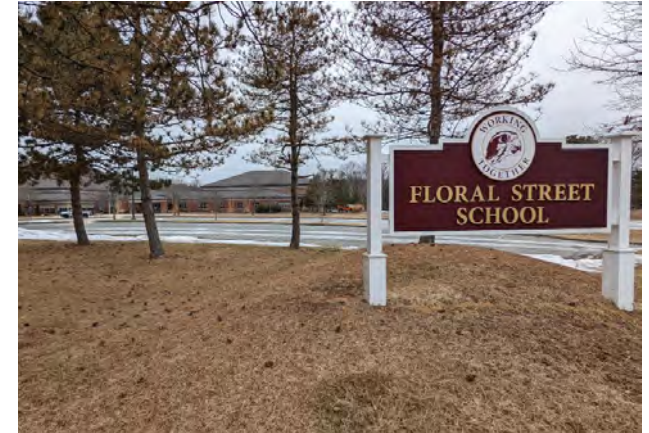
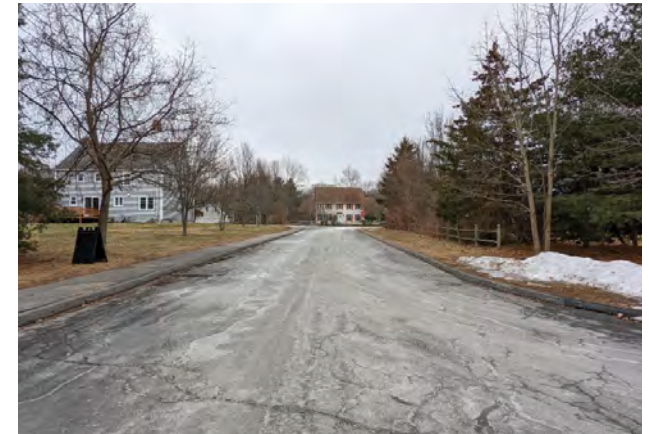
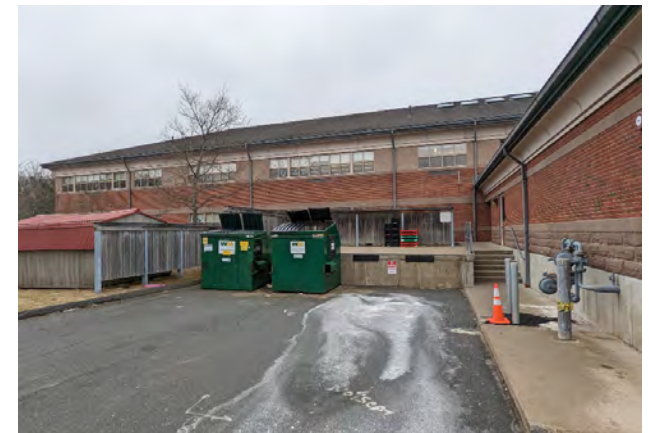
The site's soils within the developable area are characterized by Hinckley and Agawam soils, which are best described as excessively drained [see soils mapping in the Appendix]. There is a stream and associated wetlands that run east-west through the middle of the parcel that limit any opportunity to expand the facility to the north or west.

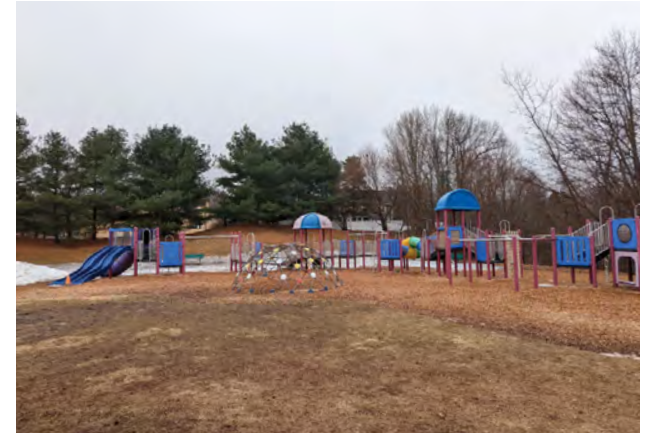
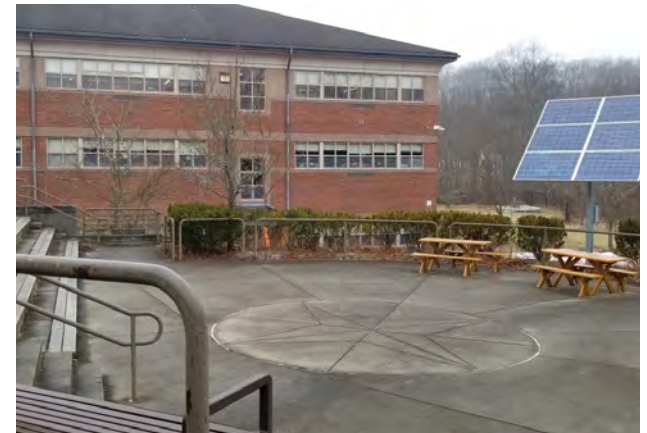
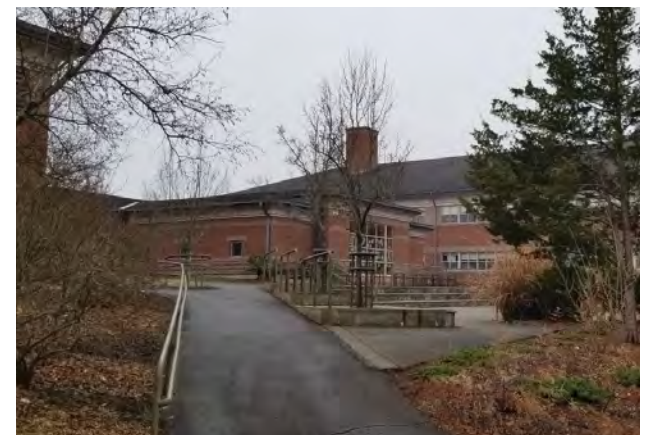
There is sufficient parking for staff and visitors to support daily operations. However, the site has limited capacity in respect to special events and relies on the paved play area and street parking. There are several pedestrian walkways throughout the site consisting of concrete, pavers, and asphalt. Overall condition of these features is fair to poor. The site appears to have sufficient drainage given its current configuration.

As previously reported, there are several deficiencies regarding the site's accessibility. There is a lack of accessible routes to exterior amenities [running/cross slopes/maintenance]. The following items do not meet the current accessibility guidelines: playground [surface/route], amphitheater [slopes], multipurpose field [route], garden [route], benches [route], van parking [not provided], and handrails/landings [not provided].

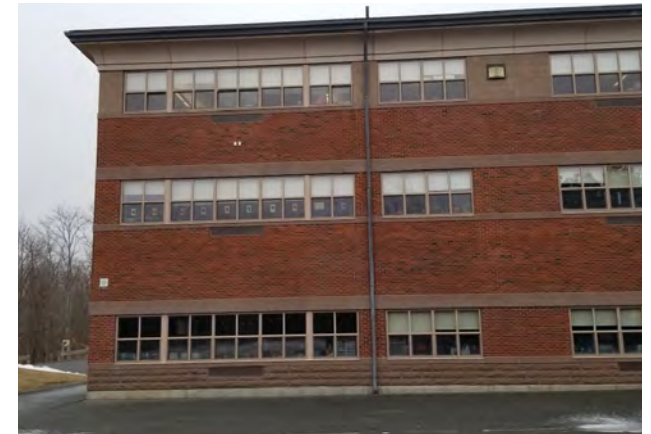
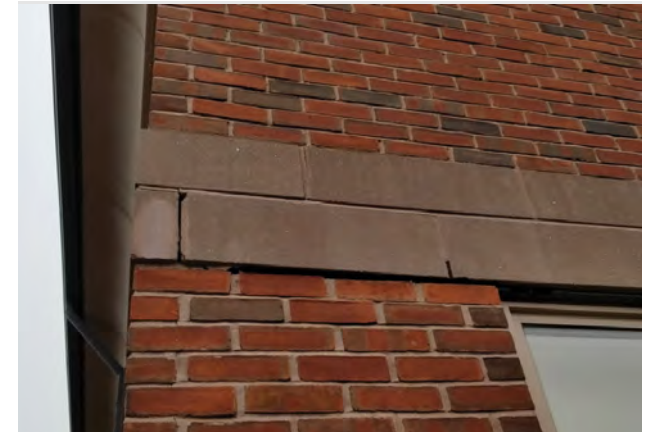
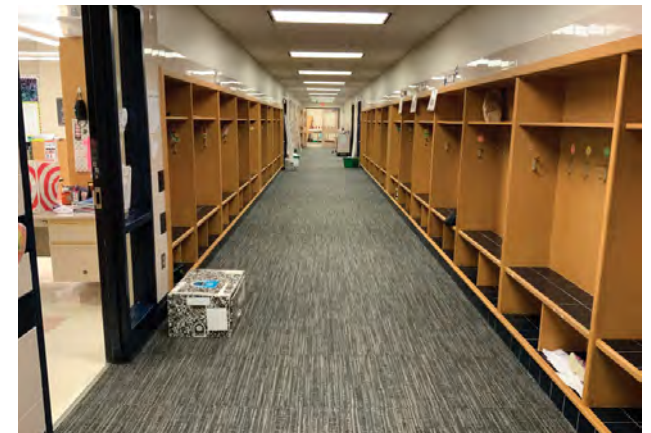
The exterior walls consist of brick masonry, cast stone, and fiberglass-reinforced polymer panels. As previously reported, the exterior joints where sealant was used have failed. LPA|A observed some replacement/repairs of these joints, but many still require attention. The brick masonry requires repointing/resetting/re-anchoring of bricks at several locations to ensure the envelope is watertight. There are some smaller concrete repairs that are also required to prevent further deterioration.

The roof is comprised of asphalt shingles. Based on previous reports, the roofing has several deficiencies, including cracking, granule loss, broken/missing shingles, and exposed/face nailed shingles. Isolated damage should be repaired in the interim. The roof has reached the end of its useful life and is currently scheduled for replacement.

The building consists of aluminum-framed windows and hollow metal doors and frames. The doors and windows are in good-to-fair condition with the exception of failed sealants and some hardware adjustments. The sealants should be replaced and maintained through a comprehensive maintenance plan.

As previously reported, there are several deficiencies regarding the building's accessibility. The following items do not meet the current accessibility guidelines: classroom sinks [non-accessible], signage [accessible means of egress], coat hooks [height] protrusions along accessible routes, reception desk [non-accessible], media center computer [non-accessible], and drinking fountains [standing user height].

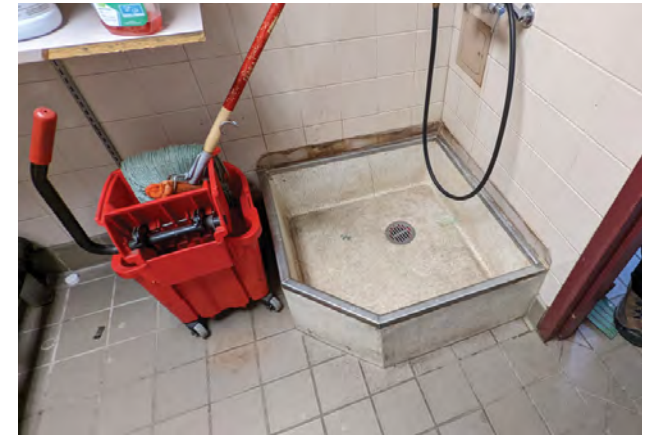
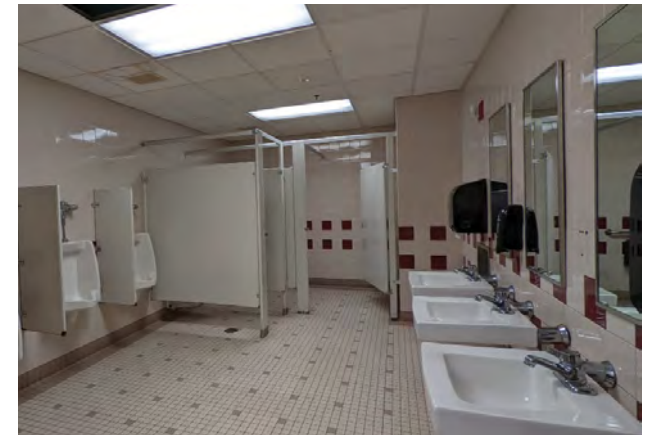
Many public use lavatory sinks have metered (self-closing) faucets as required by code. In addition, many appear to have limit stops to ensure hot water does not exceed 110°F for scald prevention. There was a bucket placed under one lavatory sink to address an active leak.

Janitor sinks inspected during our walk-through had faucet trim with vacuum breakers to limit backflow contamination caused by siphonage. Based on the age of the building we expect that all are code compliant.

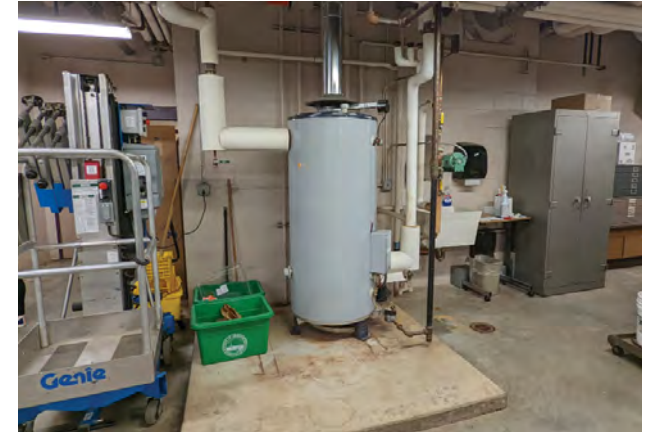
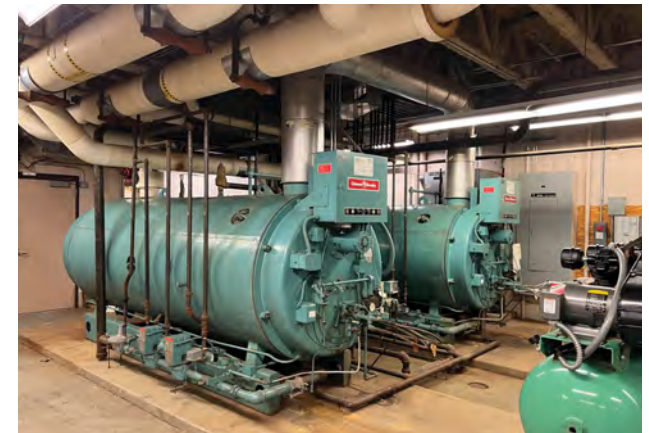
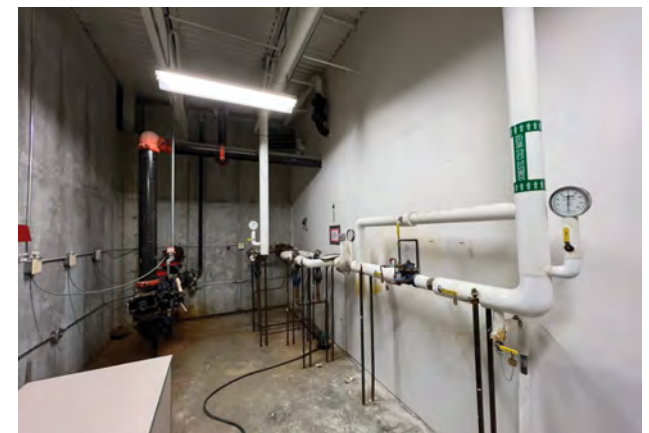
The water heater has no active signs of leakage; however, it has exceeded its useful expected service life at over 10 years of age and as such should be considered a candidate for replacement in the near future.

There is a high/low mixing valve station as manufactured by Leonard on the main hot water supply which serves most of the building fixtures. It appears there may be a higher temperature water line that runs to the kitchen for dishwash use. Current code would require differing water temperatures at different types of fixtures. Lavatory sinks and showers must not discharge hot water at a temperature exceeding 110–112°F for safety reasons, whereas service fixtures (janitor's sinks, kitchen sinks, etc.) are required to have hot water temperatures in excess of 120°F for sanitation reasons. The current system appears to supply a single temperature water to the building. After that, proper water supply to lavatories and showers should be accomplished by local mixing valves and/or fixtures with appropriate mixing limit stops. It appears the domestic hot water storage tanks are kept at approximately 140°F which is essential to prevent the possibility of bacteria growth within the tanks. It is recommend that the central mixing valve should be replaced with an electronic type.

There is one recirculation pump on the domestic hot water system, which is required per the current plumbing code since there are fixtures located beyond 100 feet of the hot water source. The domestic hot water heaters should be replaced with high efficiency condensing gas-fired style.

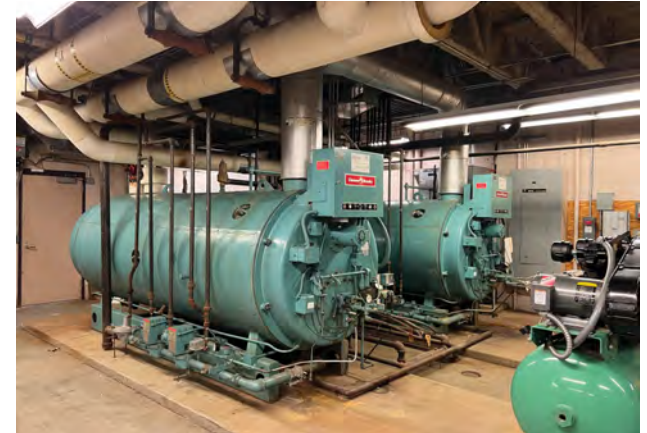
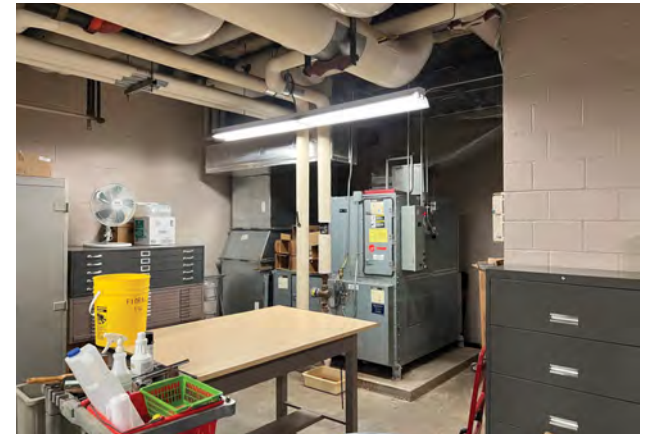
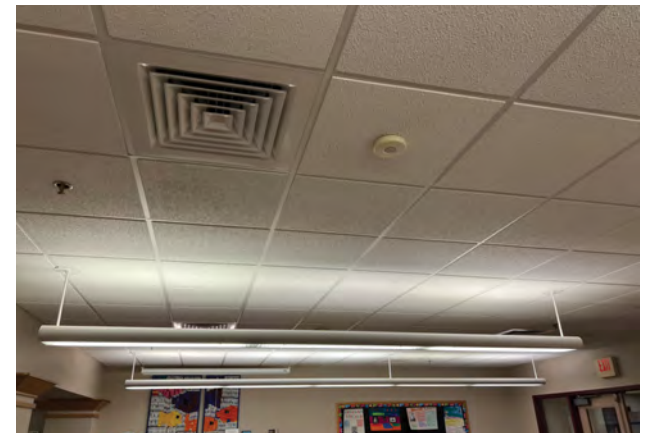
According to ASHRAE, the life expectancy of these types of boilers is 25 years, although with proper maintenance they have been known to operate for a longer service life. A 5+ year plan to replace these boilers is recommended. Although the boilers are in fair working order, when the time comes to replace them, consideration could be given to replacement with high-efficiency condensing style boilers.

The pumps are all manufactured by Taco and appear to be in fair operational order with signs of bearing assembly and motor replacement. Some pumps do show signs of external corrosion. Except for the boiler primary pumps which appear to have been recently replaced, all the pumps are at the end of their useful service life of 20-years as defined in ASHRAE and as such are prime candidates for replacement in the coming years.

Classroom unit ventilators are located throughout the classroom segments of the building. These units are located along exterior walls and each has an outdoor air louver and associate control dampers to allow outdoor air to enter the classroom space through the unit ventilator. During occupied periods, the unit fans run continuously to provide space ventilation and electric valves modulate hot water flow through the units to maintain space temperature. The unit ventilators are manufactured by Trane. Classroom exhaust in much of the building is supported by a centralized exhaust fans located on the building roof. In most cases the fans serve multiple rooms.

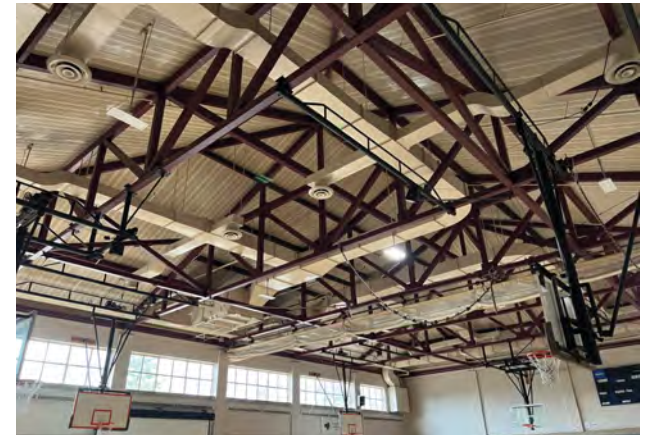
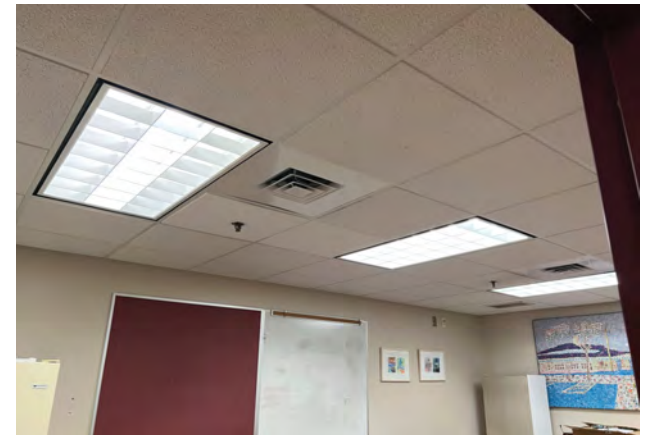
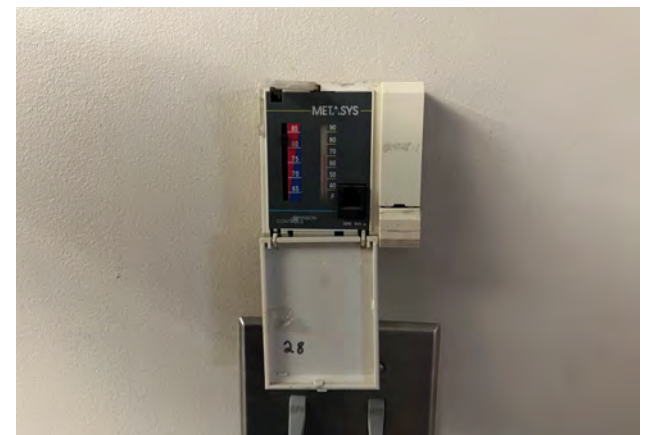
A majority of the non-classroom areas of the building such as the gym, cafeteria, etc. are served by ducted heating, ventilation units complete with fan section, filter sections and hydronic coil sections. For areas where air conditioning is supplied, such as the administration area, media center and computer room, the units also have DX cooling coils connecting to exterior remote air cooled condensers.

A majority of the air handlers, exhaust fans, classroom unit ventilators and the like are at the end of their useful service life of 20 to 25 years as defined in ASHRAE and, as such are prime candidates for replacement in the coming years.

The building appears to have a building-wide DDC energy management system throughout. The system is manufactured and supported by Siemens. The controls appear to incorporate many energy saving routines such as demand ventilation reset based on CO2 sensors as well as intelligent recovery. Sequences should be reviewed further as additional indoor air quality and energy-saving routines may be possible.
