13 March 2023

Shrewsbury Public Schools Pre-K-12
Capital Inventory & Improvement Study

TABLE OF CONTENTS

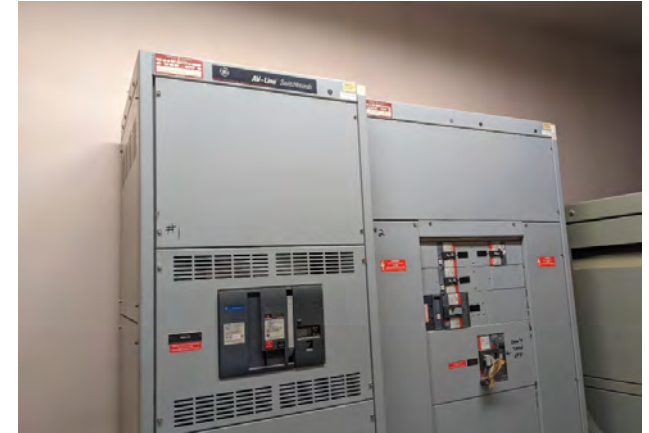
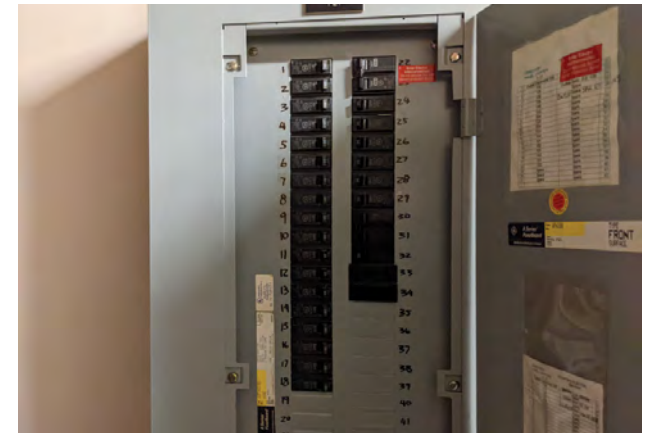
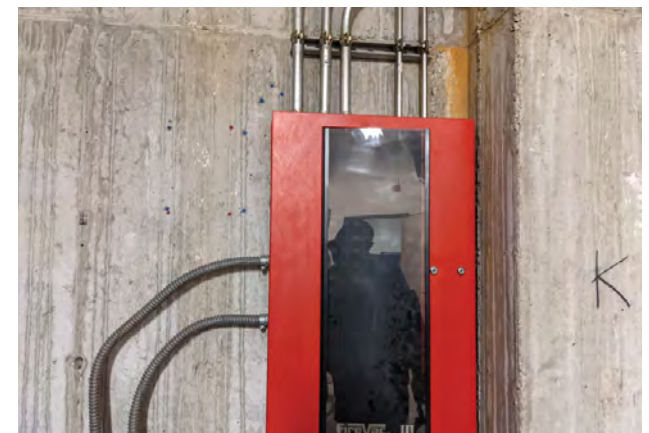
The electrical service for the building is rated 1600 amperes, 480/277 volt, 3-phase. The service consists of a utility company pad-mount transformer on the exterior of the building and underground feeds to the electrical service equipment. The electrical distribution equipment is by General Electric. The main switchboard feeds 277/480V panelboards throughout the building as well as a 500KVA transformer located in the main electrical room. The transformer feeds a 1600A 120/208V switchboard which feeds 120/208V panels throughout the building. Maintenance of the switchboard is recommended by the manufacturer and NETA.

The panelboards in the building are by General Electric. The panelboards are located throughout the building in electrical rooms and are circuit breaker type. Several different types of wiring methods were observed, namely wires in raceway, metal clad (MC) cable, and armored cable (AC). Maintenance of the panel boards is recommended by the manufacturer and NETA.

The emergency/standby generator is rated 150kW/125kVA, 480/277V, 3-phase, 4-wire, manufactured by Superior. The generator fuel is diesel. The generator feeds an automatic transfer switches (ATS) for life safety and standby power loads. The life safety ATS is located in a 2-hour rated emergency electrical room. The emergency distribution feeds both life safety and standby loads. This does not comply with current codes. It is recommended to provide separate life safety and standby branches with separate transfer switches and distribution. Locate the life safety branch transfer and distribution equipment in 2-hour rated room.

The emergency egress and exit lighting are powered from the life safety branch fed by the generator. The overall coverage appears to be adequate; ART could not confirm whether the exit discharge leading to a public way was powered from the life safety branch. The existing signs are self-contained battery type; the overall coverage of exit signs appears to be adequate.

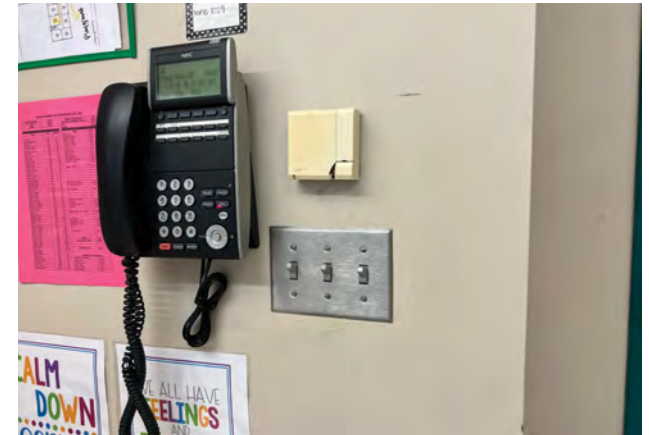
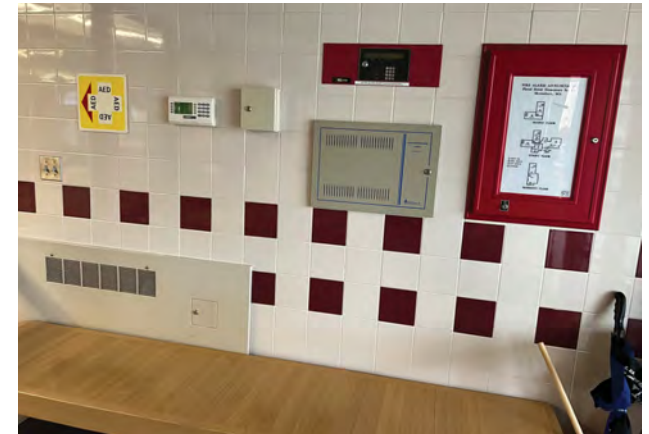
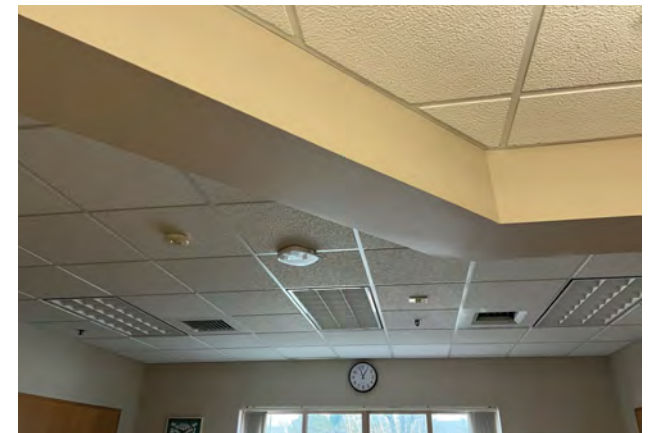
The fire alarm system is addressable with voice evacuation, fire alarm panel is FCI-7200. The fire alarm system appears to comply with current codes. The fire alarm system may require to be upgraded due to age. It is recommended to replace the initiating devices over 10 years old.

PA Speakers are located in public and common areas as well as in classrooms. The PA and clock systems appear to be in good working condition and meet the current programming needs. The PA system is Telecenter by Rauland Borg.

The video surveillance system is by Exacq with Axis cameras. The access control system is by Brivo. Card readers are provided at the exterior door entries. Building entry is through Aiphone video entry station. The existing systems are operational and meet current programming needs.

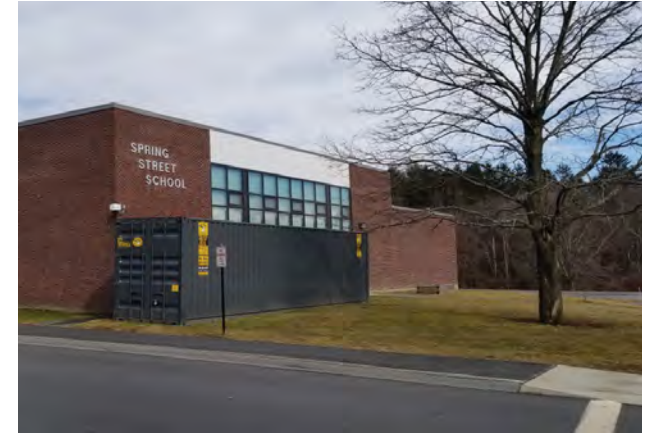
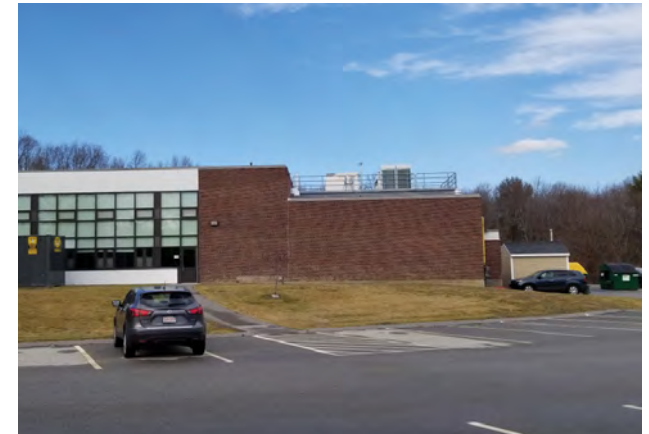
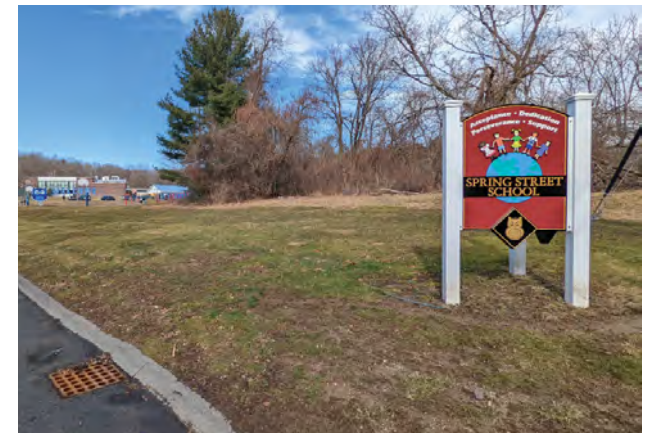
The site is characterized by Paxton and Canton soils, which are best described as being very well-drained till with rock fragments [see soils mapping in the Appendix]. There is a stream that runs north-south through the eastern portion of the property, which would require further investigation to clearly delineate the limits; however, impact on potential development of the site to the east of the current building would be significant.

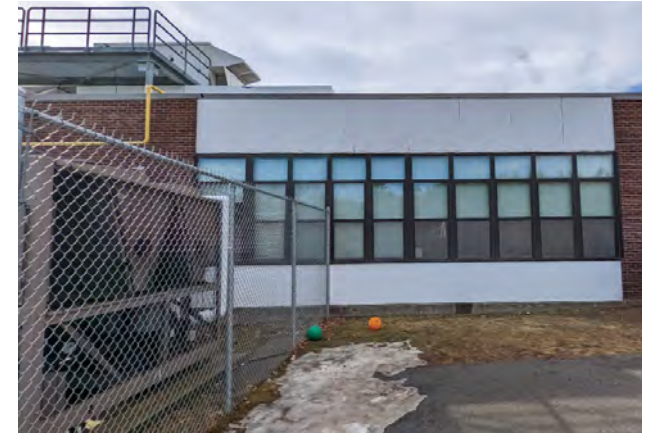
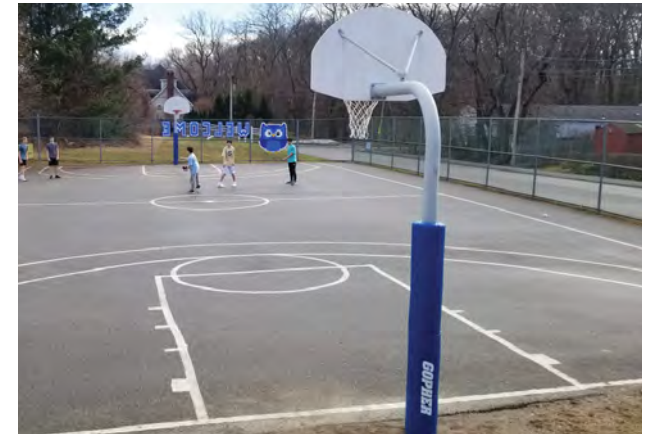
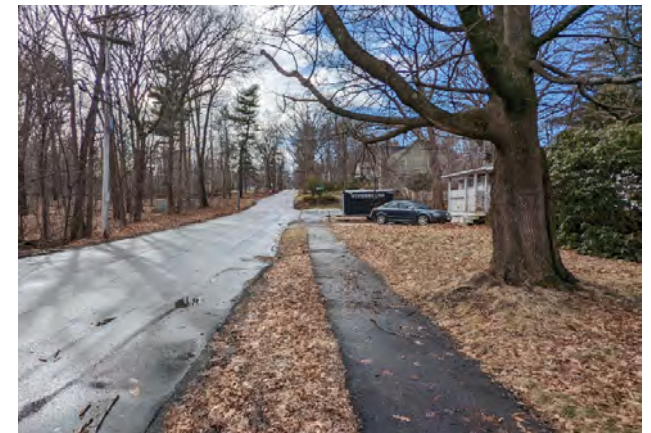
The school's playground, play field, and basketball hoops are utilized by the neighborhood community outside of school hours and are in good condition. There is a basketball court in the wooded area to the north of the building that is no longer used since the addition of a new court at the southern portion of the site. There is a grass play area along the eastern side of the site that is accessed by traversing a ±16 foot change in grade. The one feature that is missing that many of the other schools have is a large open paved play area for students.

There is sufficient parking for staff and visitors to support daily operations. However, the site has very limited capacity in respect to special events. There are several pedestrian walkways throughout the site. Overall condition of these features immediately around the building is fair. However the pedestrian pathways and court in the woods to the north are in poor condition. The site appears to have sufficient drainage given its current configuration, further development would likely require additional storm water measures.

As previously reported, there are several deficiencies regarding the site. There is a lack of accessible routes to exterior amenities [running/cross slopes/maintenance]. The following items do not meet the current accessibility guidelines: playground [surface/route], open field [route], benches [route], parking signage [height], and handrails [not provided].

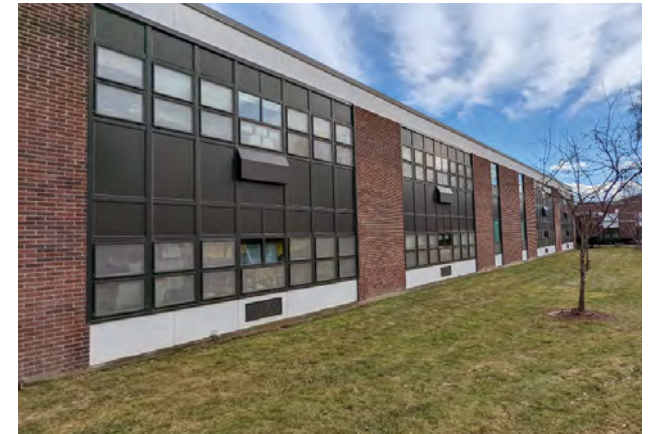
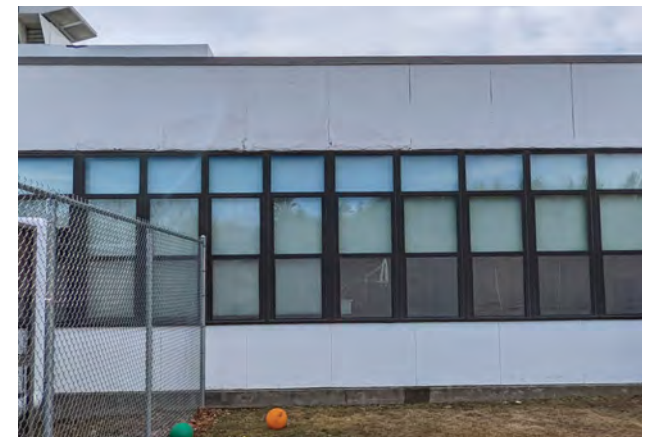
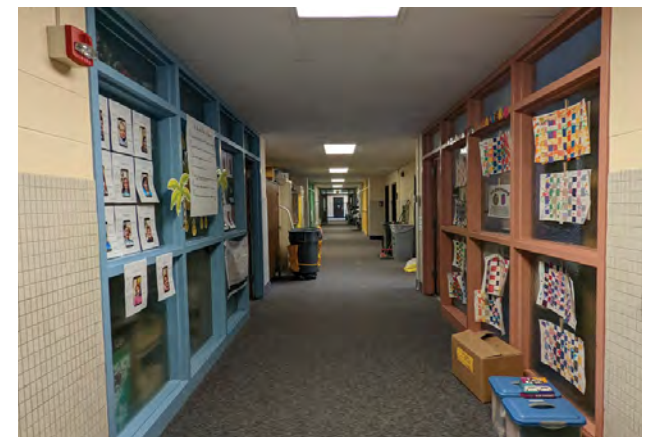
The exterior walls consist of brick masonry and stucco. As previously reported, several of the exterior joints where sealant was used have failed. LPA|A observed some replacement/repairs of these joints, but many still require attention. The brick masonry requires repointing/resetting/re-anchoring of bricks at several locations to ensure the envelope is watertight. Stucco panels at several locations require repairs/replacements due to deterioration. Corroded steel lintels have led to spalling/shifting bricks and should be replaced. There are some smaller concrete repairs that are also required to prevent further deterioration.

The roof is comprised of white EPDM over mechanically-fastened insulation. Based on previous reports, the roofing has several deficiencies, including blistered strip flashing, damaged counter-flashing, and EPDM extending too far into drain bowls. These deficiencies are minor in nature but should be addressed before they lead to water infiltration.

The building consists of aluminum-framed windows and hollow metal doors and frames. The doors and windows are in good-to-fair condition with the exception of failed sealants. The sealants should be replaced and maintained through a comprehensive maintenance plan. Some of the window hardware requires attention to ensure windows properly seal when closed.

The interior walls consist of painted concrete masonry units, ceramic tile, and some painted gypsum wall board. These walls are all in good condition and provide good acoustical separation between spaces. The flooring is best characterized as in fair condition and consists of carpet, VCT, wood, and ceramic tile. The ceiling primarily consists of acoustical ceiling tiles with some plaster ceilings, all of which are in good condition except where leaks have occurred. The items that have the most amount of wear on them are the doors, frames, and casework, all of which are original to the building.

As previously reported, there are several deficiencies regarding the building's accessibility. The following items do not meet the current accessibility guidelines: classroom sinks [non-accessible], stage [non-accessible], cafeteria tables [non-accessible], toilet rooms [hardware & flushometers], plumbing fixtures [non-accessible], signage [not provided], protrusions along accessible routes, drinking fountains [standing user height], reception desk [non-accessible], and handrails/guardrails/nosings [non-accessible/not provided].

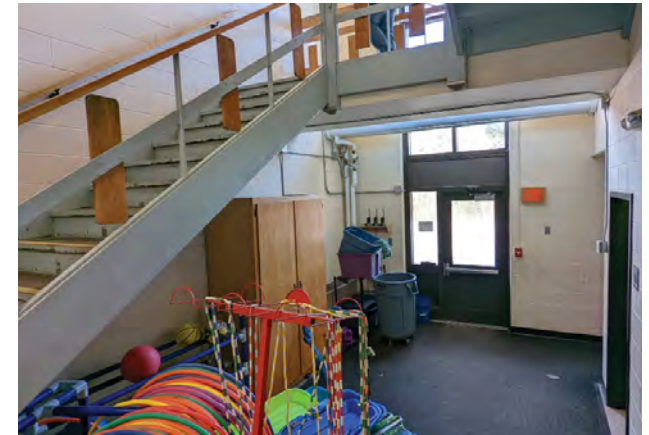
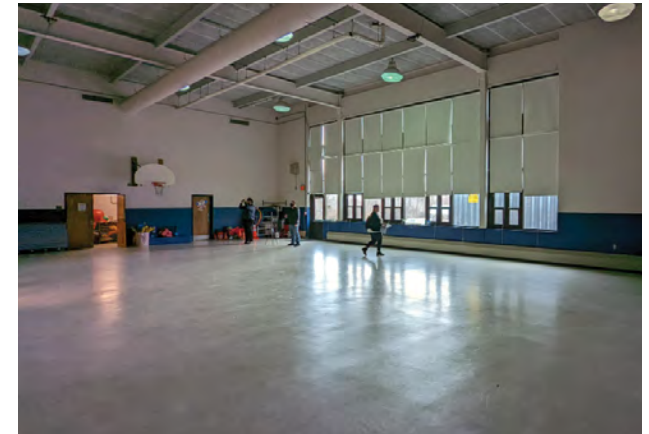
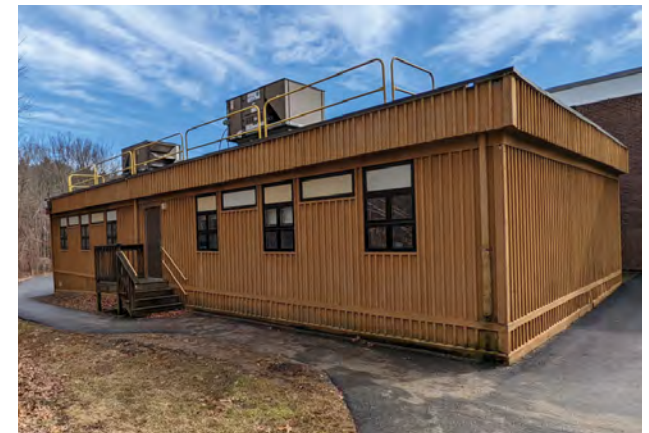
The main structural system consists of a steel frame with concrete floor slabs and frost walls. There are some cracks in the masonry that should be re-pointed and monitored for future cracking. Corroded lintels and steel members should also be remediated in conjunction with any masonry repairs.

The modular classrooms are of two separate vintages, both consisting of wood frame construction with membrane roofing. One is clad in vinyl brick siding while the other is clad in wood battens. The modulares have served the district well for many years and are not intended for long-term utilization, as is seen here. We recommend removal of these structures.

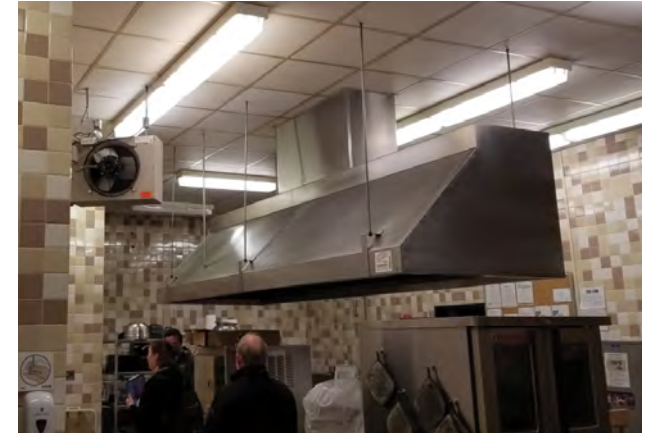
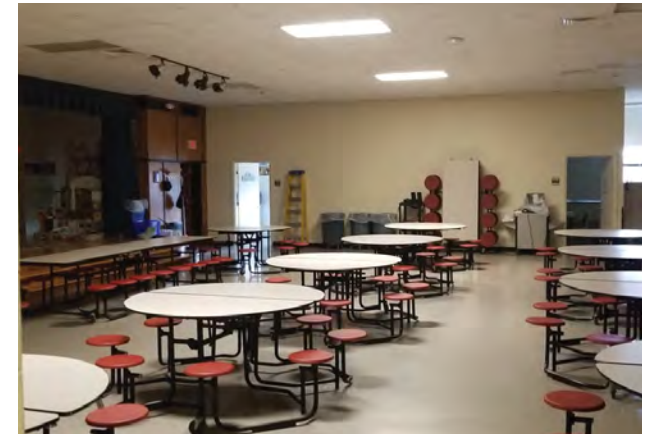
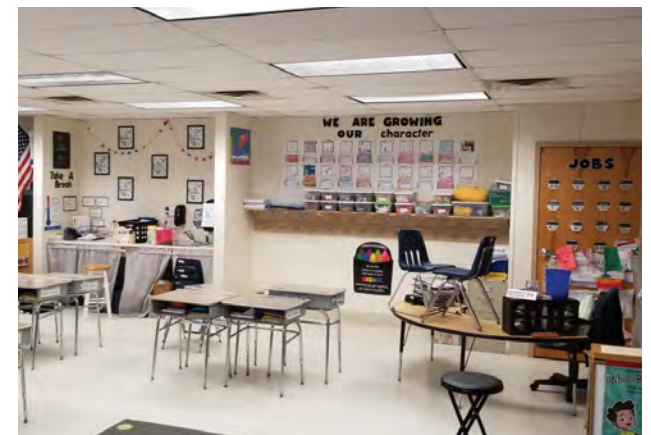
There is currently no fire suppression system serving the building. The kitchen hood also had no chemical-based suppression system; however, the equipment below the hood would not require such a system. If any additions or substantial renovations are proposed, the code would require a building-wide suppression system to be installed.

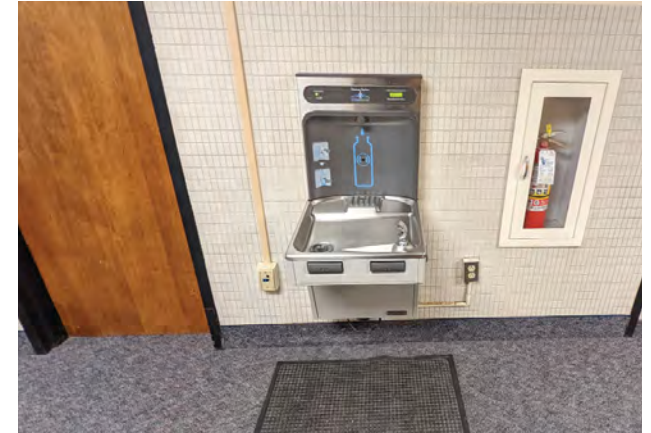
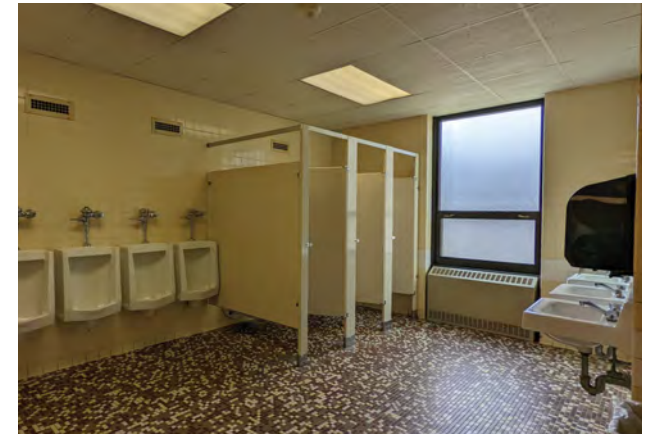
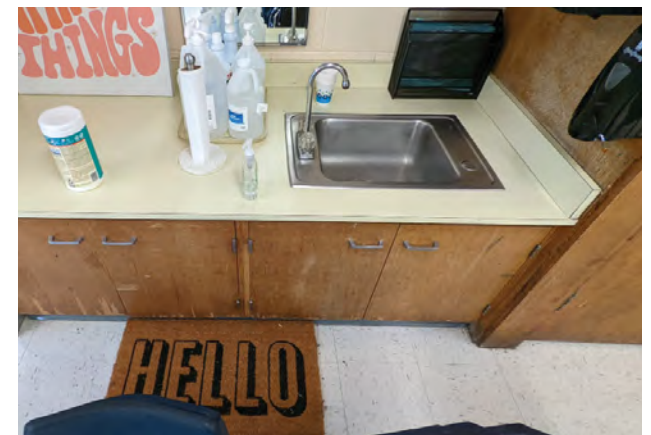
Janitor sinks inspected during our walk-through had faucet trim with vacuum breakers to limit backflow contamination caused by siphonage.

Fixtures are a mix of vintage with some restrooms renovated with water-saving-type fixtures compliant with the code enforced at the time of the upgrade. Apparently, maintenance is routinely performed on faucets, toilet flush valves, etc. as needed

As renovations occur, the following items should be considered: replace all flushometers/faucets with automatic low flow flushometers/faucets.

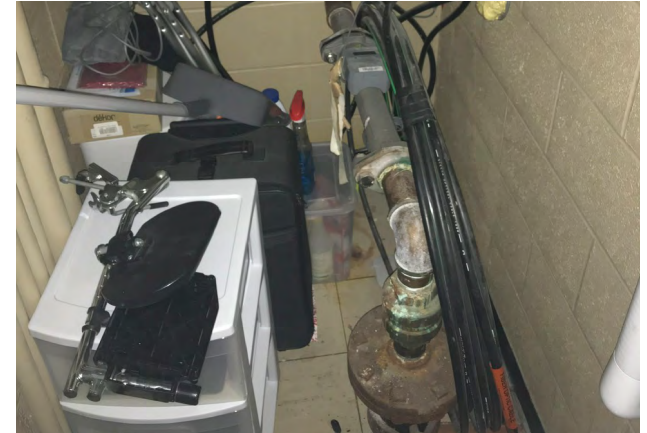
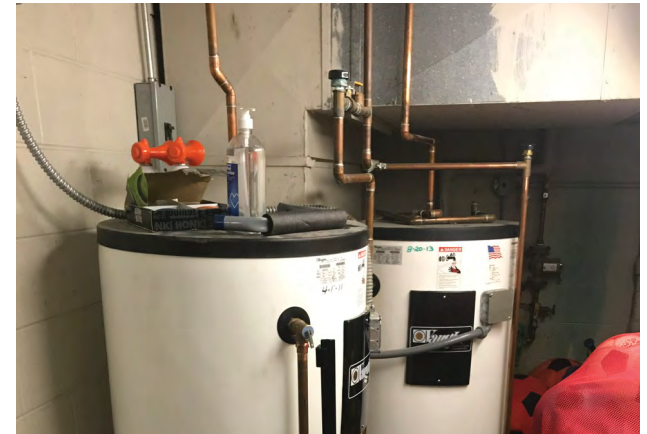
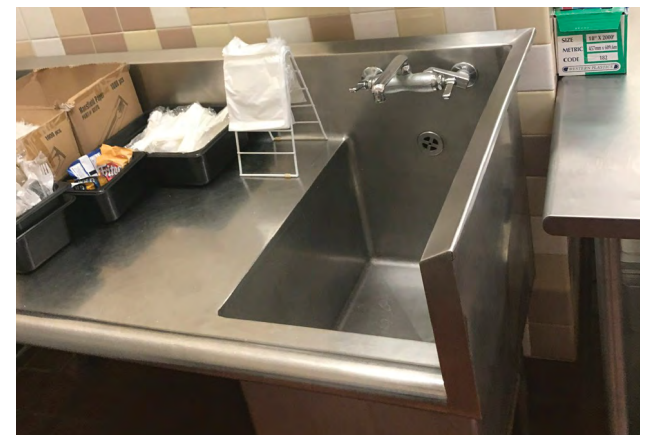
We noted most of the piping in the building appears to be copper, and, based on its age, should be in good condition; however, this can vary based on water quality. We recommend a pipe sample from both the cold and hot water system be taken to verify pipe condition.

The water heaters have no active signs of leakage; however, they have both either met or exceeded their useful expected service life at near or over 10 years of age, and as such should be considered a candidate for replacement in the near future.

There is one recirculation pump on the domestic hot water system, which is required per the current plumbing code since there are fixtures located beyond 100 feet of the hot water source.

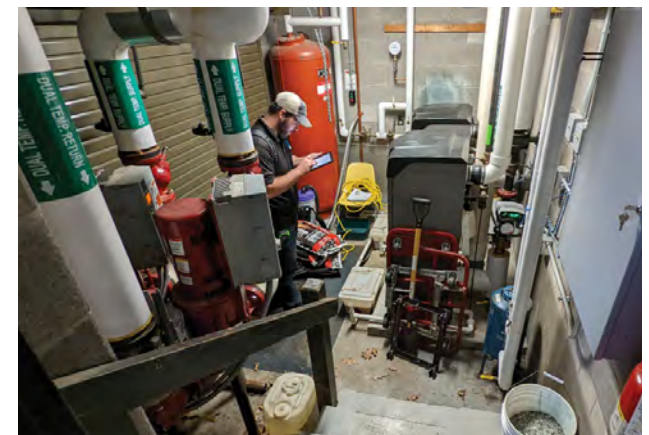
The heating needs for the building are supported by two (2) Lochinvar #FTX850N fire-tube gas-fired boilers installed in 2016. Each boiler has a rated input capacity of 850,000 BTUH. The boilers are high-efficiency condensing style, and, at 6 years old, are in good condition and well within their useful service life.

An air-cooled chiller with pump package supports a majority of the building classrooms' air conditioning needs. The chiller is a York/JCI #YLAA0070SE series rotary scroll unit with an approximate capacity of 70-tons. The chiller uses R-134A refrigerant. At 6 years of age, the chiller is well within its useful service life of 20 years as defined by ASHRAE. The chiller includes dual pumps in a lead/stand-by configuration.

Classroom unit ventilators are located throughout the classroom segments of the building. These units are located along exterior walls, and each has an outdoor air louver and associate control dampers to allow outdoor air to enter the classroom space through the unit ventilator. During occupied periods, the unit fans run continuously to provide space ventilation, and electric valves modulate hot water flow through the units to maintain space temperature. The unit ventilators are manufactured by JCI/York with most having a nominal supply airflow capacity of 1,500 CFM. Classroom exhaust in much of the building is supported by a centralized exhaust fans located on the building roof. In most cases, the fans serve multiple rooms.

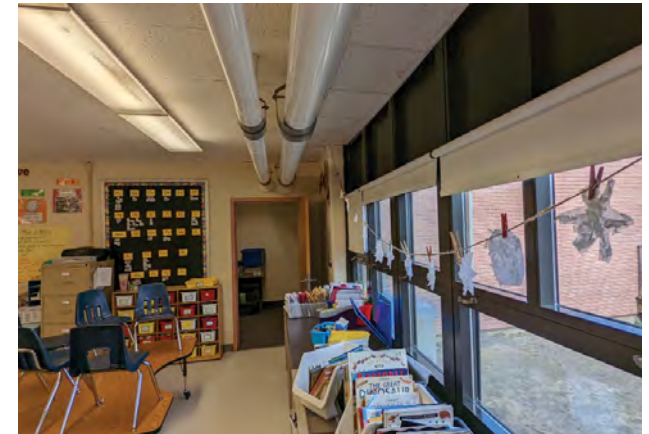
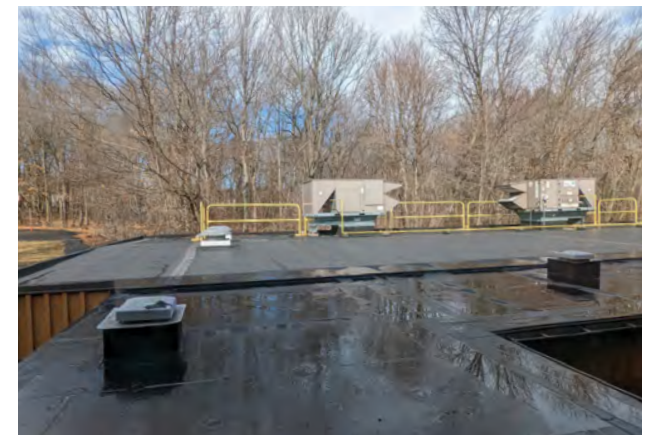
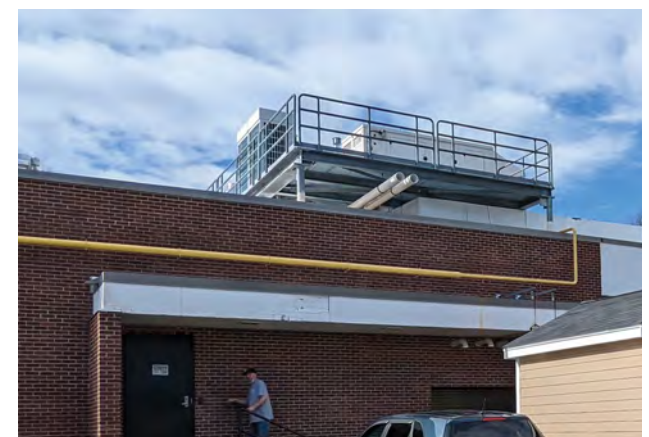
The cafeteria and the gym space are heated, cooled, and ventilated through the use of packaged roof-top units tagged as RTU-1 for the cafeteria and RTU-2 for the gym. Each unit includes filter sections, gas-fired heating section, DX cooling coil & condenser section, supply fan, and exhaust fan. In addition, the cafeteria unit has an energy recovery wheel to pretreat outdoor air with recaptured energy from the exhaust air. Both units have a nominal cooling capacity of 14-tons.

Most of the HVAC equipment, including the rooftop units, exhaust fans, classroom unit ventilators and the like, are all in good condition and being only 6 years old are well within their useful service life of 20 to 25 years, as defined in ASHRAE.

The building appears to have a building-wide DDC energy management system throughout. The system is manufactured and supported by Johnson Controls. According to facility personnel, the system has undergone and continues to undergo upgrades. Sequences should be reviewed further as additional indoor air quality and energy-saving routines may be possible.

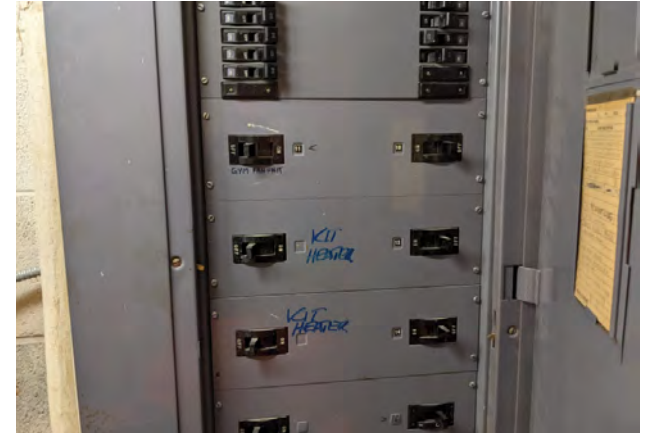
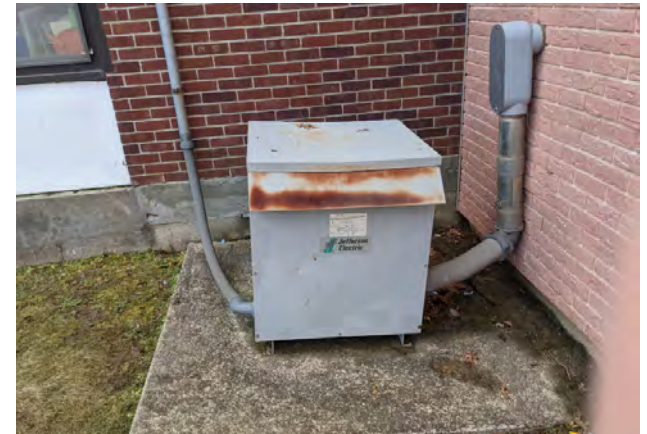
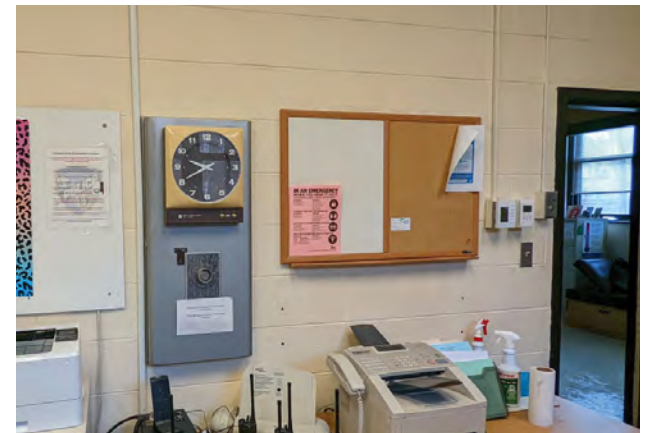
The building electrical service is rated 1000 amperes, 480/277 volt, 3-phase, 4-wire. The service consists of a utility company pad-mount transformer on the exterior of the building and underground feeds to the electrical service equipment. The electrical distribution equipment is by Square D. Maintenance of the switch board is recommended by the manufacturer and NETA.

The panelboards in the building are by General Square D. The panelboards are located throughout the building in electrical rooms and are circuit breaker type. Several different types of wiring methods were observed, namely wires in raceway, metal clad (MC) cable, and armored cable (AC). Maintenance of the panelboards is recommended by the manufacturer and NETA.

The egress and exit lighting are through battery-powered exit signs and emergency lighting units. ART observed that emergency lighting was not installed at all the exit discharge leading to a public way. It is recommended to test the emergency egress and exit lighting system and rectify any discrepancies.

The ambient lighting system in the building consists of various types of fixtures (recessed, surface, pendant, etc.) primarily with fluorescent lamps. The lighting system is inefficient and does not meet current energy codes. The lighting throughout the facility is controlled with snap switches. Ambient light system consisting of LED light fixtures should be provided. Networking lighting controls including occupancy, vacancy, and daylight sensors should also be provided.

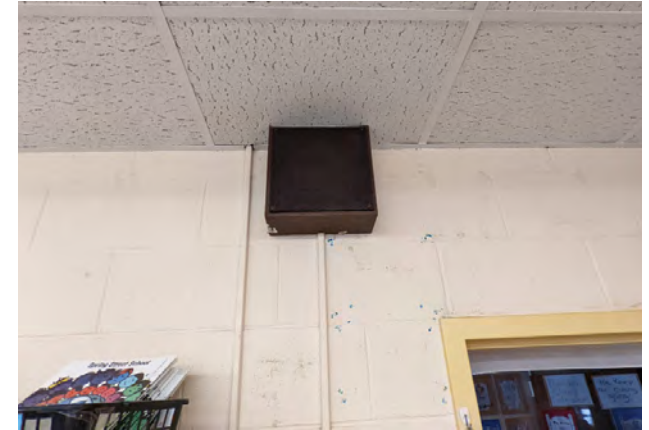
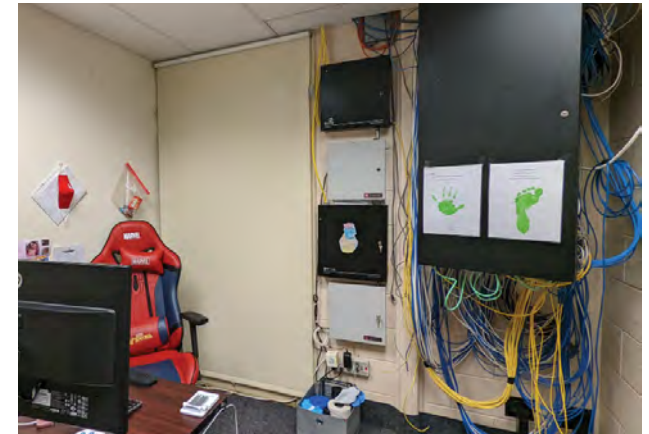
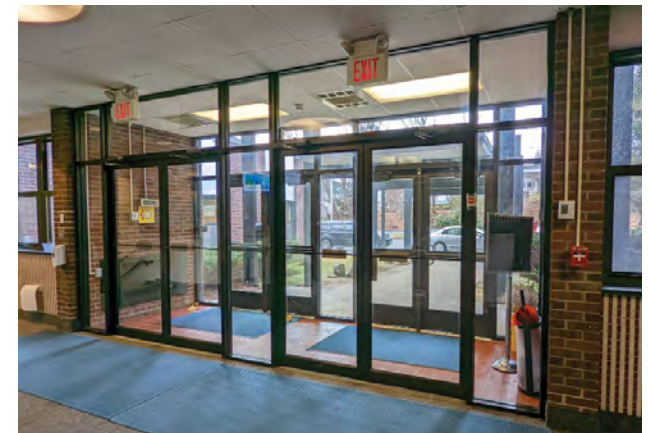
PA speakers are located in public and common areas as well as in classrooms. The PA and clock systems appear to be in good working condition and meet the current programming needs. The PA system is Telecenter by Rauland Borg.

The video surveillance system is by Exacq with Axis cameras. The access control system is by Brivo. Card readers are provided at the exterior door entries. Building entry is through Aiphone video entry station.

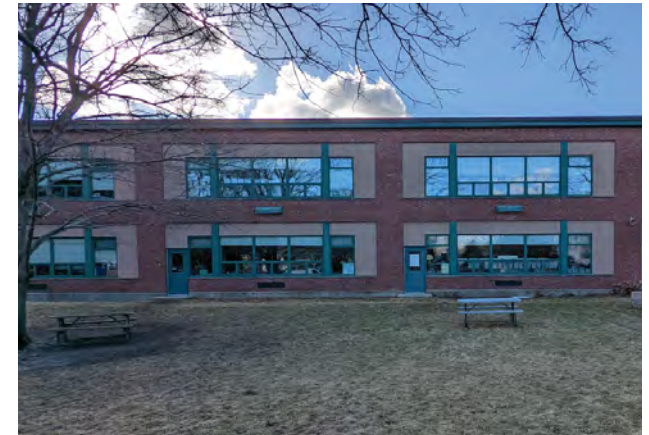
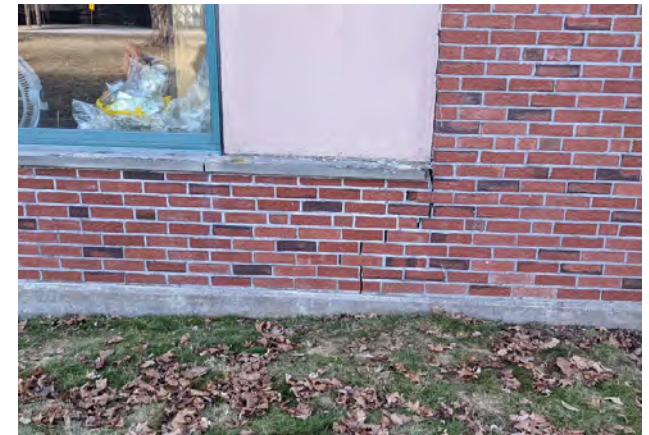
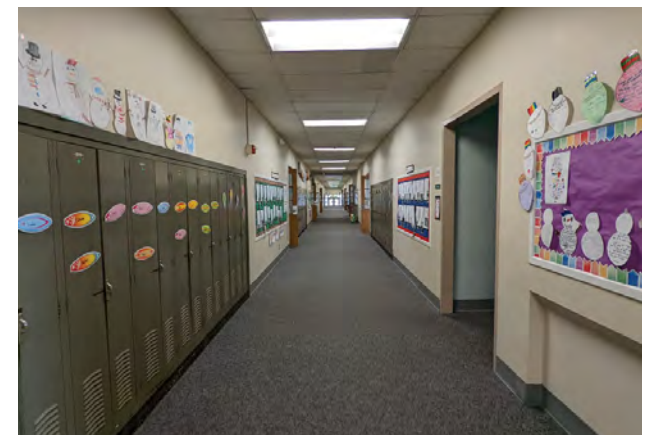
The exterior walls consist of brick masonry, stone veneer, and stucco. As previously reported, the exterior joints where sealant was used have failed. LPA|A observed some replacement/repairs of these joints, but many still require attention. The brick masonry requires repointing/resetting/re-anchoring of bricks at several locations to ensure the envelope is watertight. Corroded steel lintels have led to spalling/shifting bricks and should be replaced. There are some smaller concrete repairs that are also required to prevent further deterioration.

The roof is comprised of black EPDM over mechanically-fastened insulation. Based on previous reports, the roofing has several deficiencies, including splits in flashing, damaged metal roof edge, unadhered membrane, and raised insulation fasteners. These deficiencies are minor in nature but should be addressed before they lead to water infiltration. The roof has approximately 5 more years before full replacement will be needed.

The building consists of aluminum-framed windows and hollow metal doors and frames. The doors and windows are in good-to-fair condition with the exception of failed sealants and corroded lintels. The sealants and lintels should be replaced and maintained through a comprehensive maintenance plan.

The interior walls consist of painted & glazed concrete masonry units and gypsum block walls with plaster finish. These walls are all in good condition and provide good acoustical separation between spaces. The flooring is best characterized as in fair condition and consists of carpet, VCT, wood, and ceramic tile. The ceiling primarily consists of acoustical ceiling tiles with some plaster ceilings, all of which are in good condition except where leaks have occurred. The items that have the most amount of wear on them are the doors, frames, and lockers, all of which are original to the building.

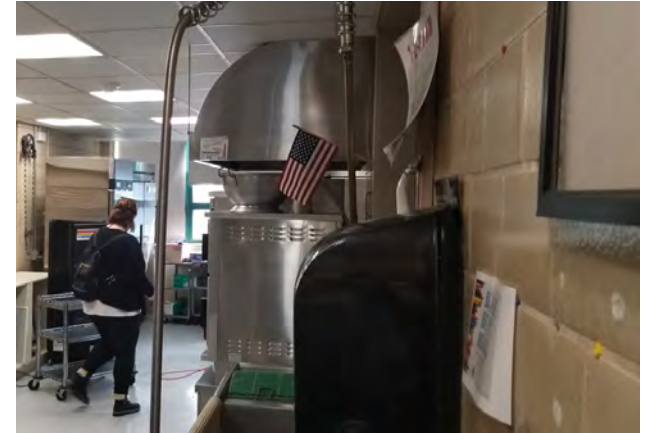
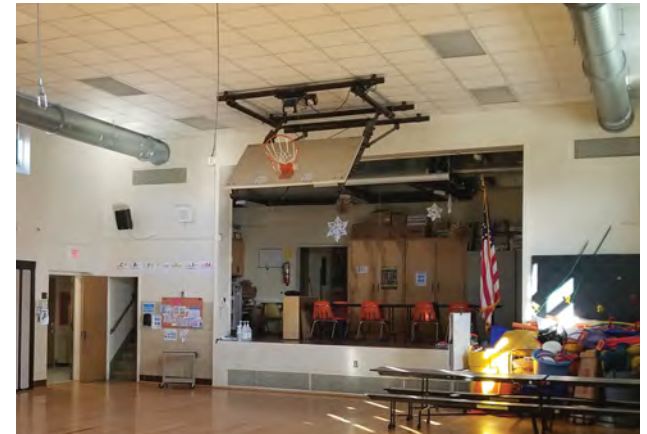
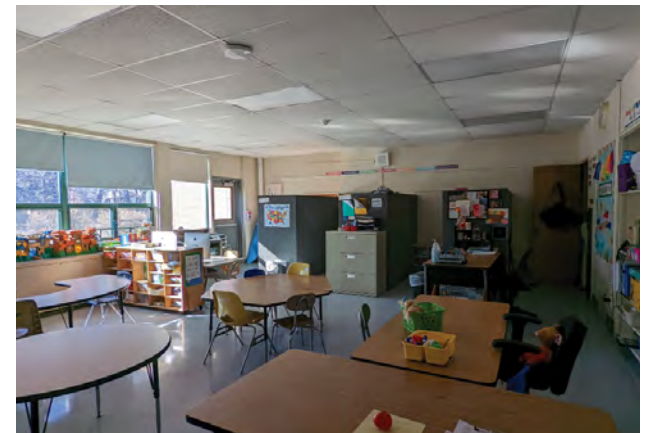
There is currently no fire suppression system serving the building. The kitchen hood also had no chemical-based suppression system, however, the equipment below the hood would not require such a system. If any additions are proposed or any substantial renovations, the code would require a building wide suppression system be installed.

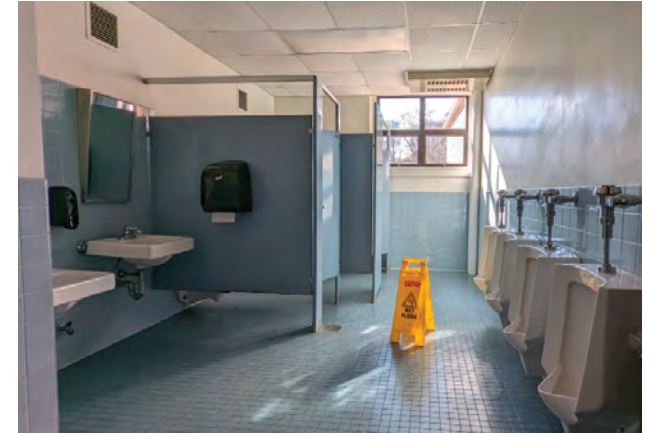
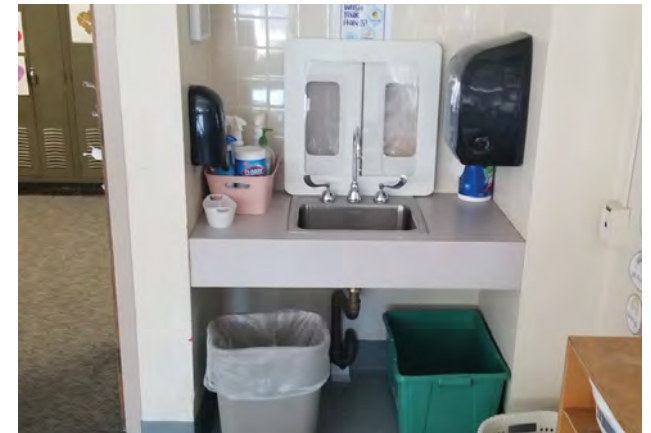
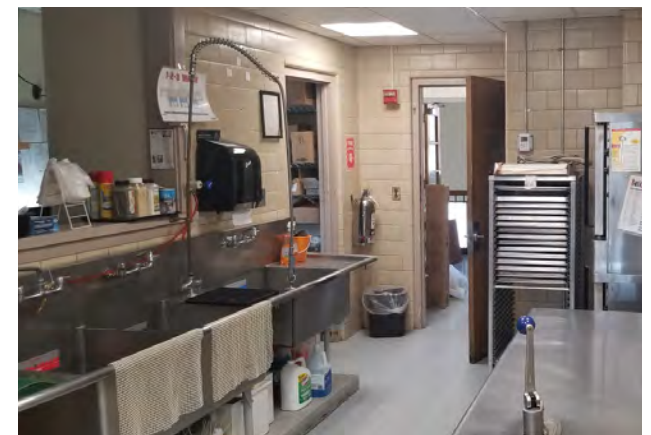
Walter J Paton School | Plumbing

Janitor sinks inspected during our walk-through had faucet trim with vacuum breakers to limit backflow contamination caused by siphonage. Based on the age of the building renovations, we expect that all are code compliant.

Fixtures are a mix of vintage with most in restrooms from a 1999/2000 renovation and, as such, are of the water-saving type for the code enforced at the time of the upgrade. Apparently, maintenance is routinely performed on faucets, toilet flush valves, etc. as needed.

As renovations occur, the following items should be considered: replace all flushometers/faucets with automatic low flow flushometers/faucets.

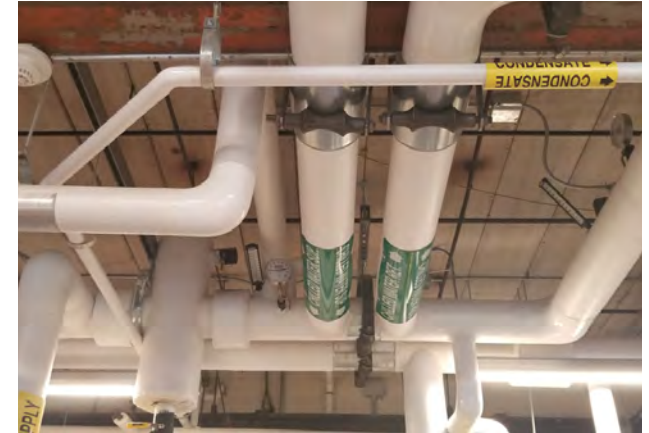
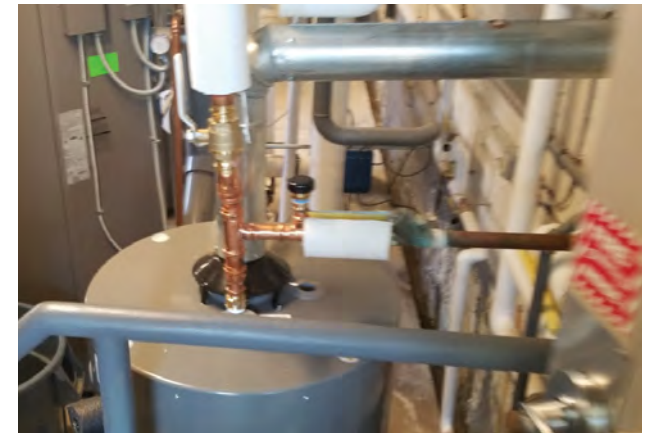
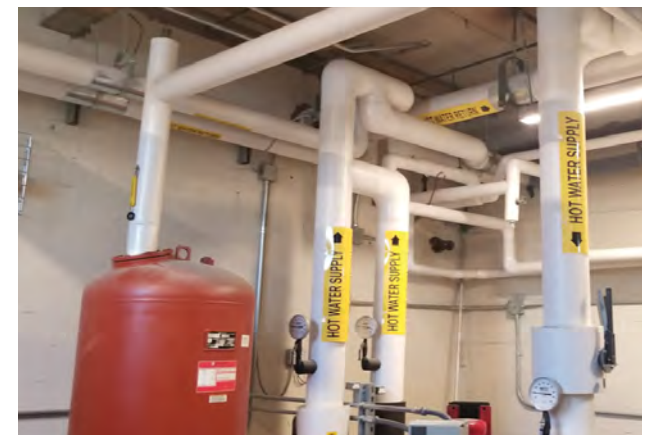
Walter J Paton School | Plumbing

We noted most of the piping in the building appears to be copper and based on its age should be in good condition however, this can vary based on water quality. We recommend a pipe sample from both the cold and hot water system be taken to verify pipe condition.

The water heater has no active signs of leakage; however, it is nearing the end of its useful expected service life of 10 years of age and as such should be considered a candidate for replacement in the near future.

There is a central mixing valve station on the main hot water supply which serves most of the building fixtures. It appears there may be a higher temperature water line that runs to the kitchen. Current code would require differing water temperatures at different types of fixtures. Lavatory sinks and showers must not discharge hot water at a temperature exceeding 110–112°F for safety reasons, whereas service fixtures (janitor’s sinks, kitchen sinks, etc.) are required to have hot water temperatures in excess of 120°F for sanitation reasons. The current system appears to supply a single temperature water to the building. After that, proper water supply to lavatories and showers should be accomplished by local mixing valves and/or fixtures with appropriate mixing limit stops. It appears the domestic hot water storage tanks are kept at approximately 140°F which is essential to prevent the possibility of bacteria growth within the tanks. It is recommend that the central mixing valve should be replace with an electronic type.

There is one recirculation pump on the domestic hot water system, which is required per the current plumbing code since there are fixtures located beyond 100 feet of the hot water source. The domestic hot water heaters should be replaced with high efficiency condensing gas-fired style.

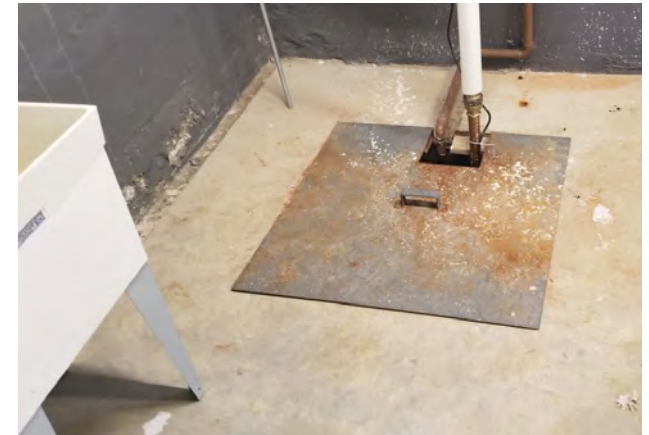
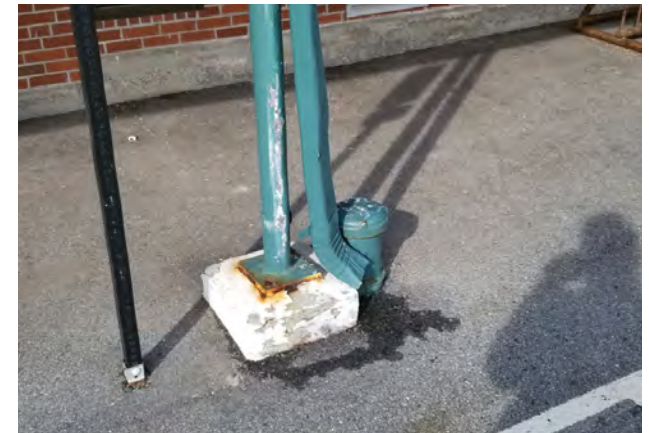
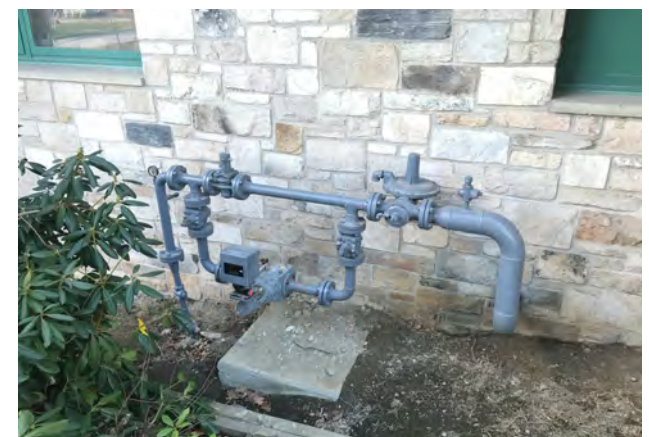
Walter J Paton School | Plumbing

Roof storm water is drained via roof drains connecting to internal leaders. The lines presumably exit to a municipal storm water system. The building does not appear to have any emergency roof overflow drains. These are required by current code as a clogged drain can lead to water build-up on the roof and structural failure due to weight. During any reroofing project or building upgrade, we highly recommend emergency roof drains be added. The emergency drains should be added near the current roof drains and run to discharge to the side of the building. The visible discharge location is required as it gives users and indication of a failed main drain system.

A natural gas service meter is located outside the building along the front/street side of the building. A 1.25" intermediate line fed by Eversource exits grade and serves a rotary style gas meter, then runs through a pressure reducer prior to increasing to 4" and entering a building crawl space. The 4" service main feeds the gas loads in the building which include the heating boilers, domestic hot water boilers, and kitchen cooking loads.

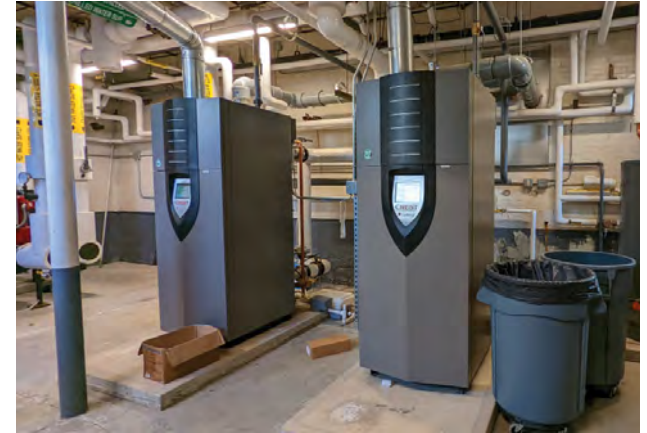
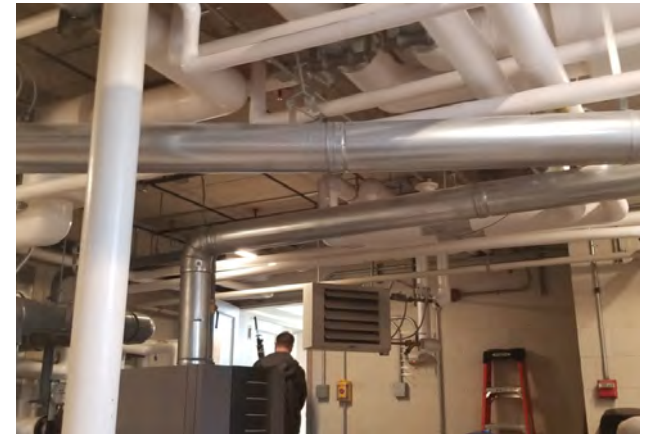
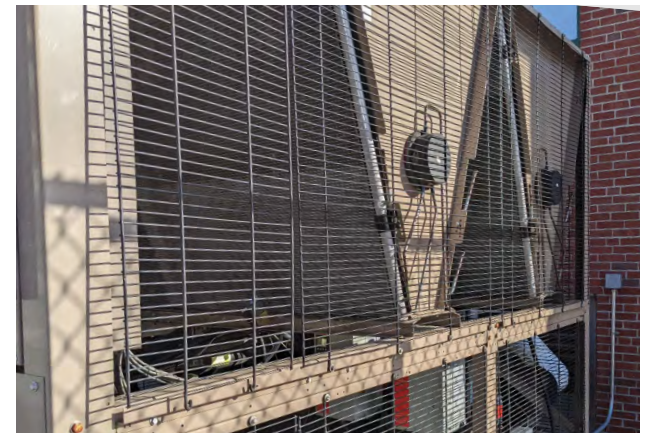
Walter J Paton School | HVAC

The heating needs for the building are supported by two (2) Lochinvar #FBN1001 fire-tube gas fired boilers installed in 2016. Each boiler has a rated input capacity of 1,000,000 BTUH. The boilers are high efficiency condensing style and at 6 years old are in good condition and well withing their useful service life.

An air-cooled chiller with pump package supports a majority of the building classrooms' air conditioning needs. The chiller is a York/JCI #YLAA0070SE series rotary scroll unit with an approximate capacity of 70 tons. The chiller uses R-134A refrigerant. At 6 years of age, the chiller is well within its useful service life of 20 years as defined by ASHRAE. The chiller includes dual pumps in a lead/stand-by configuration.

Classroom unit ventilators are located throughout the classroom segments of the building. These units are located along exterior walls, and each has an outdoor air louver and associate control dampers to allow outdoor air to enter the classroom space through the unit ventilator. During occupied periods, the unit fans run continuously to provide space ventilation and electric valves modulate hot or chilled water flow through the units to maintain space temperature. The unit ventilators are manufactured by JCI/York with most having a nominal supply airflow capacity of 1,000 CFM. Classroom exhaust in much of the building is supported by a centralized exhaust fans located on the building roof. In most cases the fans serve multiple rooms.

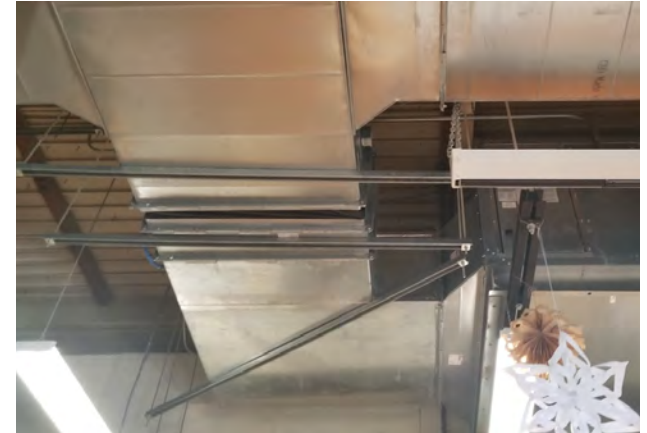
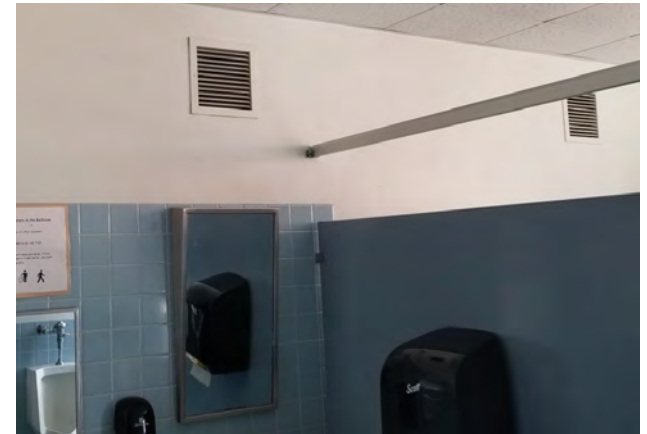
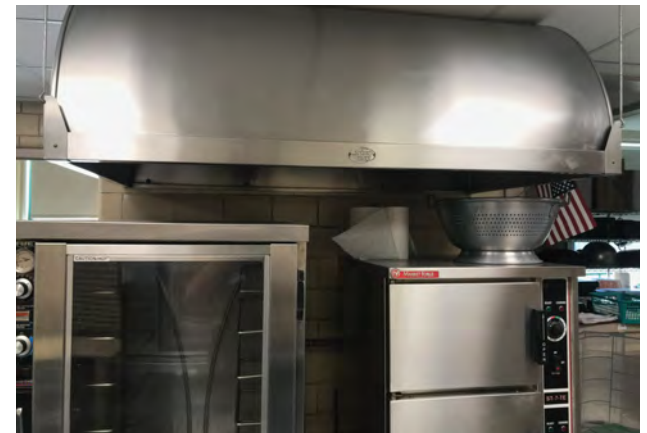
Walter J Paton School | HVAC

The cafeteria/gym space is heated, cooled, and ventilated with an indoor air handling unit with fan section, filter sections, hydronic heating coil section and DX cooling coil section. An exterior grade mounted condensing unit supports the cooling needs of this air handling unit. The split AHU system is manufactured by York/JCI and has a nominal cooling capacity of 20 tons.

The modular addition portion of the building is supported by packaged rooftop heating and cooling units. The units are nearing the end of their useful service life and are candidates for replacement.

The building appears to have a building wide DDC energy management system throughout. The system is manufactured and supported by Siemens. The controls appear to incorporate many energy-saving routines such as demand ventilation reset based on CO2 sensors as well as intelligent recovery. Sequences should be reviewed further as additional indoor air quality and energy-saving routines may be possible.
