13 March 2023

Shrewsbury Public Schools Pre-K-12
Capital Inventory & Improvement Study

TABLE OF CONTENTS

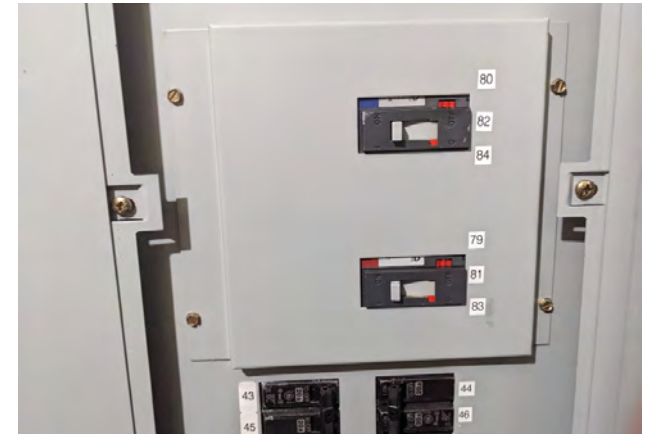
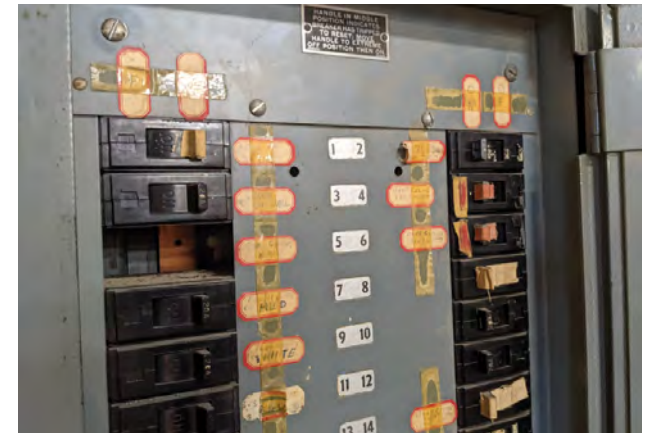
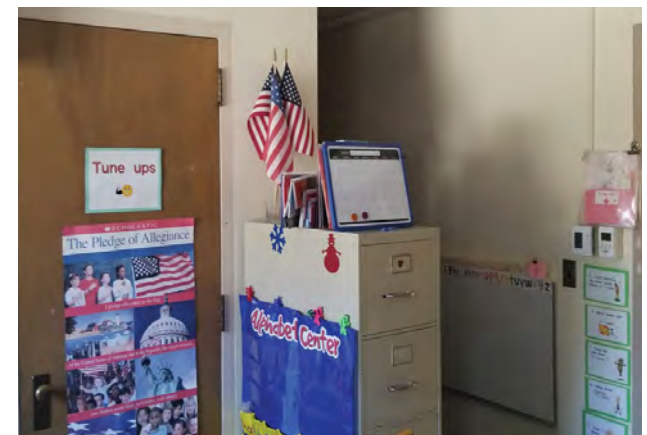
Walter J Paton School | Electrical

The building electrical service is rated 1200 amperes, 208/120 volts, 3-phase, 4-wire. The service consists of a utility company pad-mount transformer on the exterior of the building and underground feeds to the electrical service equipment. The 1200A distribution is on the exterior of the building. The electrical distribution equipment is by General Electric. Maintenance of the switch board is recommended by the Manufacturer and NETA.

The panelboards in the building installed as part of the mechanical systems upgrades are by General Electric. Panelboards original to the building are by Trumbull Elec. Co., Federal Pacific, etc. which are no longer supported. Panelboards by other manufacturers have been installed over the years. The panelboards are located throughout the building in electrical rooms and are circuit breaker type. Several different types of wiring methods were observed, namely wires in raceway, metal clad (MC) cable, and armored cable (AC). Electrical distribution equipment should be replaced.

The egress and exit lighting are through battery powered exit signs and emergency lighting units. ART observed that emergency lighting was not installed at all the exit discharge leading to a public way. It is recommended to test the emergency egress and exit lighting system and rectify any discrepancies.

The ambient lighting system in the building consists of various types of fixtures (recessed, surface, pendant, etc.) primarily with fluorescent lamps. The lighting system is inefficient and does not meet current energy codes. The lighting throughout the facility is controlled with snap switches. Ambient light system consisting of LED light fixtures should be provided. Networking lighting controls including occupancy, vacancy, and daylight sensors should also be provided.

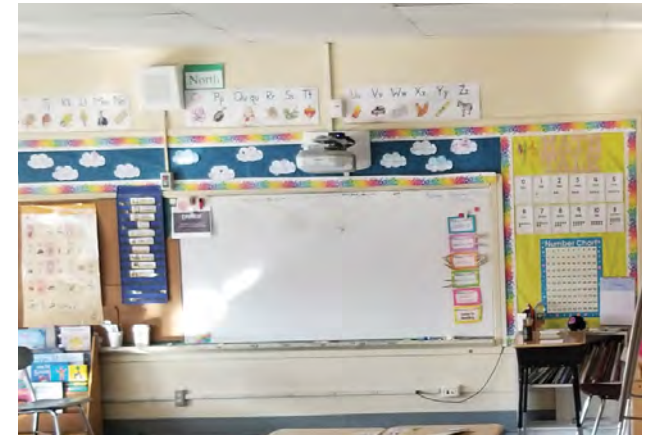
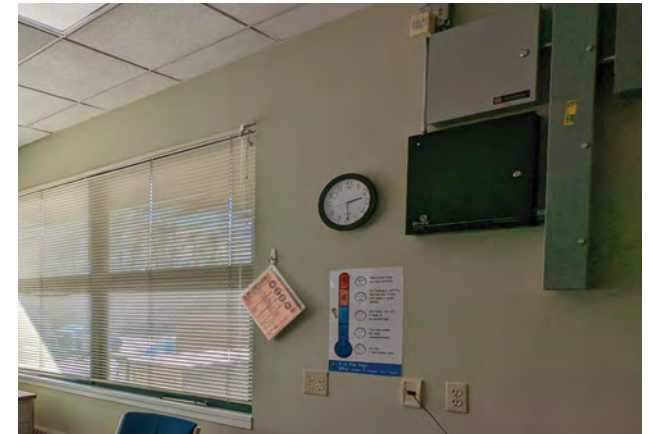
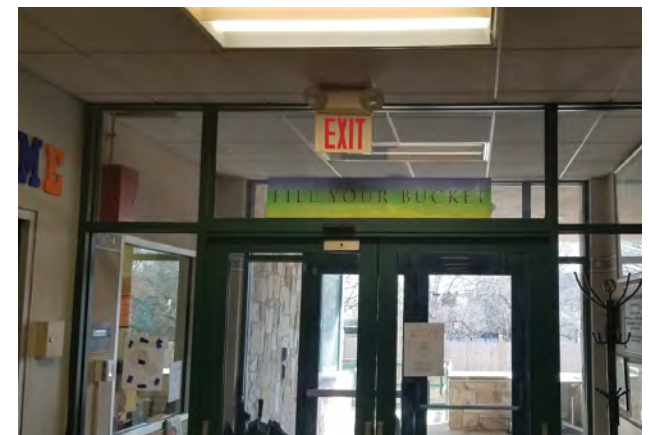
Walter J Paton School | Electrical

PA Speakers are located in public and common areas as well as in classrooms. The PA and clock systems appear to be in good working condition and meet the current programming needs. The PA system is Telecenter by Rauland Borg.

The video surveillance system is by Exacq with Axis cameras. The access control system is by Brivo. Card readers are provided at the exterior door entries. Building entry is through Aiphone video entry station. The existing systems are operational and meet current programming needs.

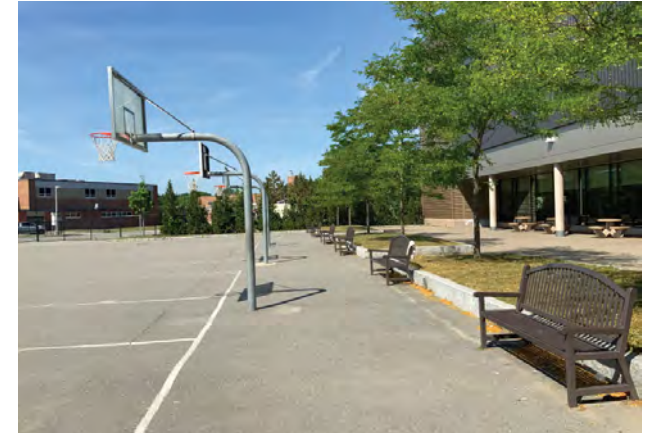
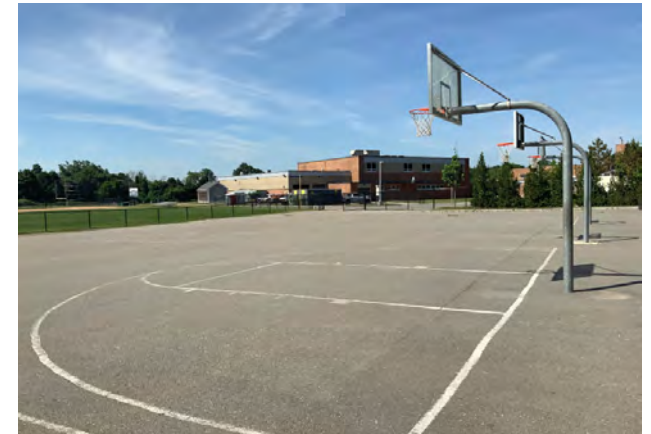
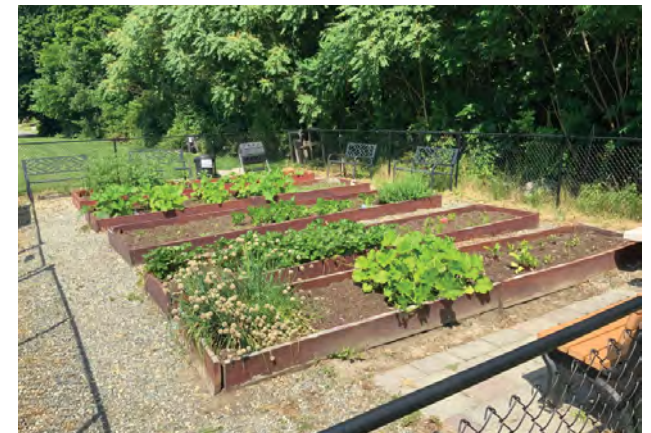
Sherwood Middle School | Site Review

The school's paved play area and basketball hoops are utilized by the neighborhood community outside of school hours and are in good condition. The school, however, does not have any type of age-appropriate play structures.

There is sufficient parking for staff and visitors to support daily operations. During special events, parking at the neighboring middle school and use of the paved play area meets the need. There are several pedestrian walkways throughout the site consisting of asphalt, concrete, and pavers. Overall condition of these features is good to fair. The site appears to have sufficient drainage given its current configuration.

The site landscaping would be best characterized as mature and well-established. There were some dead trees observed during our visit that should be removed and replaced. There are raised garden beds along the north side of the property that are maintained by the students.

There are several site furnishings located on the site, including trash receptacles, benches, signage, flag pole, and bicycle racks. These site furnishings are in good condition.

As previously reported, there are very few deficiencies regarding the site. The following items do not meet the current accessibility guidelines: picnic table [non-accessible], garden [surface/route], and fields/bleachers [route].

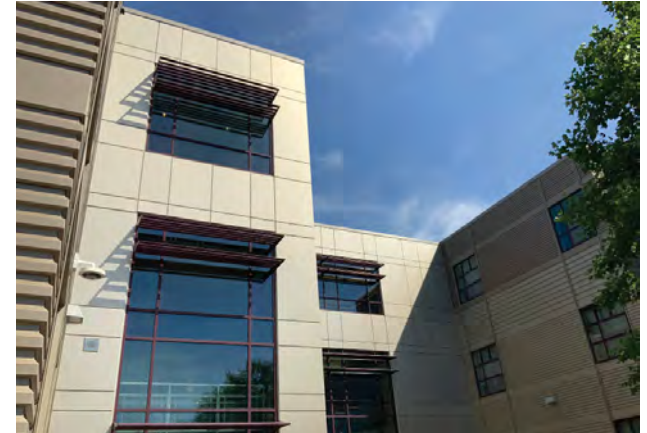
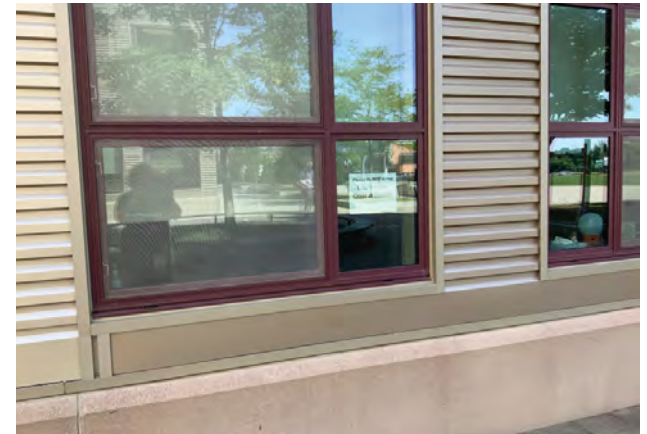
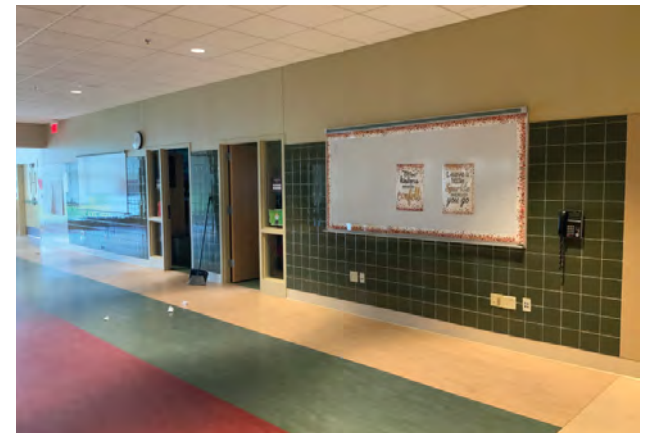
The exterior walls consist of aluminum composite metal [ACM] panels, precast concrete, concrete, and corrugated metal rain-screen siding. There are some small concrete repairs that are required to prevent further deterioration. Other than the issues with the concrete, no other deficiencies were observed. Exterior joint sealants should be monitored via a comprehensive maintenance plan and replaced as needed.

The roof is comprised of white EPDM over mechanically-fastened insulation. There are no known deficiencies with the roofing system.

The building consists of aluminum-framed windows and hollow metal doors and frames. The doors and windows are in good condition.

The interior walls consist of painted gypsum walls, ceramic tile, and plastic laminate paneling. These walls are all in good condition and provide good acoustical separation between spaces. The ceiling primarily consists of acoustical ceiling tiles with some gypsum ceilings, all of which are in good condition. The flooring consists of sheet linoleum, ceramic tile, and carpet, which are in good condition. Other than some large scrapes in the corridor flooring, there were no other items that showed signs of wear and tear.

As previously reported, there are very few deficiencies regarding the building. The following items do not meet the current accessibility guidelines: classroom sink skirts [non-accessible due to installation], media center work surface [non-accessible], signage [accessible means of egress], cane-detectable barriers under stairs [not provided], toilet compartment hardware [not provided], and accessible shower stall [clearances].

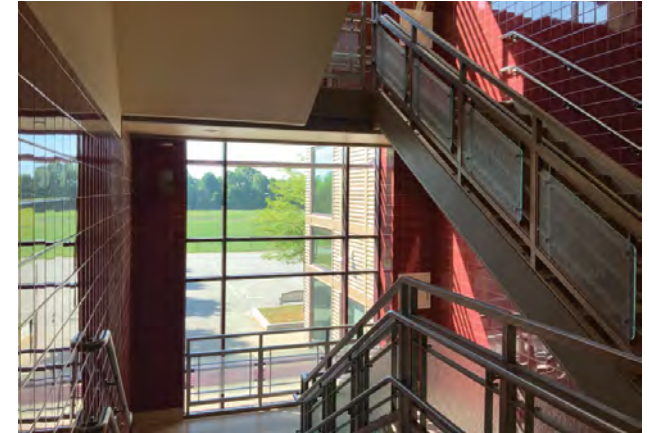
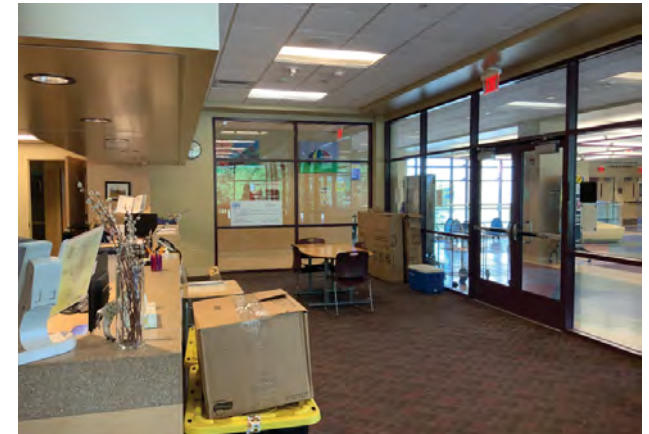
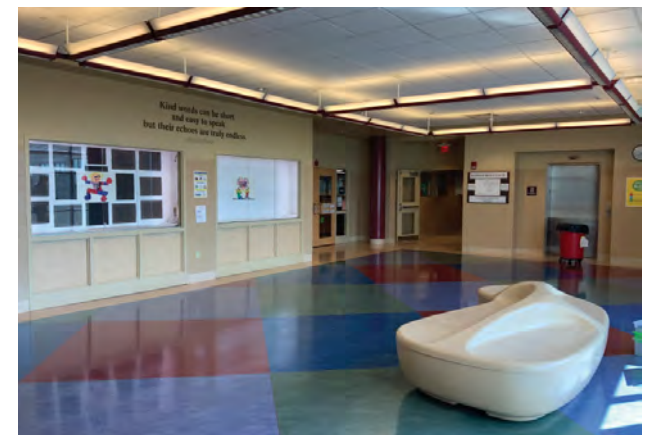
The main structural system consists of a wide-flange steel moment frame with concrete floor slabs, roof joists, and frost walls. There are no signs of structural issues.

The potential for any asbestos-containing materials within the building is unlikely given the age of the building. There are several other items that may require special disposal, including light fixtures, light ballasts, hydraulic door closers, and exit light batteries, should renovations/replacements be considered.

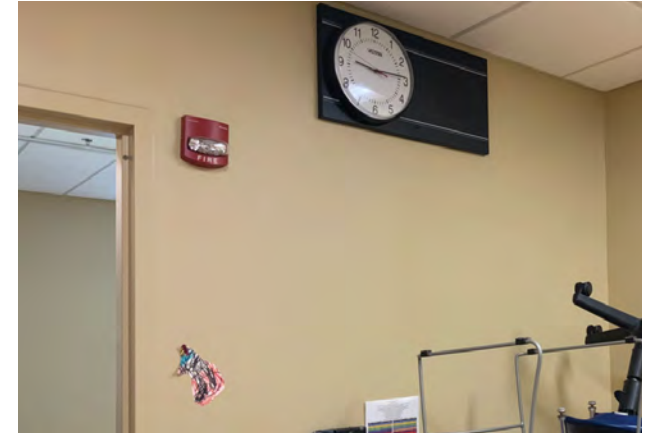
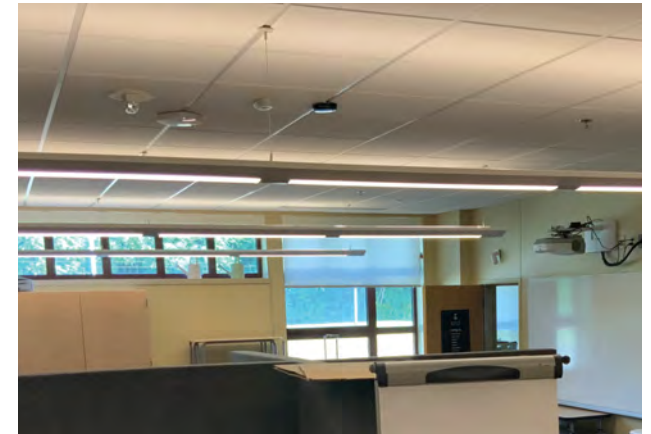
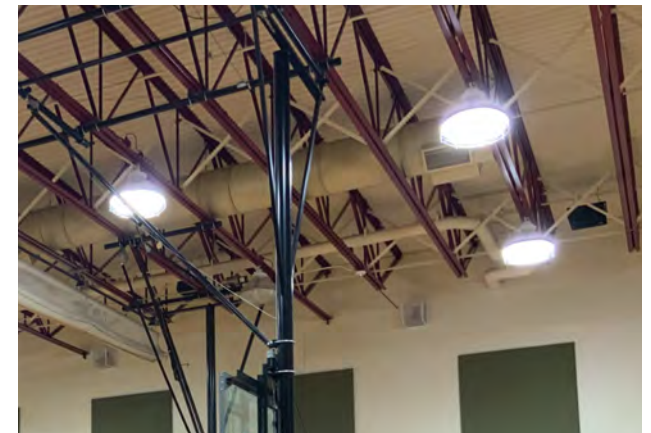
Sherwood Middle School | Fire Protection

The fire suppression system serving the building is a wet pipe type system which provides essentially complete coverage throughout the building except as otherwise noted herein.

The kitchen hood did have chemical-based suppression over equipment requiring such.

In general, the building's fire sprinkler coverage appears to be fairly comprehensive and compliant with current code.

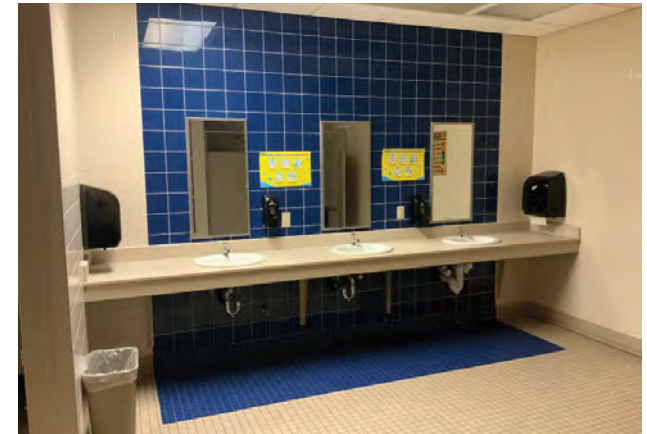
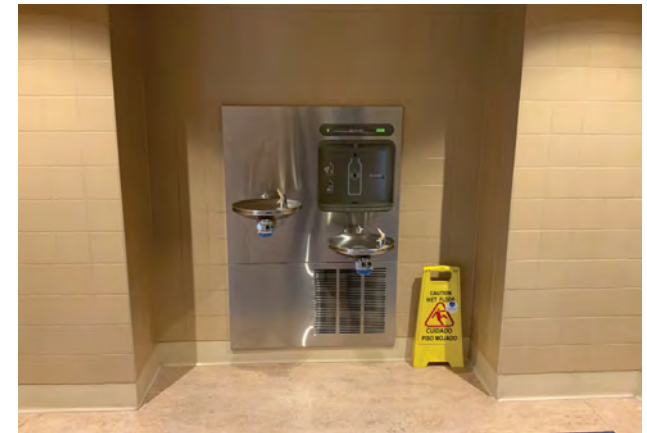
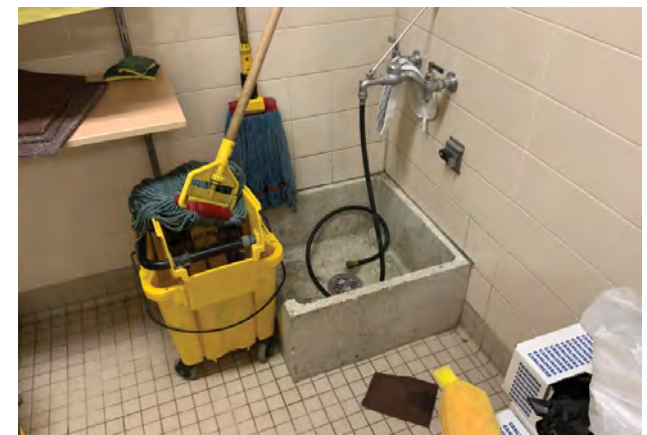
Sherwood Middle School | Plumbing

Janitor sinks inspected during our walk-through had faucet trim with vacuum breakers to limit backflow contamination caused by siphonage.

Fixtures are all of the same age as the building being installed in 2012. Apparently, maintenance is routinely performed on faucets, toilet flush valves, etc. as needed.

As renovations occur the following items should be considered: replace all flushometers/faucets with automatic low flow flushometers/faucets.

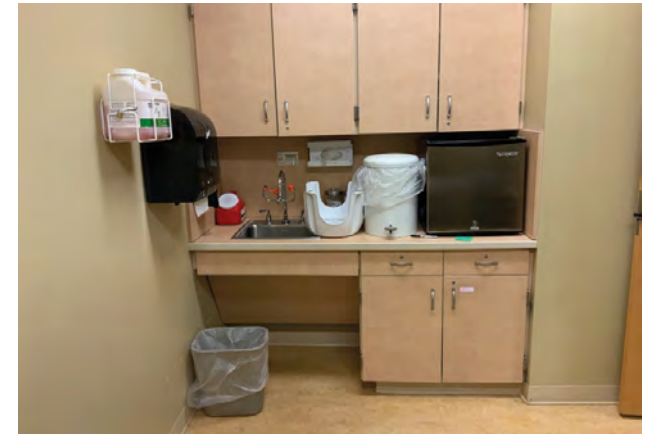
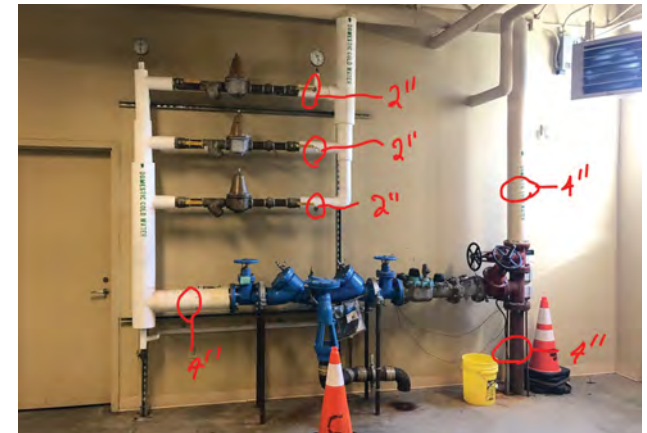
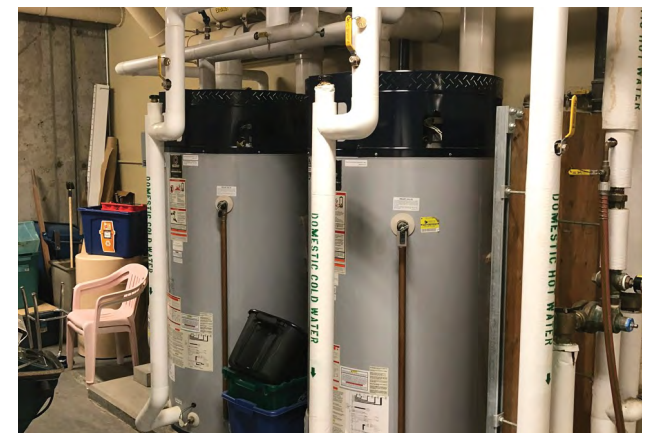
Sherwood Middle School | Plumbing

We noted most of the piping in the building appears to be copper, and, based on its age of only 10 years, should be in good condition.

The water heaters have no active signs of leakage; however, the tank units have either met or exceeded their useful expected service life at 10 years of age and as such should be considered a prime candidate for replacement in the near future. Life expectancy of the units is highly dependent on water quality.

The temperature/pressure gauge located at the outlet of the mixing valve has water in the gauge glass and should be replaced.

There is one recirculation pump on the domestic hot water system, which is required per the current plumbing code since there are fixtures located beyond 100 feet of the hot water source.

The domestic hot water heaters should be replaced with high efficiency condensing gas-fired style.

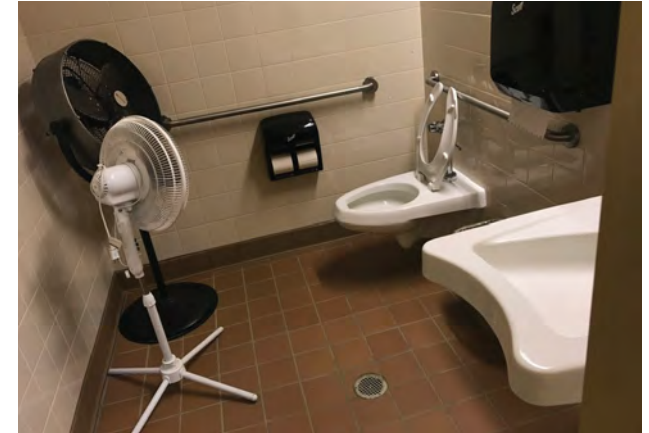
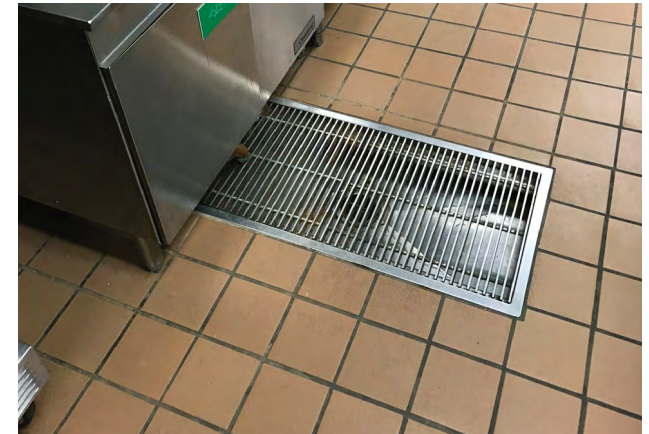
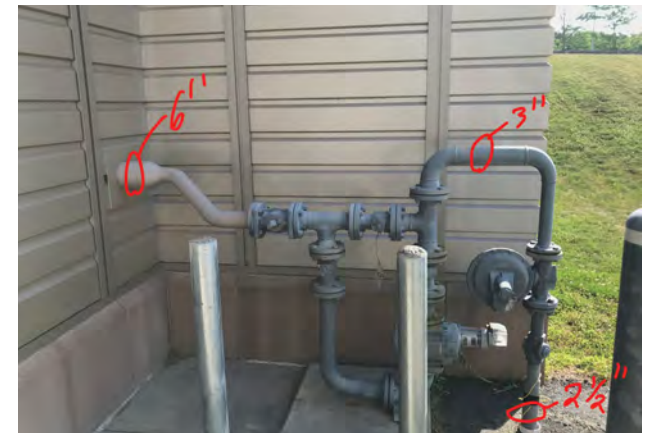
Sherwood Middle School | Plumbing

We noticed no other outward signs of failure in either the sanitary sewer system or the storm drainage system during our site inspection.

A natural gas service enters the building in the main-level mechanical room. The exterior service is a 2" intermediate gas pressure line which runs through a pressure regulator and a gas meter prior to increasing to 6" to feed the building's gas loads, which include the heating boilers, water heaters, and packaged rooftop equipment. The gas service to the building is supported by Eversource.

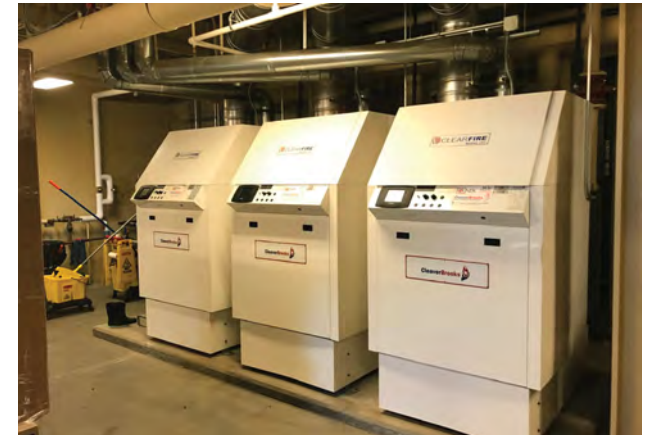
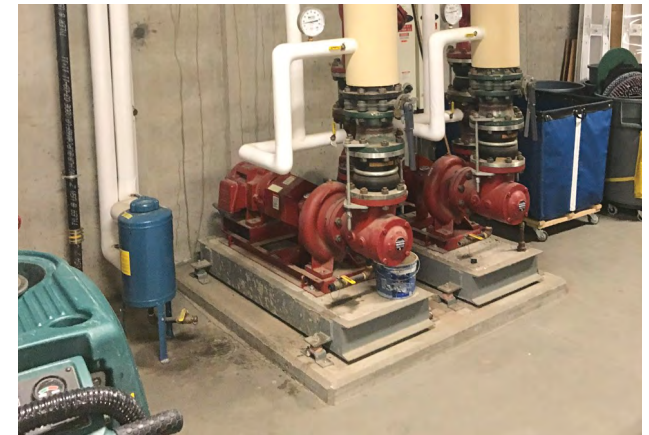
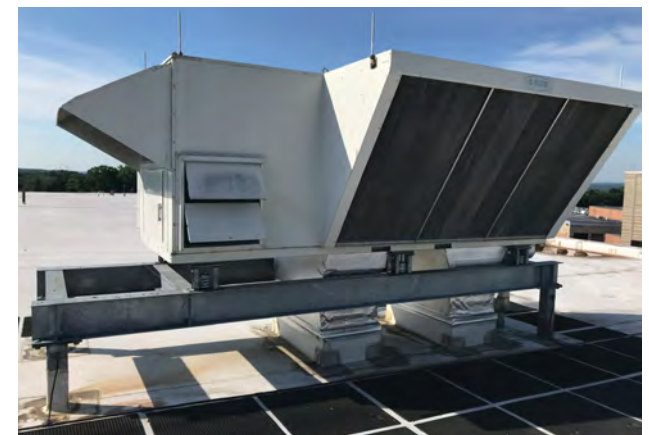
Sherwood Middle School | HVAC

The heating needs for the building are supported by three (3) CleaverBrook #CFC-700-1800 fire-tube gas fired boilers installed in 2012. Each boiler has a rated input capacity of 1,800,000 BTUH. The boilers are high efficiency condensing style and, at 10 years old, are in good condition and well within their useful service life.

A majority of the building's cooling, tempered heating and ventilation needs are supported by ten (10) packaged DX cooling, hot water heating rooftop units. The rooftop units are manufactured by Aaon and most incorporate a supply fan, exhaust fan, filter sections, DX coil with condenser section, hot water coil and a hot gas reheat coil for active dehumidification control. These units provide either full cooling or tempered cooling to the respective spaces.

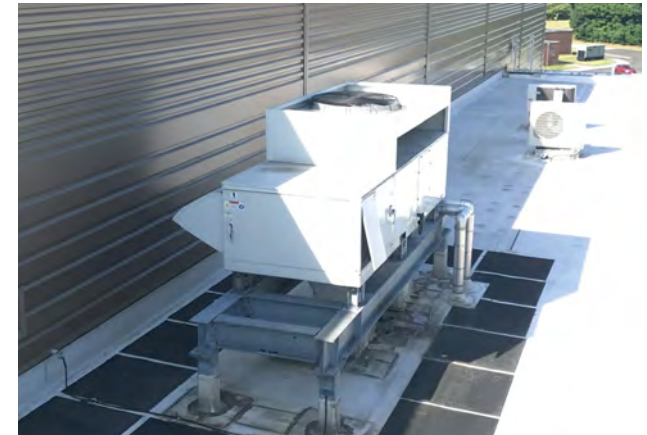
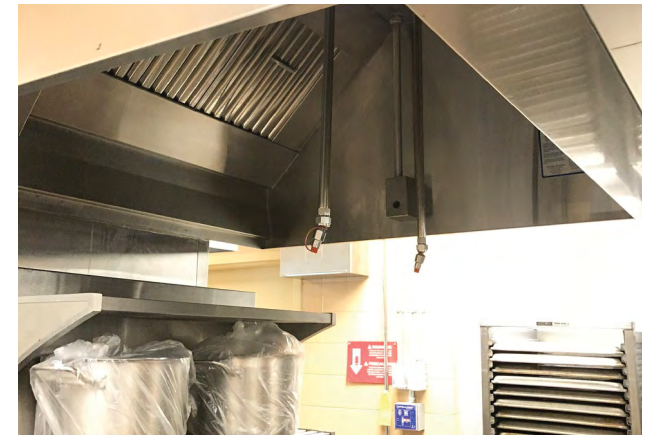
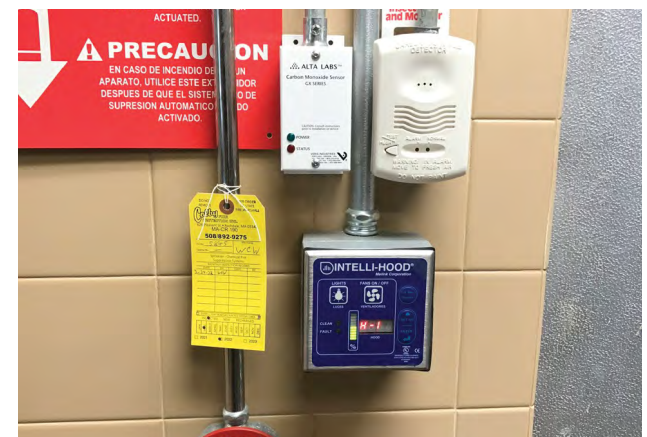
Sherwood Middle School | HVAC

- AHU-1: Kitchen Make-up Air, 6,000 CFM
- AHU-2: Café, 6,000 CFM, H&V with ERU & CO2 control
- AHU-3: Gymnasium, 12,000 CFM, H&V with CO2 control
- AHU-4: Lobbies, 8,000 CFM, H&V
- AHU-5 Locker Room 2,400 CFM, H&V with ERV
- RTU-1 Art Rooms, 1,900 CFM VAV, H&V with ERV and Dehum. Control
- RTU-2 Media & Tech., 8,000 CFM VAV, HVAC with ERV
- RTU-3 Office, 8,000 CFM VAV, HVAC with ERV
- RTU-4 Classrooms, 4,100 CFM VAV, H&V with ERV and Dehum. Control
- RTU-5 Classrooms, 3,000 CFM VAV, H&V with ERV and Dehum. Control
- RTU-6 Classrooms, 6,300 CFM VAV, H&V with ERV and Dehum. Control
- RTU-7 Classrooms, 5,400 CFM VAV, H&V with ERV and Dehum. Control
- RTU-8 Band, 810 CFM, H&V with ERV and Dehum. Control
- RTU-9 Music/Drama, 945 CFM VAV, H&V with ERV and Dehum. Control
- RTU-10 Core Restrooms, 2,700 CFM, H&V with ERV

The lobby and the gymnasium air handling systems also have the capability to preheat the incoming outdoor air through the use of a passive solar wall. When used in the cooler months, the outdoor air for the units is pulled through a southerly-facing metal panel wall system to allow for some preheating of the outdoor air when solar conditions allow.

Most of the HVAC equipment including the rooftop units, air handlers, exhaust fans and the like are all in good condition and, being only 10 years old, are within their useful service life of 15 to 25 years as defined by ASHRAE.

The building appears to have a building wide DDC energy management system throughout. The system is manufactured and supported by Automated Building Systems. The controls appear to incorporate many energy saving routines such as demand ventilation reset based on CO2 sensors as well as intelligent recovery. Sequences should be reviewed further as additional indoor air quality and energy saving routines may be possible.

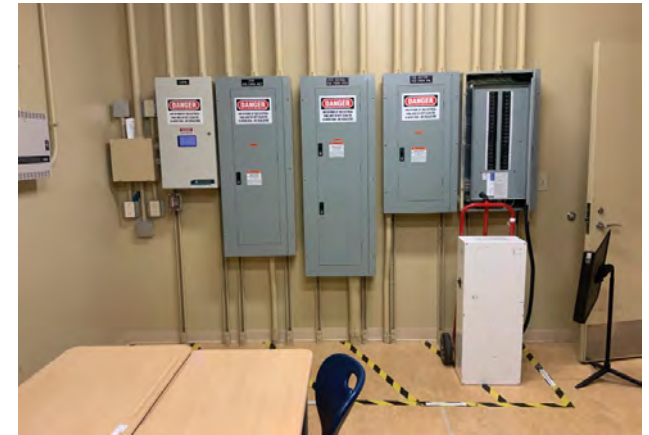
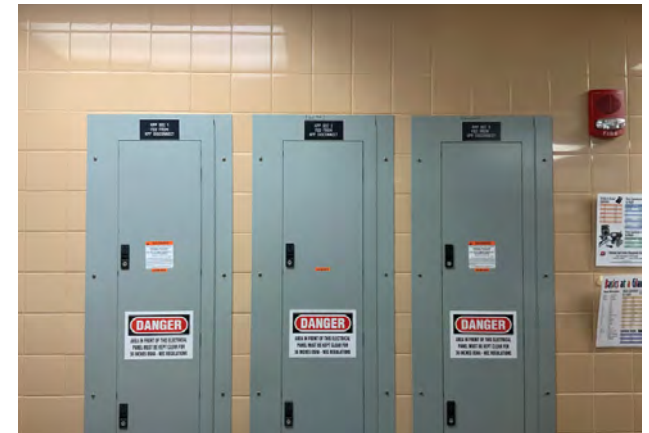
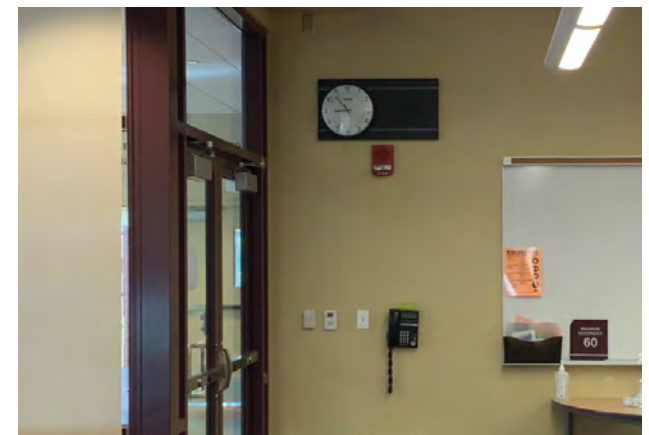
Sherwood Middle School | Electrical

The building electrical service is rated 1600 amperes, 480/277 volt, 3-phase, 4-wire. The service consists of a utility company pad-mount transformer on the exterior of the building and underground feeds to the electrical service equipment. The electrical distribution equipment is by General Electric. Maintenance of the switchboard is recommended by the manufacturer and NETA.

The panelboards in the building are by General Electric. The panelboards are located throughout the building in electrical rooms and are circuit breaker type. Several different types of wiring methods were observed, namely wires in raceway, metal clad (MC) cable, and armored cable (AC). Maintenance of the panelboards is recommended by the manufacturer and NETA.

The ambient lighting system in the building consists of various types of fixtures (recessed, surface, pendant, etc.) primarily with fluorescent lamps. The lighting system is inefficient and does not meet current energy codes. Lighting control is primarily by wall mounted switches, occupancy sensors and relay panels. Ambient light system consisting of LED light fixtures should be provided. Networking lighting controls including occupancy, vacancy, and daylight sensors should also be provided.

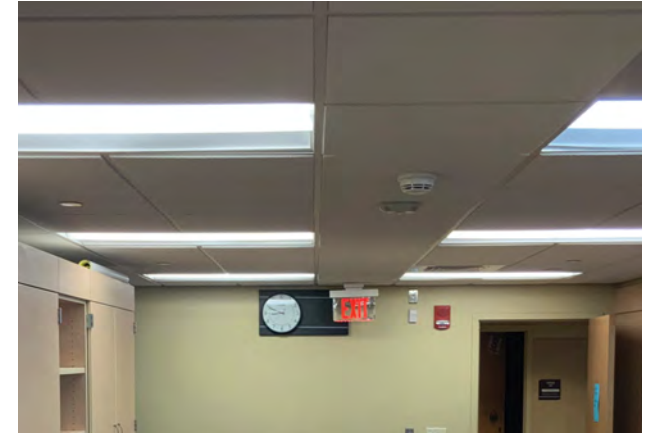
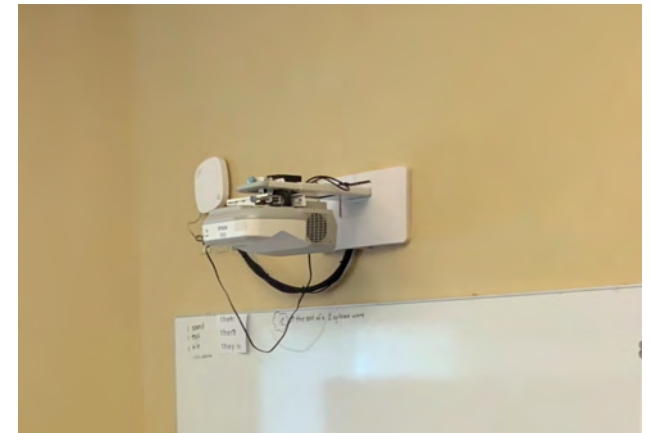
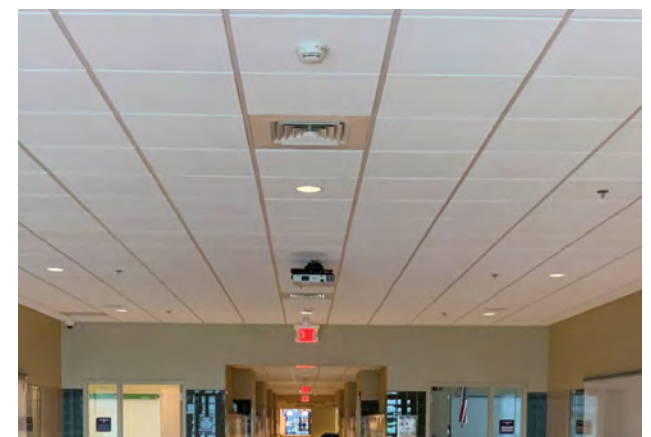
Sherwood Middle School | Electrical

The fire alarm system is addressable with voice evac; the fire alarm panel is JCI (Simplex) 4100ES. The fire alarm complies with current codes. Recommended to replace the initiating devices over 10-years old.

PA Speakers are located in public and common areas as well as in classrooms. The PA and clock systems appear to be in good working condition and meet the current programming needs. The PA system is by Valcom.

The video surveillance system is by American Dynamics. The access control system is by Kantech. Card readers are provided at the exterior door entries. Building entry is through Aiphone video entry station. The existing systems are operational and meet current programming needs.

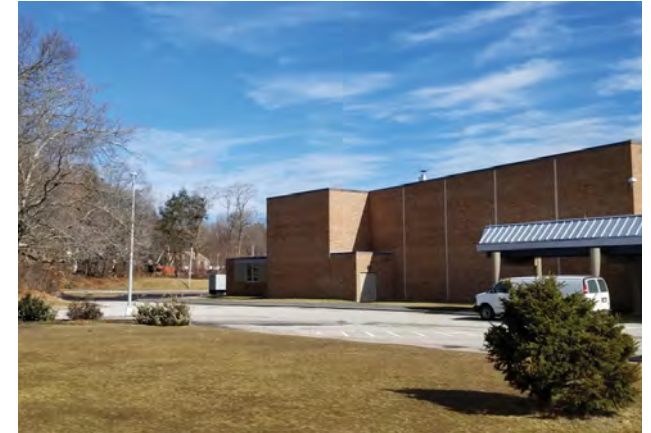
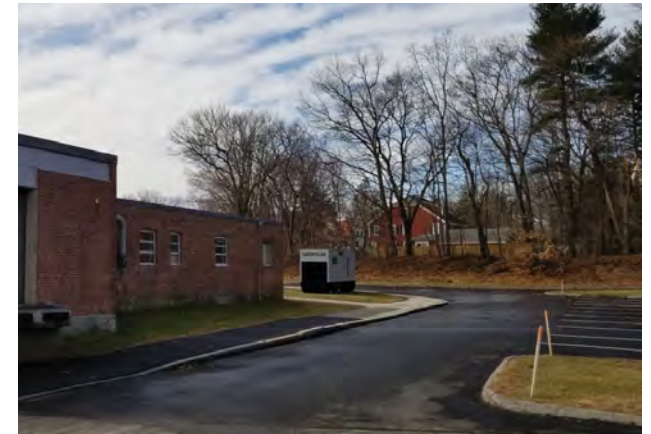
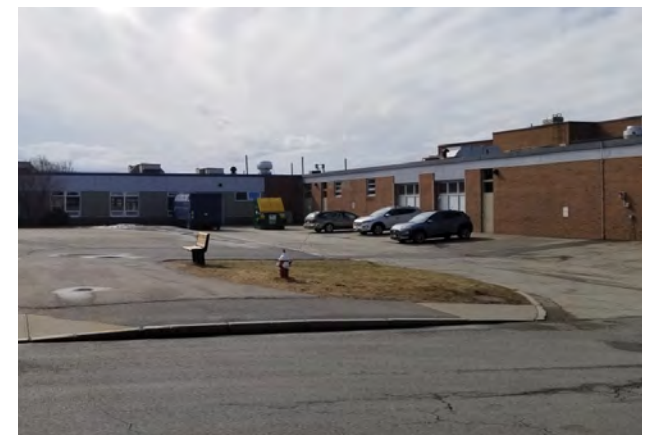
Oak Middle School | Site Review

The site is characterized by Urban Fill and Woodbridge soils, from well-drained friable conditions which cover most of the site to poorly drained pockets to the east and southeast [see soils mapping in the Appendix]. There is a wetland in the eastern portion of the property that would have limited impact on any future development of the site.

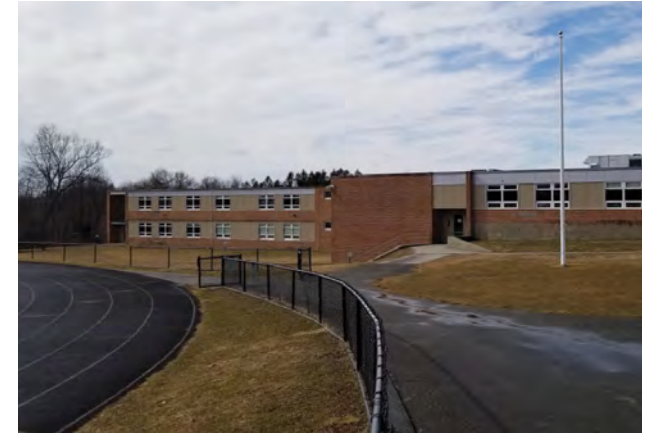
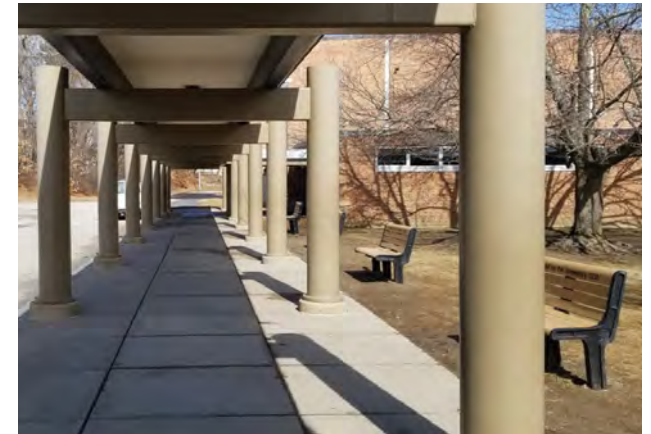
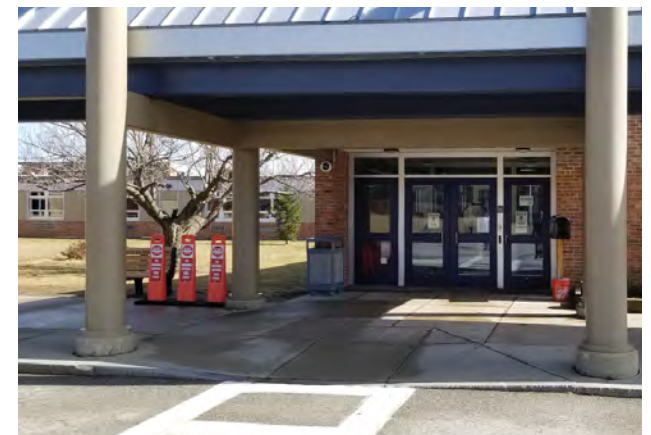
Oak Middle School | Site Review

The school's baseball field, football field, softball field, tennis courts, and track are utilized by the neighborhood community outside of school hours and are in good to fair condition.

There is sufficient parking for staff and visitors to support daily operations. During special events, parking at the neighboring middle school and use of the paved play area meets the needs. There are several pedestrian walkways throughout the site consisting of asphalt, concrete, and pavers. Overall condition of these features is fair to poor. The asphalt at the front of the building is in poor condition. The site appears to have sufficient drainage given its current configuration.

There are several site furnishings located on the site, including trash receptacles, benches, bike racks, signage, and a flag pole. These site furnishings are in good condition.

As previously reported, there are only a few deficiencies regarding the site. The following items do not meet the current accessibility guidelines: athletic fields/bleachers [route], tennis courts [maintenance], and concession stand counter [non-accessible].

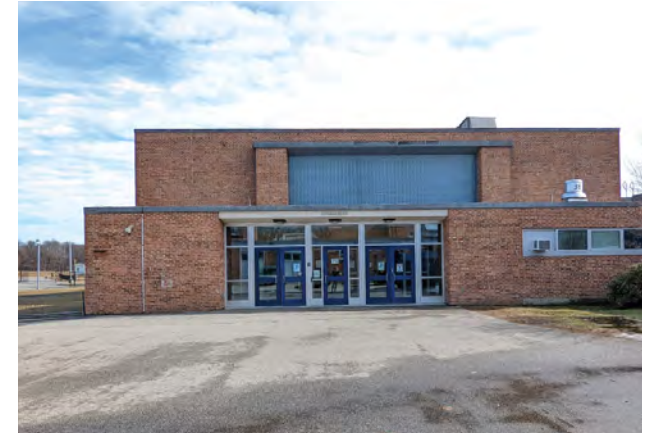
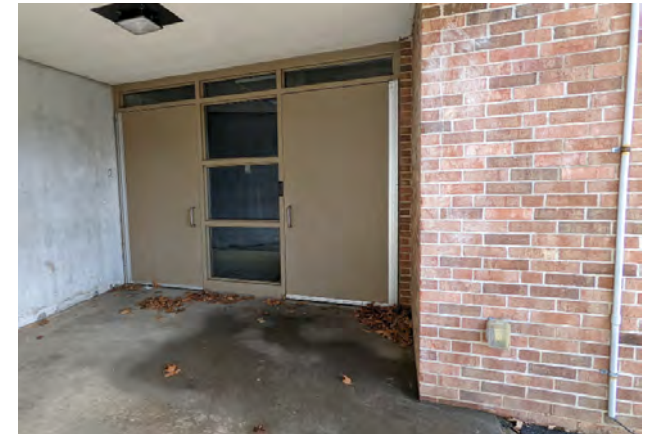
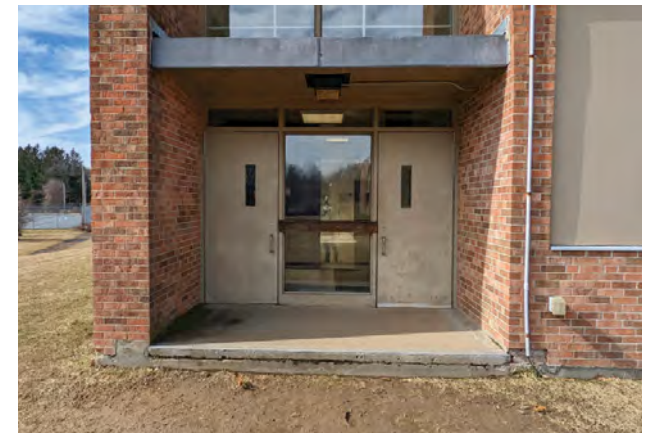
The main structural system consists of a steel frame with concrete floor slabs and frost walls. There appears to have been some settling in certain areas that should be investigated and remediated prior to any masonry repairs. Corroded lintels and steel members should also be remediated in conjunction with any masonry repairs.

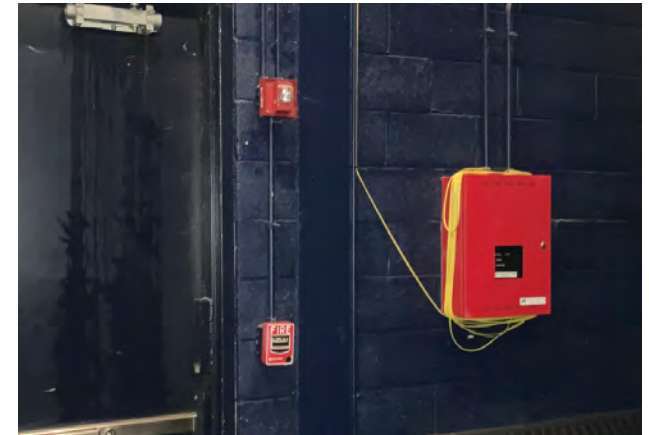
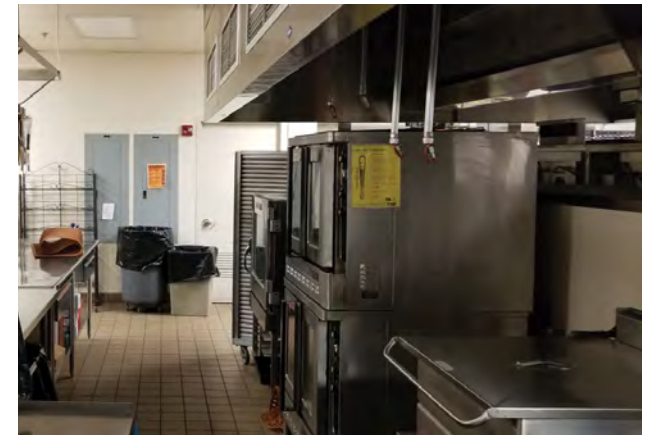
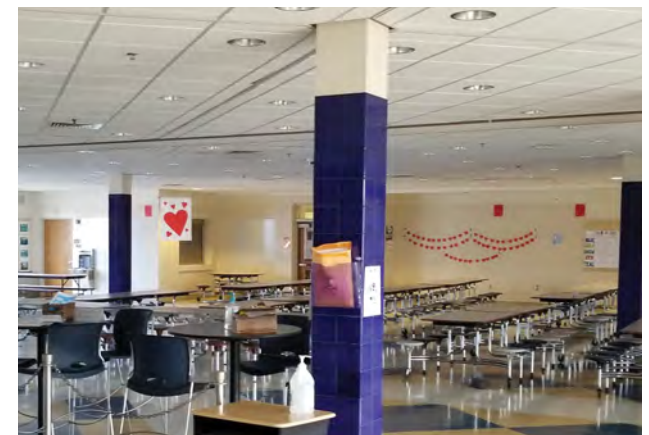
There is a presumed fire department connection provided on the exterior wall of the building. The kitchen hood is equipped with a chemical-based suppression over equipment requiring such.

In general, the building's fire sprinkler coverage appears to be fairly comprehensive and compliant with current code. Where quick-response type sprinklers are utilized, testing and/or replacement will be required for these types of sprinklers at 25 years of age. The current age of the sprinklers appears to be near 25 years.

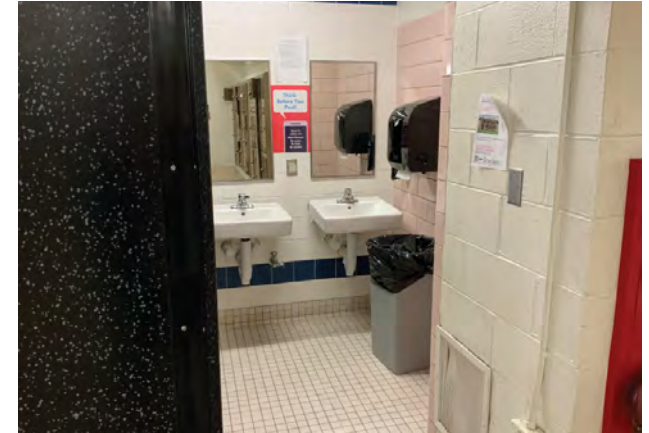
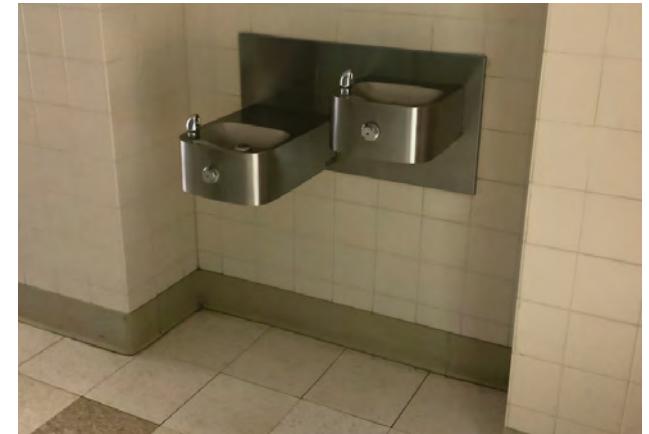
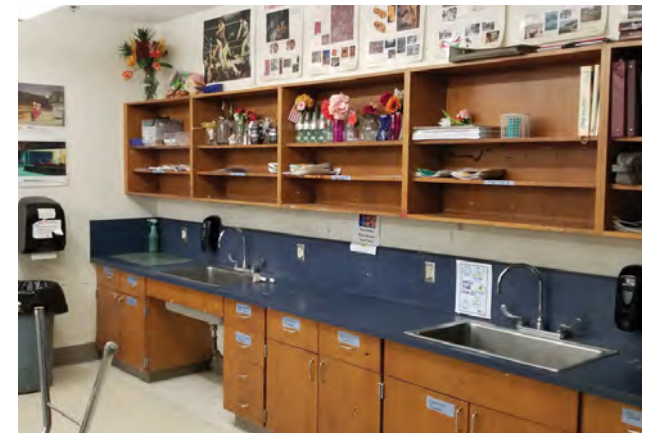
Janitor sinks inspected during our walk-through had faucet trim with vacuum breakers to limit backflow contamination caused by siphonage. Based on the age of the building renovations, we expect that all are code compliant.

Most of the fixtures are of the water-saving type for the code enforced at the time of the building's construction. Apparently, maintenance is routinely performed on faucets, toilet flush valves, etc. as needed.

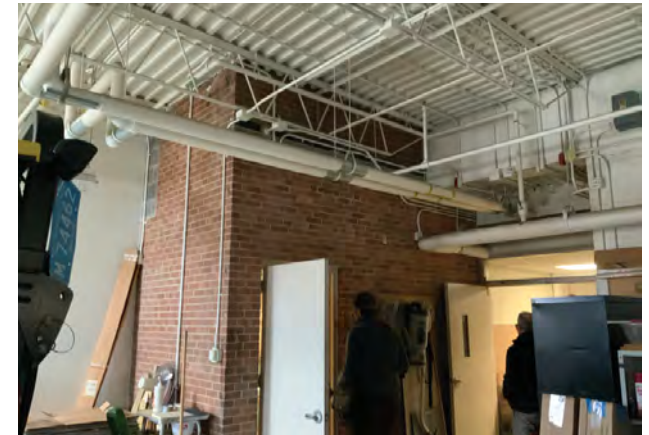
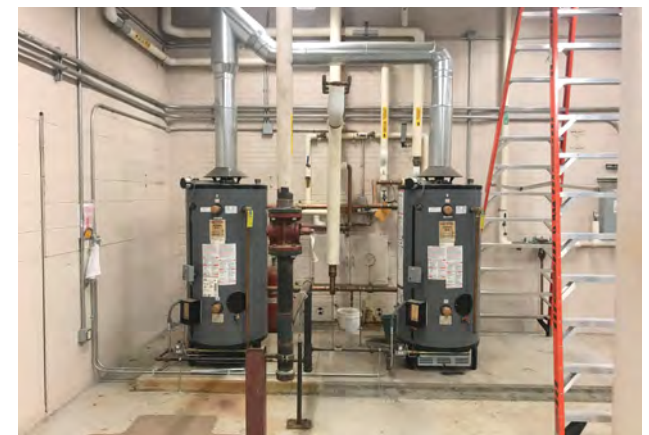
We noted most of the piping in the building appears to be copper, and, based on its age, should be in good condition; however, this can vary based on water quality. We recommend a pipe sample from both the cold and hot water system be taken to verify pipe condition.

The water heaters have no active signs of leakage; however, they are nearing the end of their useful expected service life of 10 years and, as such, should be considered a candidate for replacement within the next 5 years.

There is one recirculation pump on the domestic hot water system, which is required per the current plumbing code since there are fixtures located beyond 100 feet of the hot water source.

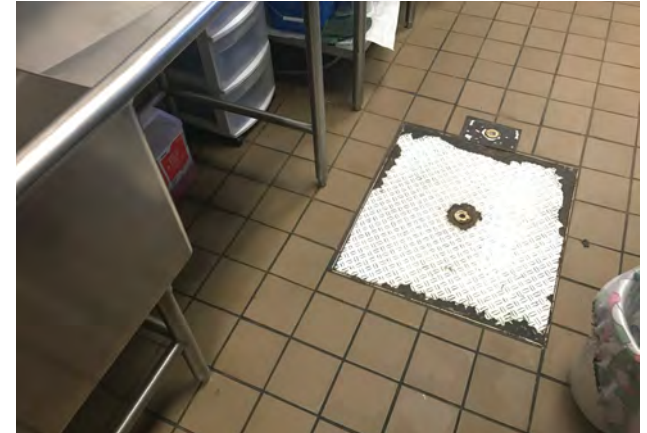
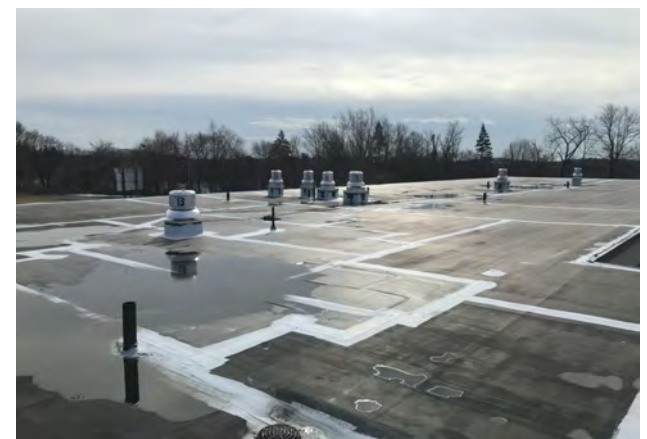
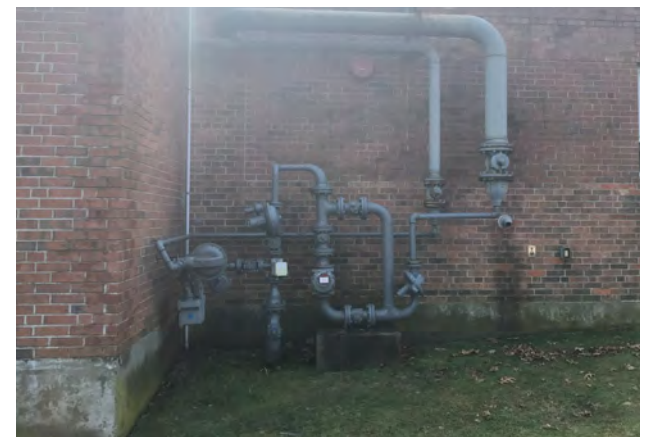
Roof storm water is drained via roof drains connecting to internal leaders. The lines presumably exit to a municipal storm water system. The building does not appear to have any emergency roof overflow drains. These are required by current code, as a clogged drain can lead to water build-up on the roof and structural failure due to weight. During any reroofing project or building upgrade we highly recommend emergency roof drains be added. The emergency drains should be added near the current roof drains and run to discharge to the side of the building. The visible discharge location is required as it gives users and indication of a failed main drain system.

A 5" intermediate pressure natural gas service is located exterior to the building outside the main level maintenance area/mechanical room. The service splits to two (2) pressure reducers which each feed a gas meter. After each meter, the gas runs through another pressure reducer prior to increasing in size to serve a 4" gas line and an 8" gas line. The 8" gas line appears to serve the main heating boilers and domestic hot water heaters, with the 4" line serving the kitchen and other building gas loads.

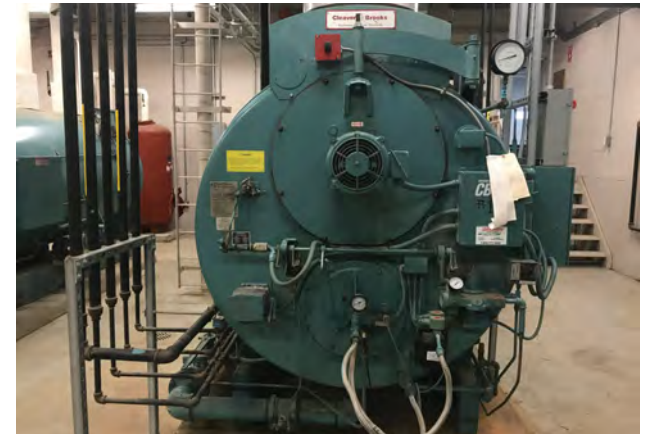
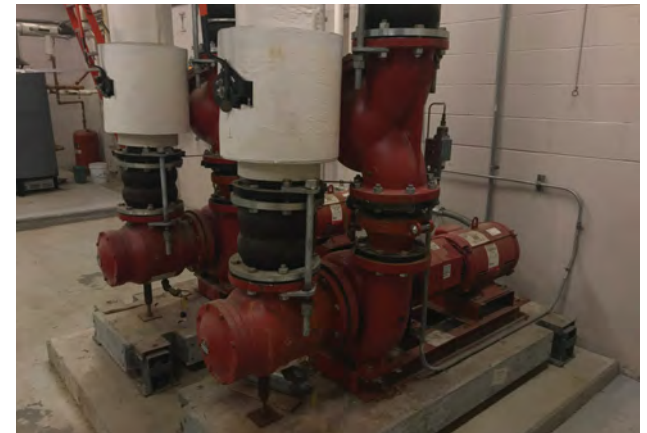
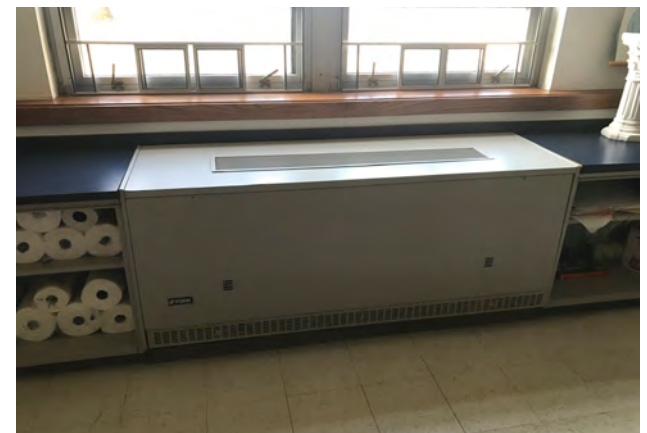
The system is supported by two (2) constant speed hot water loop pumps as manufactured by Bell & Gossett. The pumps appear to be in fair operational order with signs of bearing assembly and motor replacement. The pumps are at nearing the end of their useful service life of 20-years as defined in ASHRAE and as such are prime candidates for replacement in the coming years.

Classroom exhaust in much of the building is supported by a centralized exhaust fans located on the building roof. In most cases the fans serve multiple rooms. It is recommended to incorporate energy recovery ventilation systems on new and supplemental systems where feasible.
