13 March 2023

Shrewsbury Public Schools Pre-K-12
Capital Inventory & Improvement Study

TABLE OF CONTENTS

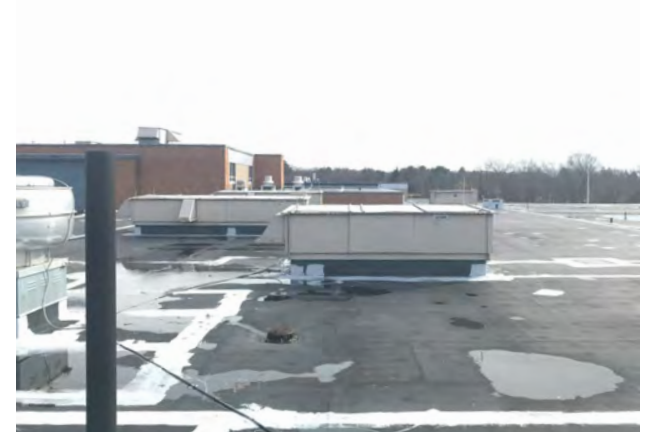
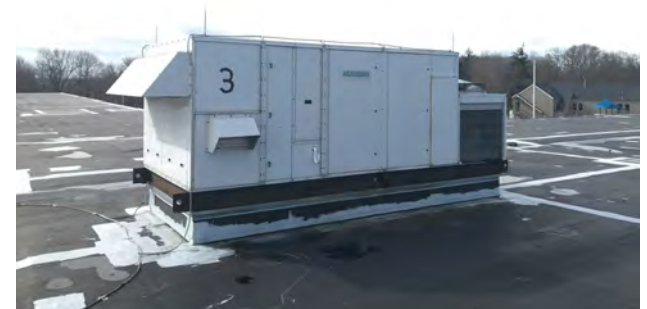
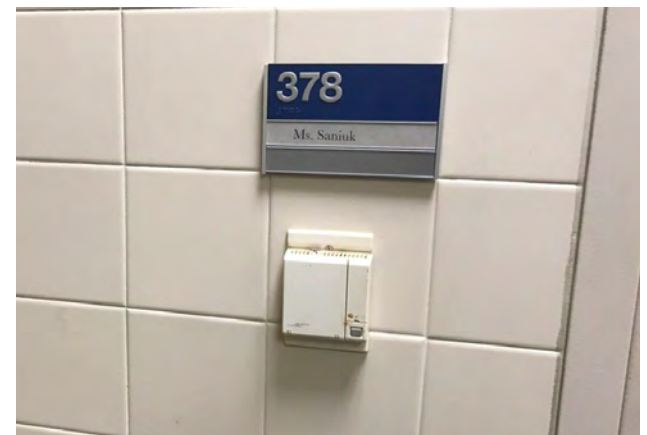
In addition, large portions of the rest of the building are supported by a mix of packaged rooftop units and air handling units, some of which have air cooled DX cooling sections in either a packaged or split arrangement. The following is a brief summary of the major roof top air handling equipment types and configuration:

The building appears to have a building wide DDC energy management system throughout. The system is manufactured and supported by Johnson Controls. According to facility personnel, the system has undergone and continue to undergo upgrades. Sequences should be reviewed further as additional indoor air quality and energy-saving routines may be possible.

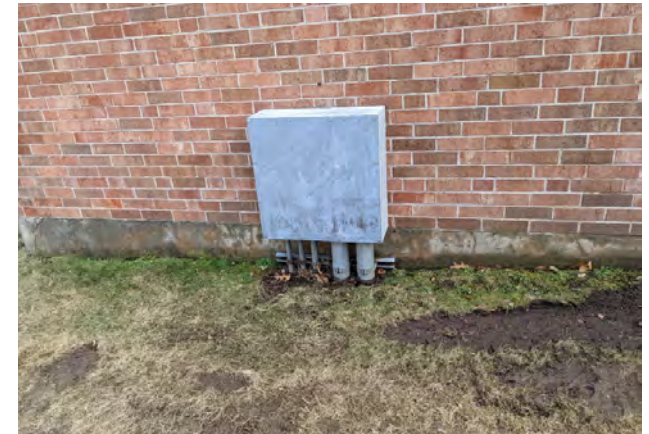
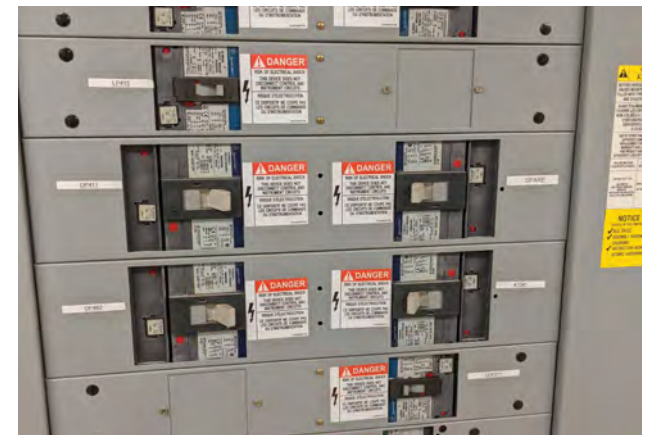
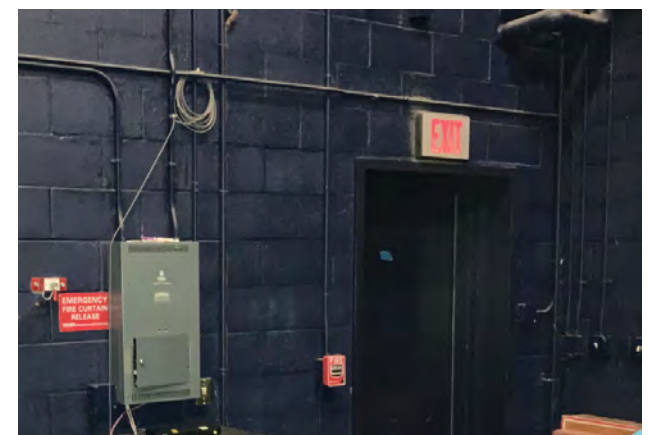
The building electrical service is rated 3000 amperes, 480/277 volt, 3-phase, 4-wire. The service consists of a utility company pad-mount transformer on the exterior of the building and underground feeds to the electrical service equipment. The electrical distribution equipment is by General Electric. Maintenance of the switchboard is recommended by the manufacturer and NETA.

The emergency/standby generator is rated 450kW/562.5kVA, 480/277V, 3-phase, 4-wire, manufactured by Caterpillar. The generator fuel is diesel. The generator feeds two automatic transfer switches (ATS) for life safety and standby power loads. The life safety transfer switch and distribution equipment are located in a 2-hour rated room. The main emergency electrical room housing the life safety transfer switch is being used as a storage room; this is a code violation and must be rectified as soon as possible.

The ambient lighting system in the building consists of various types of fixtures (recessed, surface, pendant, etc.) primarily with fluorescent lamps. The lighting system is inefficient and does not meet current energy codes. The lighting throughout the facility is controlled with motion sensors, snap switches, and relay panels. An ambient light system consisting of LED light fixtures should be provided. Networking lighting controls including occupancy, vacancy, and daylight sensors should also be provided.

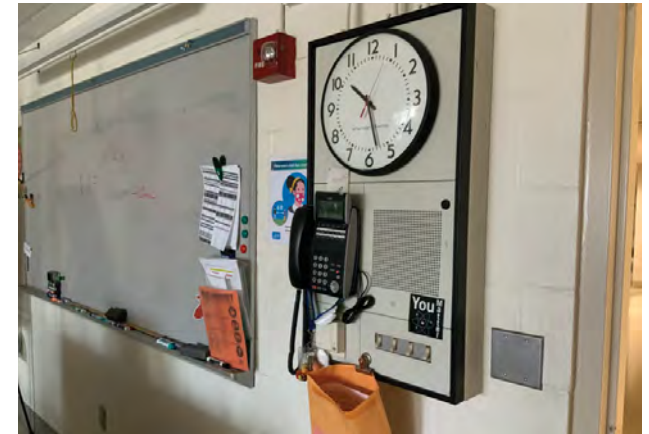
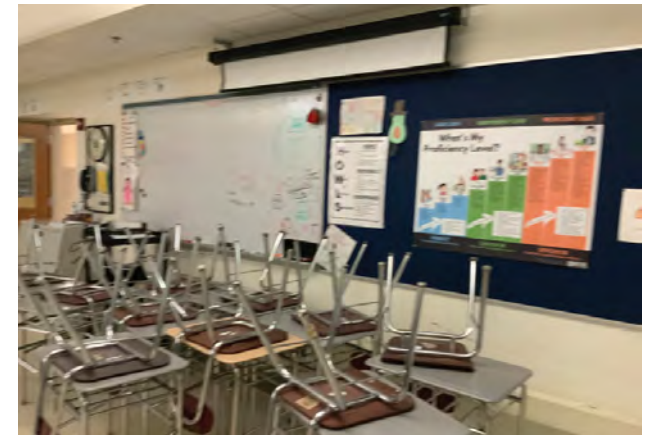
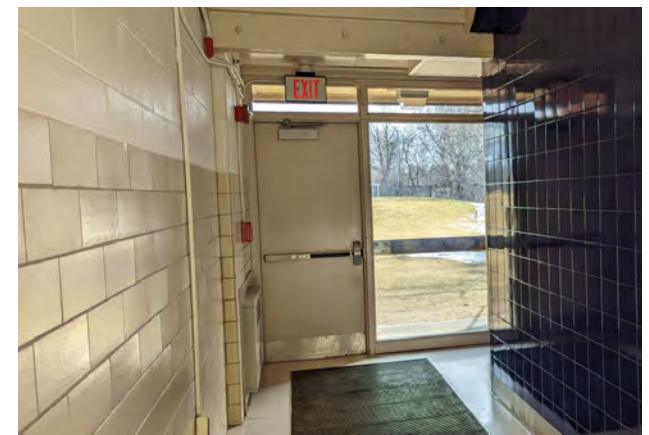
PA Speakers are located in public and common areas as well as in classrooms. The PA and clock systems appear to be in good working condition and meet the current programming needs. The PA system is Telecenter by Rauland Borg.

The video surveillance system is by Exacq with Axis cameras. The access control system is by Brivo. Card readers are provided at the exterior door entries. Building entry is through Aiphone video entry station. The existing systems are operational and meet current programming needs.

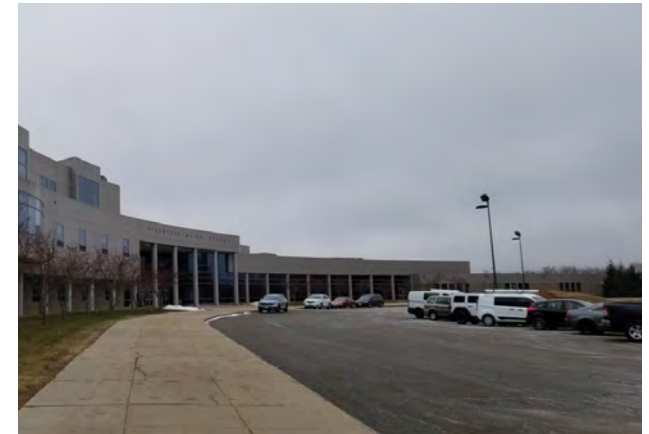
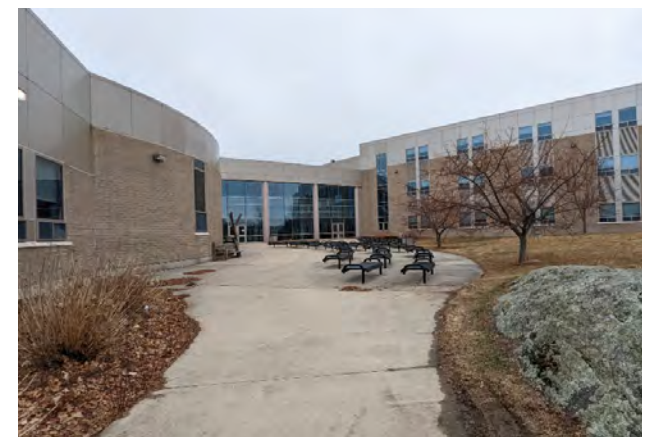
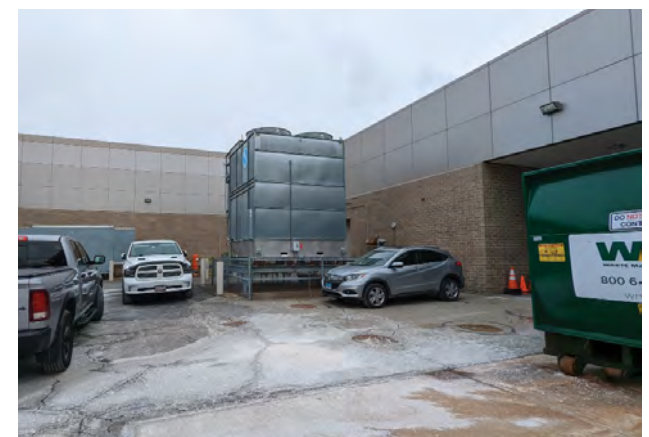
There are pedestrian sidewalks along all access roads, allowing students safe passage from all directions to the site. The condition of these walks is good to fair; however, the remoteness of this site limits the usefulness of these features. Only 5 students currently walk to and from school.

The site is characterized by Canton soils and Chatfield Hollis-Rock Outcroppings, both of which are very stony and well draining [see soils mapping in the Appendix]. There are wetlands in the northern portion of the property, which would require further investigation to clearly delineate the limits; however, impact on potential development of the site would not be significant given the limits of the current site improvements. Any expansion outside of the current developed areas would likely encounter ledge that would require blasting.

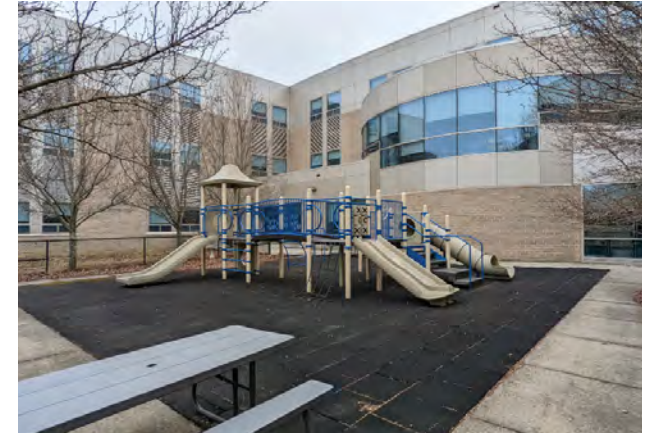
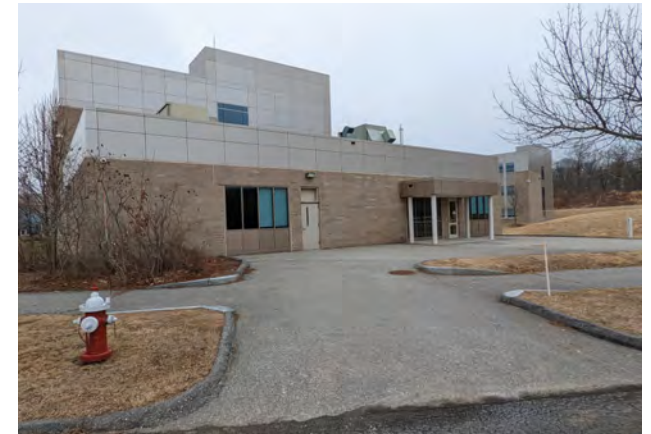
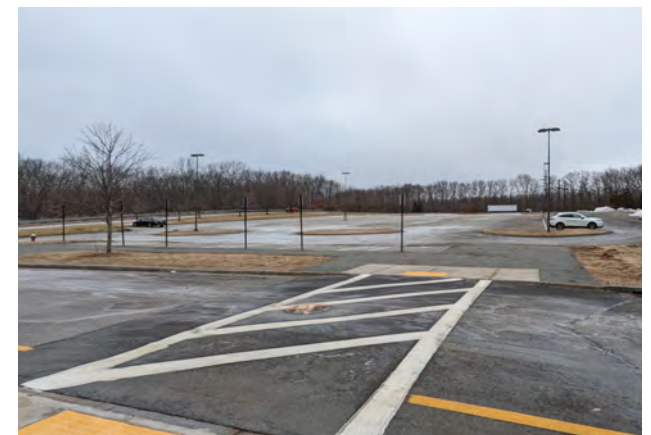
There is sufficient parking for staff and visitors to support daily operations. However, the site has limited capacity in respect to special events. There are several pedestrian walkways throughout the site consisting of asphalt and concrete. Overall condition of these features is good to fair. The site appears to have sufficient drainage given its current configuration.

As previously reported, there are only a few deficiencies regarding the site. The following items do not meet the current accessibility guidelines: athletic fields [route], bleachers [non-accessible], handrails [maintenance], playground surface [maintenance], parking lots [slopes], accessible parking [insufficient], and picnic tables [non-accessible].

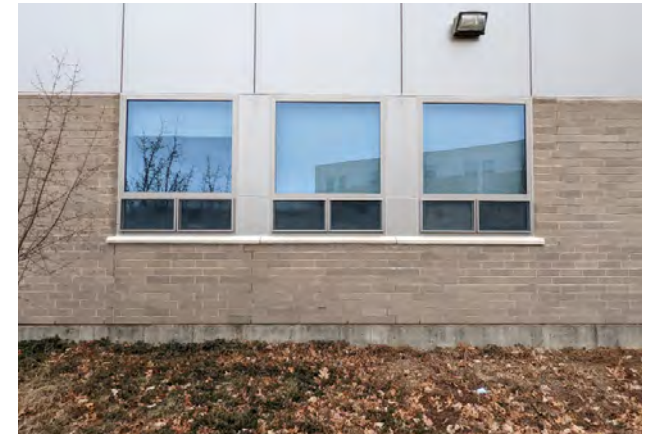
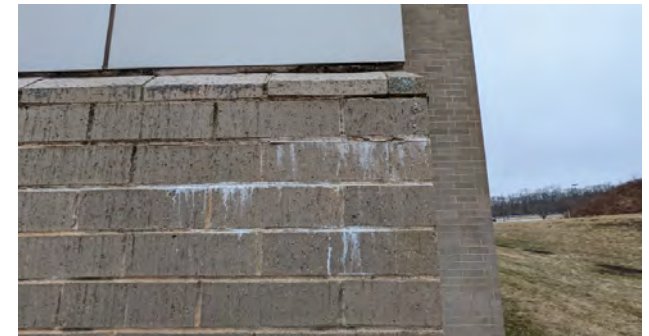
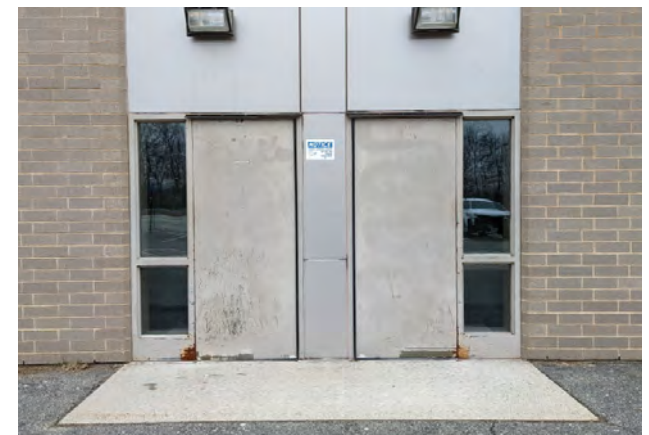
The exterior walls consist of brick masonry, aluminum composite panels, and concrete. As previously reported, the exterior joints where sealant was used have failed. LPA|A observed some replacement/repairs of these joints, but many still require attention. The brick masonry requires repointing/resetting/re-anchoring of bricks at several locations to ensure the envelope is watertight. There is some staining and organic growth at several locations. Several brick sills have been replaced with precast units due to deterioration and displacement. These should continue to be monitored and replaced on an as needed basis. There are also some smaller concrete repairs that are required to prevent further deterioration.

The roof is comprised of black EPDM over mechanically-fastened insulation. Based on previous reports, the roofing has several deficiencies, including ponding, splits in flashing, blistering, damaged metal roof edge, unadhered membrane, and raised insulation fasteners. These deficiencies are minor in nature but should be addressed before they lead to water infiltration. It was previously recommended to replace the gymnasium roof due to deficiencies. The roof should be monitored and maintained under a comprehensive maintenance plan to prolong its useful life.

The building consists of aluminum-framed windows/ doors, and hollow metal doors and frames. The doors and windows are in fair condition with the exception of failed sealants, corroded hollow metal frames & doors, and failed insulated glazing units. The sealants, doors/frames, and insulated glazing units should be replaced and maintained through a comprehensive maintenance plan.

The interior walls consist of painted concrete masonry units, painted gypsum walls, ceramic tile, and plastic laminate paneling. These walls are all in good condition with the exception of some cracks in the CMU walls. The ceiling primarily consists of acoustical ceiling tiles with some gypsum ceilings, and specialty metal ceilings, all of which are in good to fair condition except where leaks have occurred. The flooring consists of vinyl composite tile, ceramic tile, and carpet, which are in fair condition with the exception of a few locations. The items that have the most amount of wear on them are the doors, frames, hardware, millwork, and lockers. The wood veneers on the millwork have advanced delamination due to the use of cleaners during the COVID-19 pandemic.

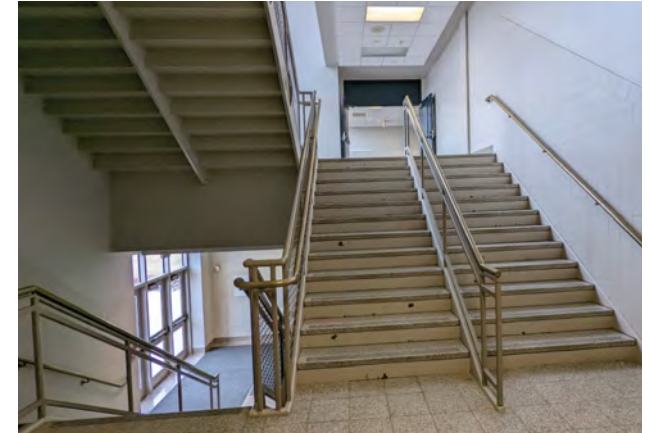
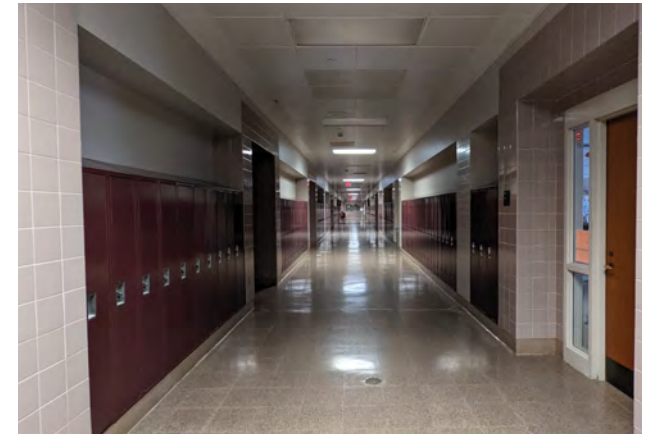
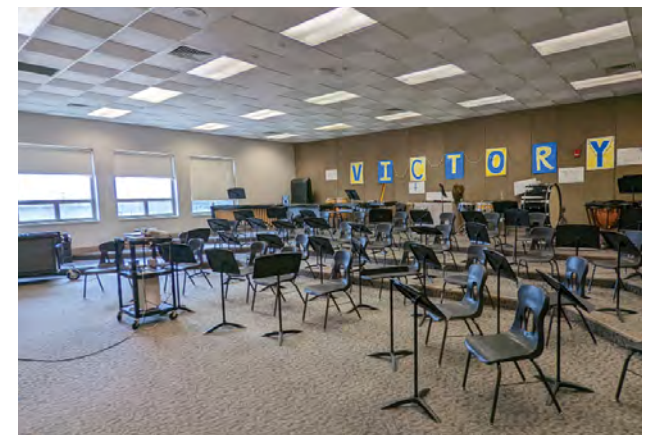
Shrewsbury High School | Building Review

As previously reported, there are several deficiencies regarding the building. The following items do not meet the current accessibility guidelines: stage [non-accessible], stage handrails [non-accessible], workspace/sinks in specialty classrooms [non-accessible], locker rooms showers [clearances], sink pipe insulation [not provided], protrusions along accessible routes, toilet compartments [hardware], signage [accessible egress], administrative reception desks [non-accessible], and cane-detectable barriers [not provided].

There are sufficient means of egress serving the building. Some of the rated doors are missing their gas-keting and should be provided to ensure compliance with fire ratings.

The main structural system consists of a wide-flange steel moment frame with concrete floor slabs and frost walls. There appears to have been some settling in certain areas that should be investigated and remediated prior to any masonry repairs.

The potential for any asbestos-containing materials within the building is unlikely given the age of the building. There are several other items that may require special disposal, including light fixtures, light ballasts, hydraulic door closers, and exit light batteries, should renovations/replacements be considered.

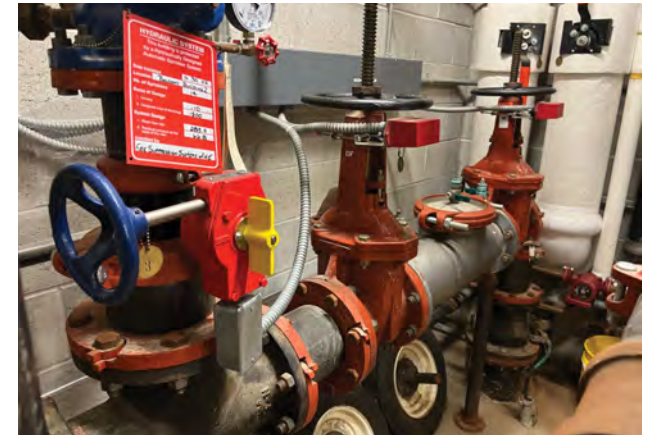
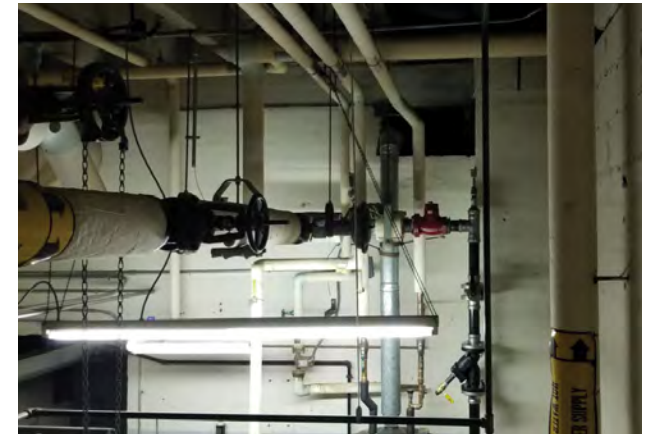
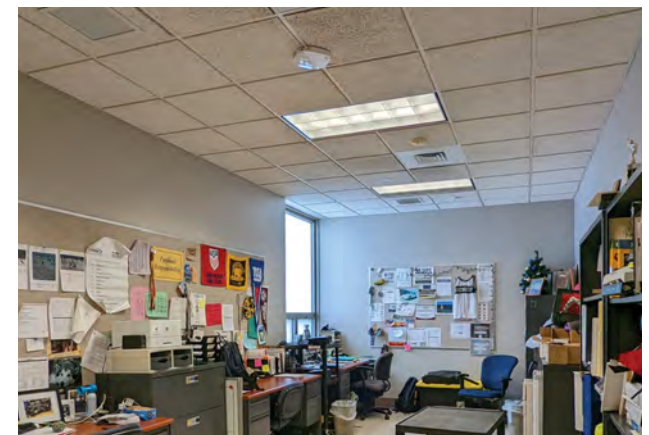
Shrewsbury High School | Fire Protection

The fire suppression system serving the building is a wet pipe type system which provides essentially complete coverage throughout the building except as otherwise noted herein.

In general, the building's fire sprinkler coverage appears to be fairly comprehensive and compliant with current code.

Where quick response type sprinklers are utilized, testing and/or replacement will be required within the next 5 years as code requires this for these types of sprinklers at 25 years of age.

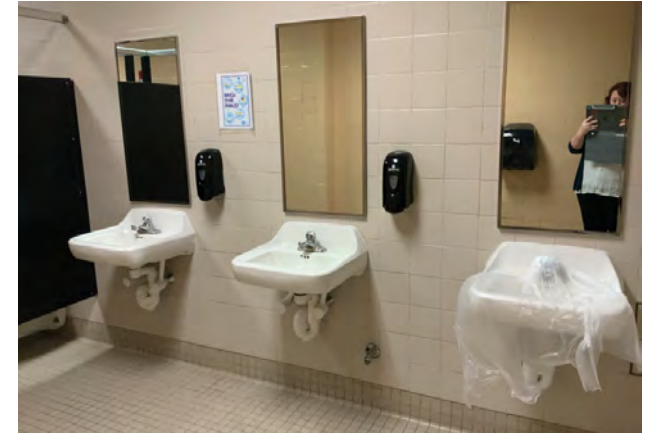
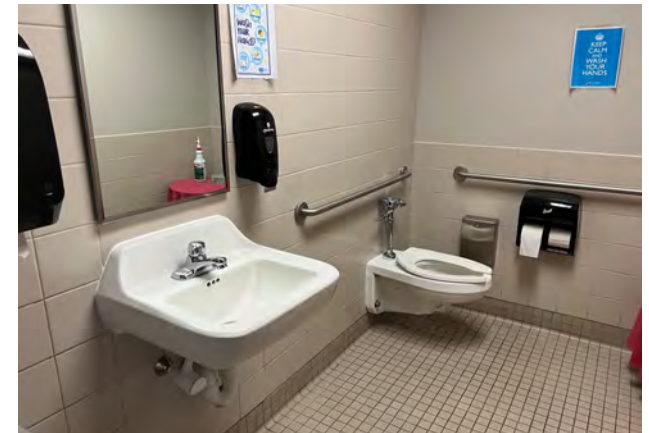
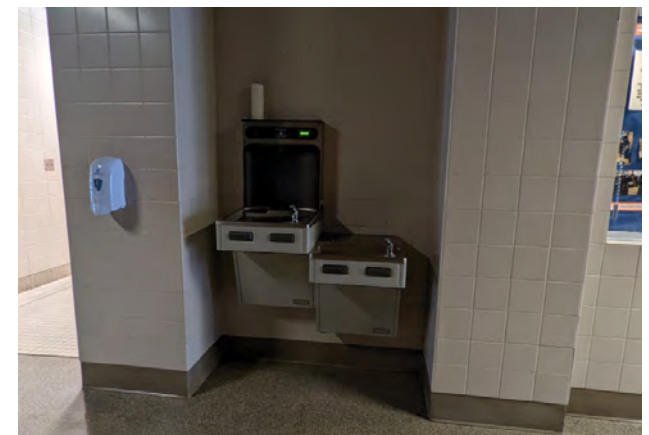
Shrewsbury High School | Plumbing

Janitor sinks inspected during our walk-through had faucet trim with vacuum breakers to limit backflow contamination caused by siphonage. Based on the age of the building, we expect that all are code compliant.

Most of the fixtures are of the water-saving type for the code enforced at the time of the building's construction. Apparently, maintenance is routinely performed on faucets, toilet flush valves, etc. as needed.

As renovations occur, the following items should be considered: replace all flushometers/faucets with automatic low flow flushometers/faucets.

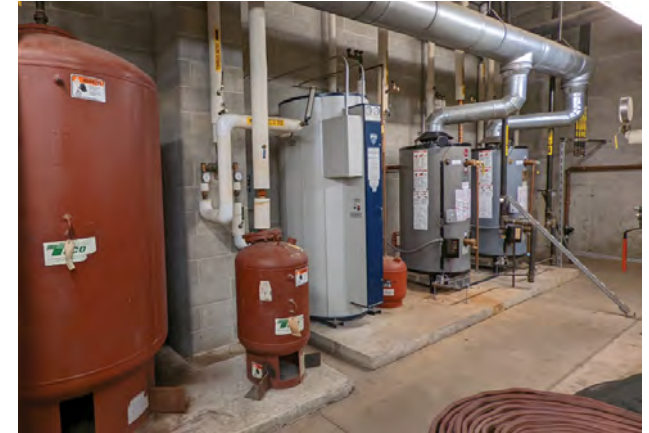
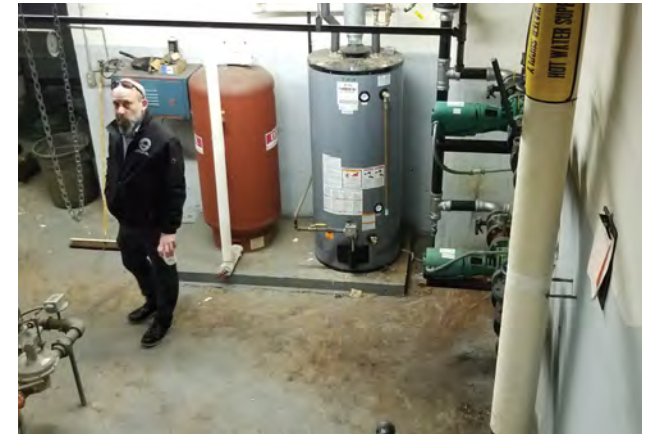
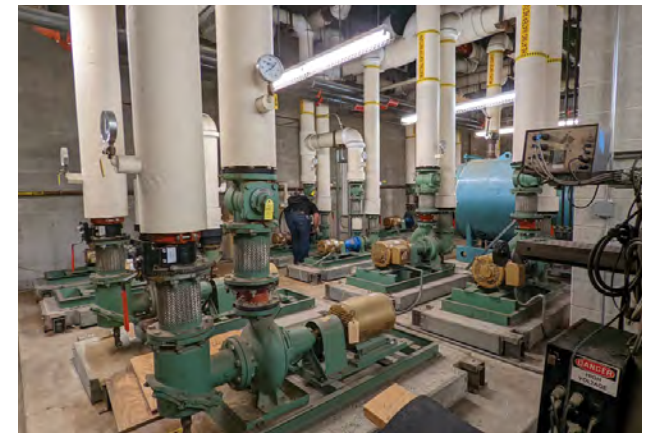
Shrewsbury High School | Plumbing

We noted most of the piping in the building appears to be copper, and, based on its age, should be in good condition; however, this can vary based on water quality. We recommend a pipe sample from both the cold and hot water system be taken to verify pipe condition.

The water heaters have no active signs of leakage; however, all have exceeded their useful expected service life at over 10 years of age for the gas water heaters and 20 years of age for the electric water heater. All should be considered good candidates for replacement.

There are multiple recirculation pumps on the domestic hot water system, which is required since there are fixtures located beyond 100 feet of the hot water source. The plumbing code requires hot water to be available within 100 feet of any hot water consuming fixture.

The domestic hot water heaters should be replaced with high efficiency condensing gas-fired style.

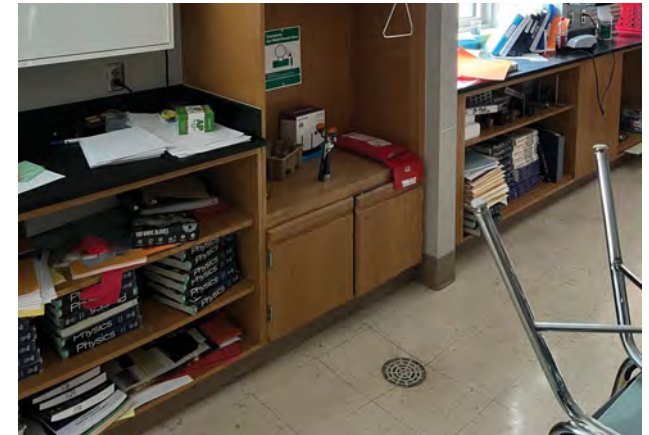
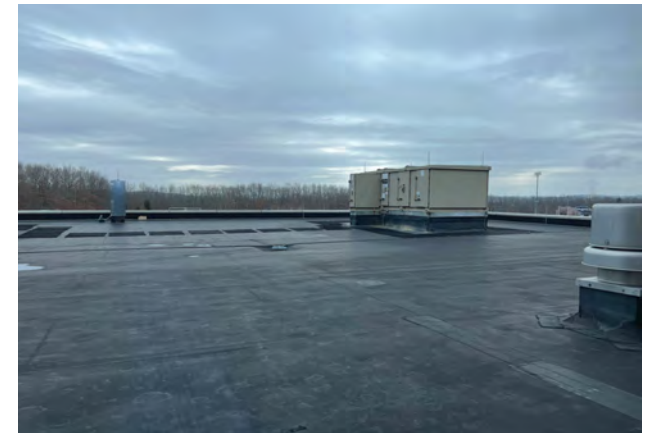
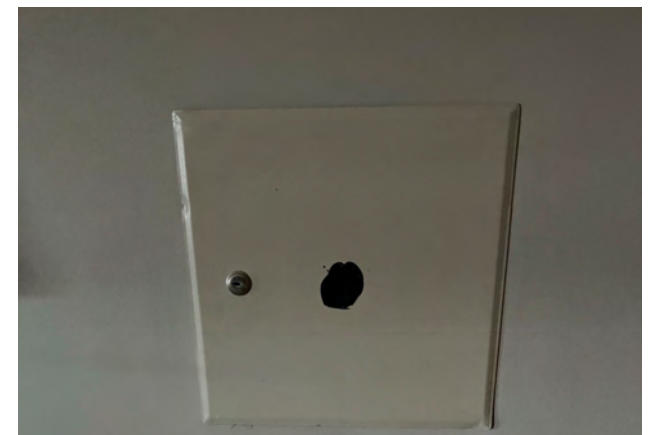
Shrewsbury High School | Plumbing

Roof storm water is drained via roof drains connecting to internal leaders. The lines presumably exit to a municipal storm water system. The building does not appear to have any emergency roof overflow drains. These are required by current code as a clogged drain can lead to water build-up on the roof and structural failure due to weight. During any reroofing project or building upgrade we highly recommend emergency roof drains be added. The emergency drains should be added near the current roof drains and run to discharge to the side of the building. The visible discharge location is required as it gives users and indication of a failed main drain system.

A natural gas service enters the building in the lower level sprinkler room. The exterior service entrance consists of an elevated gas pressure line serving a gas meter and gas pressure reducers, one of which feeds an 8" gas line while the other feeds a 6" service prior to entering the building and supporting the building loads, which include the heating boilers, domestic hot water boilers and kitchen cooking loads.

Both main lines have a thermally activated shut-off valve where it enters the building. This valve would shut the gas supply off to the building in the event there were a fire within the mechanical room. This device is typically required by the gas utility for pipes over 4" in size.

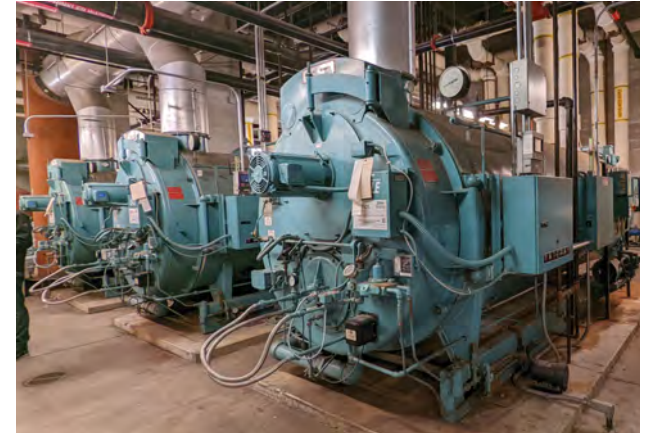
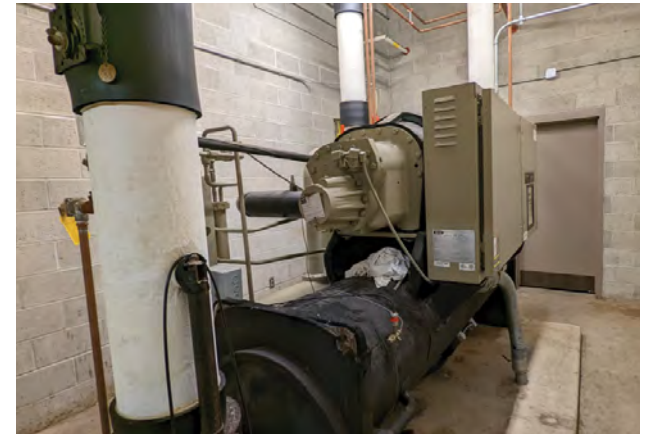
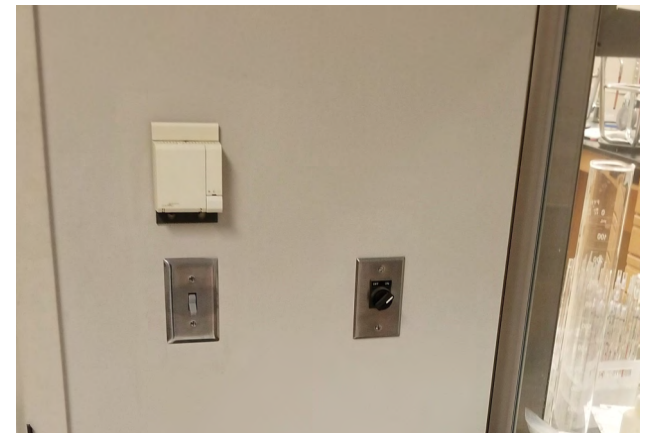
Shrewsbury High School | HVAC

According to ASHRAE, the life expectancy of these types of boilers is 25 years, although with proper maintenance they have been known to operate for a longer service life. A 5+ year plan to replace these boilers is recommended.

A majority of the cooling needs for the areas of the building which are cooled is supported by one (1) water cooled chiller. The chiller is a Trane #RTHC series rotary screw unit with an approximate capacity of 180-tons. The chiller uses R-134A refrigerant. At 20 years of age, the chiller is approaching the end of its useful service life of 23 years as defined by ASHRAE. As such, we recommend replacement options be considered for this chiller within the next 5 years.

The cooling tower that supports the chiller is located at grade outside the mechanical room and is manufacturer by Baltimore Air Coil (BAC) #FXV series. The tower is in poor condition with visible exterior rot through the casing and failing fill media. The cooling tower must be replaced as soon as feasible as its failure is imminent.

The building appears to have a building-wide DDC energy management system throughout. The system is manufactured and supported by Johnson Controls. According to facility personnel, the system has undergone and continues to undergo upgrades. Sequences should be reviewed further as additional indoor air quality and energy-saving routines may be possible.

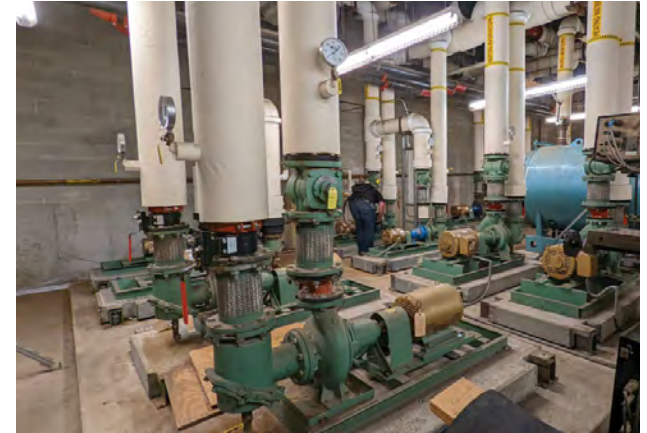
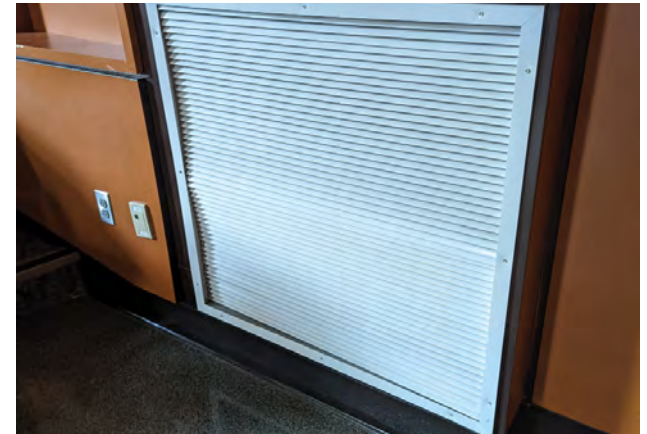
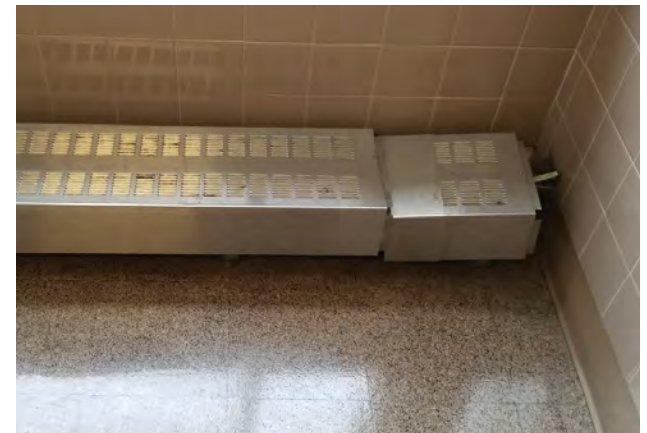
Shrewsbury High School | HVAC

Chilled water and hot water from the chiller and heating plant is distributed to the building via a 4-pipe hot water and chilled water supply and return distribution system. The hot water system circulates hot water to air handlers, fin-tube radiation and classroom unit ventilators units located throughout the building. Chilled water is sent to air handling equipment supporting sections of the building with air-conditioned cooling, including the main administration, the presentation room, the media center and the TV studio.

- P-1 & P-2: (lead/stand-by) variable speed secondary loop hot water, serving Gymnasium Wing; Taco FE300 base mounted end-suction style.
- P-3 & P-4: (lead/stand-by) variable speed secondary loop, hot water, serving Classroom & Other Wings; Taco FE300 base mounted end-suction style
- P-5 & P-6: (lead/stand-by) constant speed chilled water loop; Taco FE series base mounted end-suction style
- P-7 & P-8: (lead/stand-by) constant speed condenser water loop; Taco FE401 base mounted end-suction style
- P-9, P-10 & P-11: constant speed boiler primary loop Taco FE501 base mounted end-suction style

The pumps are all manufactured by Taco and appear to be in fair operational order with signs of bearing assembly and motor replacement. Some pumps do show signs of external corrosion. All the pumps are at the end of their useful service life of 20 years as defined in ASHRAE, and as such are prime candidates for replacement in the coming years.

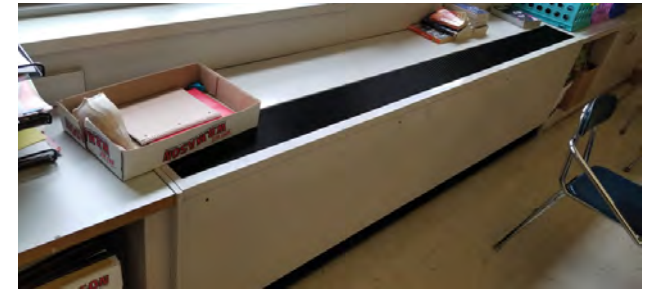
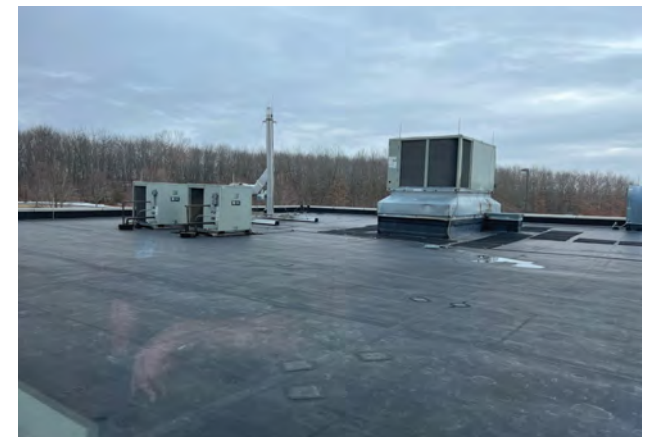
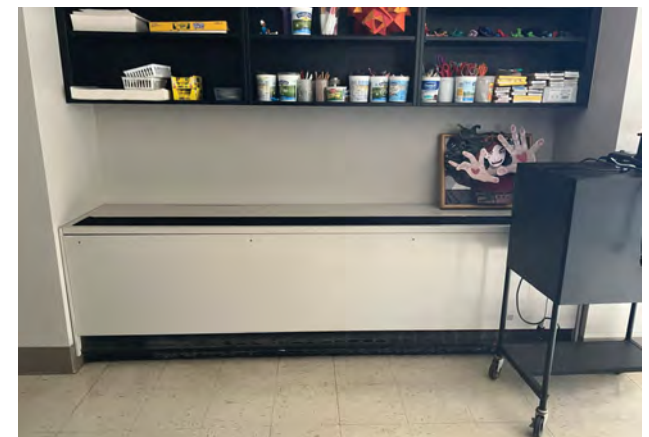
Shrewsbury High School | HVAC

A majority of the non-classroom areas of the building, such as the gym, auditorium, offices, cafeteria, etc., are served by ducted rooftop heating, ventilation units complete with fan section, filter sections and hydronic coil sections. For areas where air conditioning is supplied, as noted previously, the units also have chilled water coils. The roof mounted air handlers are modular style Climate Changers as manufactured by Trane.

A majority of the air handlers, exhaust fans, classroom unit ventilators and the like are at the end of their useful service life of 20 to 25 years as defined in ASHRAE and as such are prime candidates for replacement in the coming years.

As unit ventilators and air handlers are replaced, coils should be sized for low temperature (140F or less) hot water. This lower temperature hot water will maximize efficiency of the condensing gas boilers and also allow opportunity for possible future implementation of air to water heat pumps to assist the building hydronic heating loop. Incorporating energy recovery ventilation systems on new and supplemental systems where feasible is recommended.

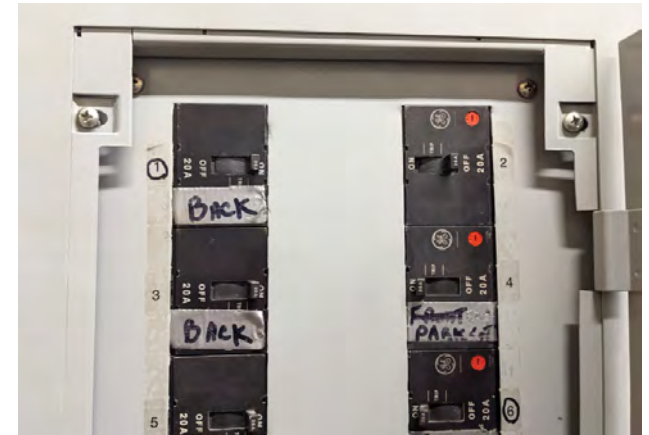
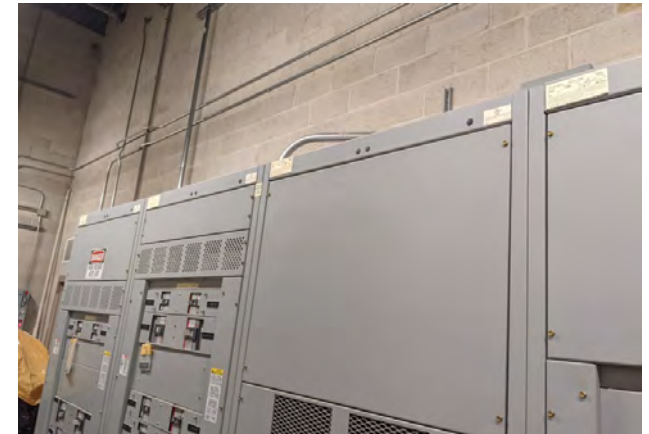
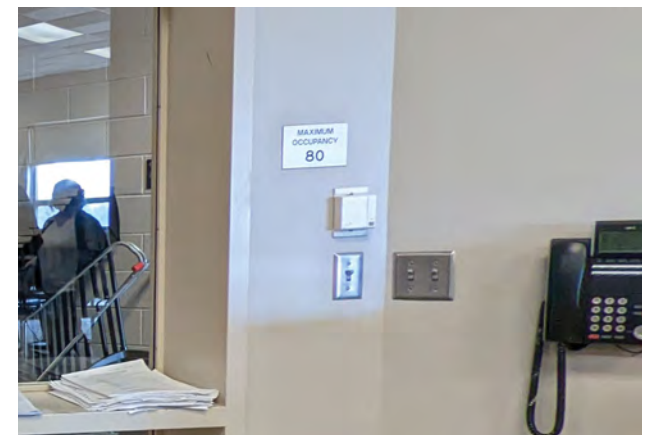
Shrewsbury High School | Electrical

The building electrical service is rated 5000 amperes, 480/277 volt, 3-phase, 4-wire. The service consists of a utility company pad-mount transformer on the exterior of the building and underground feeds to the electrical service equipment. The electrical distribution equipment is by General Electric. Maintenance of the switchboard is recommended by the manufacturer and NETA.

The panelboards in the building are by General Electric. The panelboards are located throughout the building in electrical rooms and are circuit breaker type. Several different types of wiring methods were observed namely wires in raceway, metal clad (MC) cable, and armored cable (AC). Maintenance of the panelboards is recommended by the manufacturer and NETA.

The ambient lighting system in the building consists of various types of fixtures (recessed, surface, pendant, etc.) primarily with fluorescent lamps. The lighting system is inefficient and does not meet current energy codes. Lighting control is primarily by wall mounted switches and occupancy sensors. Ambient light system consisting of LED light fixtures should be provided. Networking lighting controls including occupancy, vacancy, and daylight sensors should also be provided.

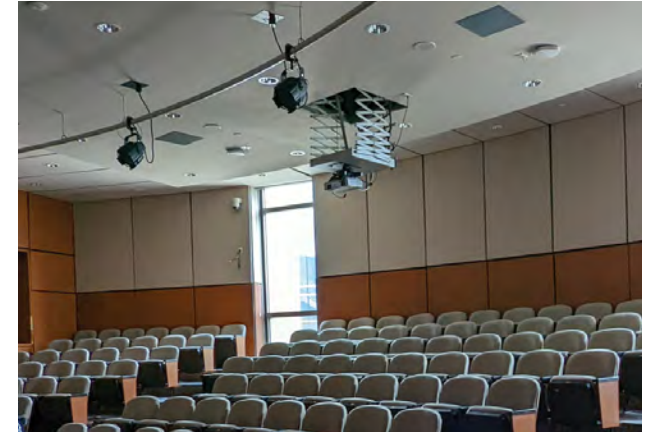
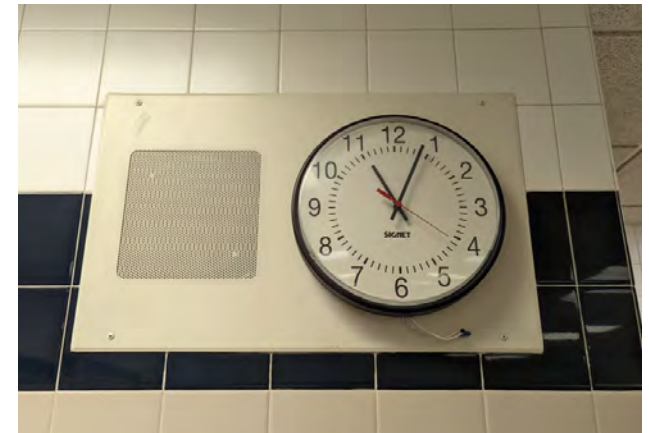
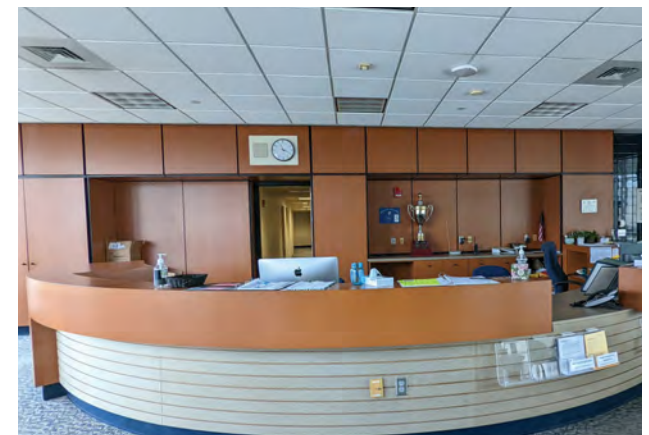
Shrewsbury High School | Electrical

The fire alarm system is addressable with voice evac; the fire alarm panel is JCI (Simplex) 4100. The fire alarm appears to comply with current codes. Initiating devices over 10-years old should be replaced

PA Speakers are located in public and common areas as well as in classrooms. The PA and clock systems appear to be in good working condition and meet the current programming needs. The PA system is Telecenter by Rauland Borg.

The video surveillance system is by Exacq with Axis cameras. The access control system is by Brivo. Card readers are provided at the exterior door entries. Building entry is through Aiphone video entry station. The existing systems are operational and meet current programming needs.

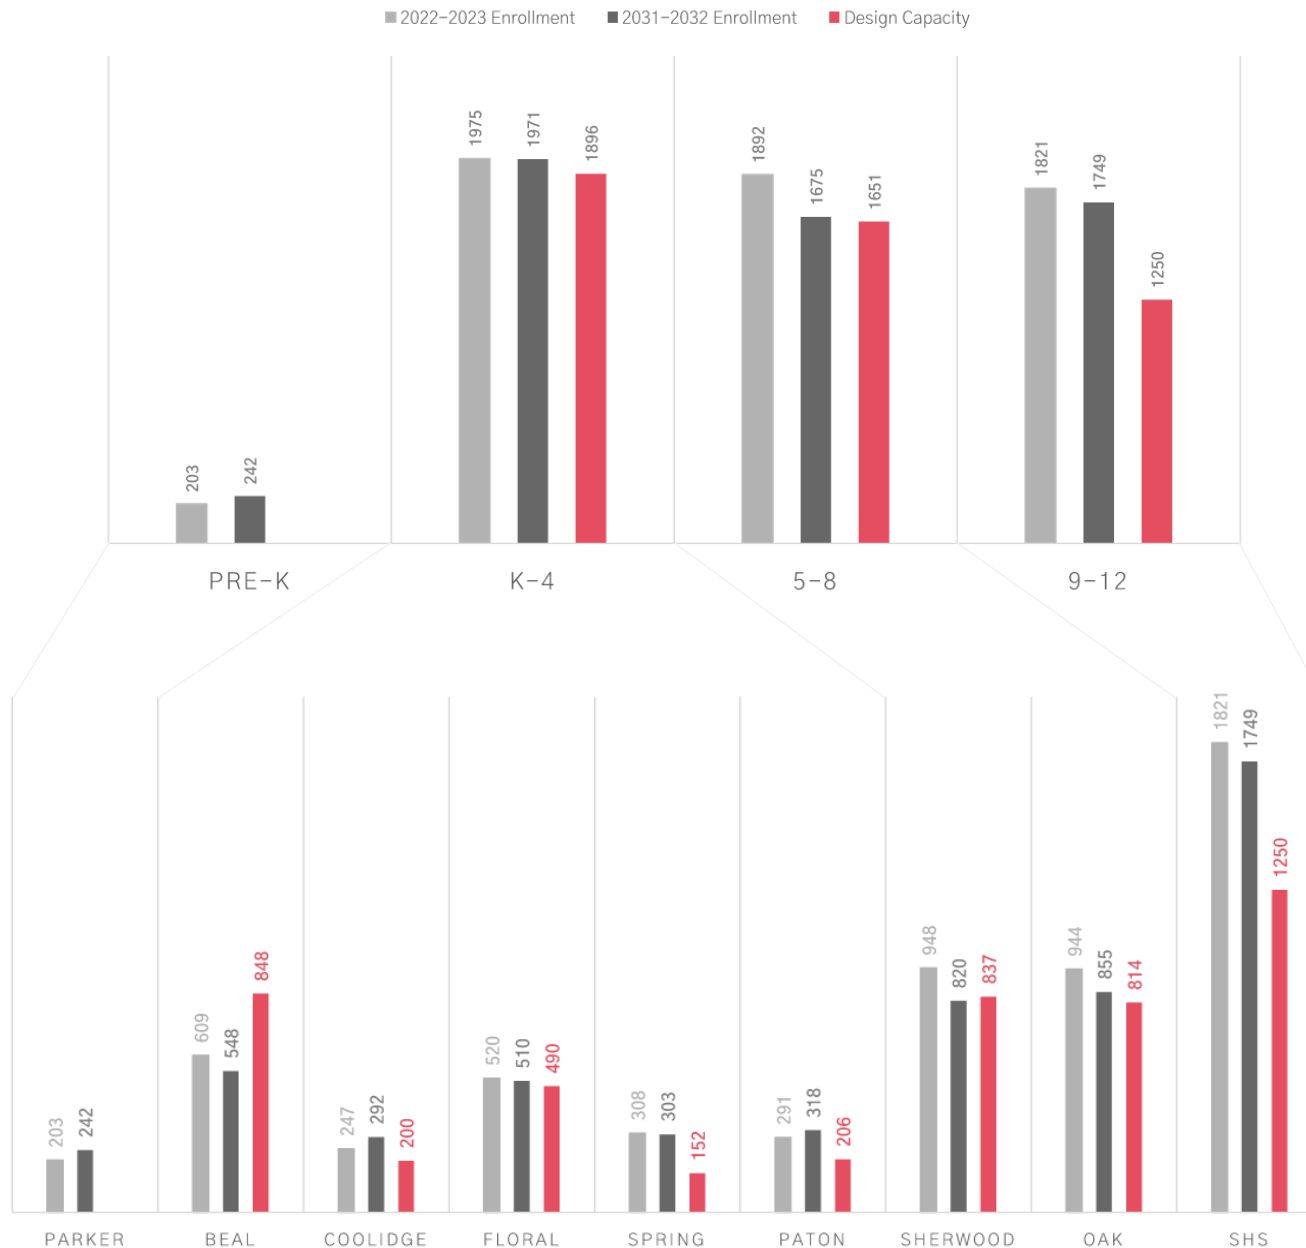
Educational Review | Enrollment/Design Capacity Charts

These graphs document the data for enrollment and design capacity by grade level (above), and then by individual school (below).

- The greatest need is clearly demonstrated at the high school level, where enrollment far exceeds design capacity.
- While the elementary school level does not appear to highlight a great need in the first graph, the second clearly shows disparity amongst the individual schools. Work needs to be done to create a more equitable distribution.
- If pre-K students are to be incorporated at the elementary level, space needs to be found for 242 students for a full-day offering, or 121 students for a half-day offering.
- The middle schools, while currently overburdened by enrollment, constitute the lowest priority for large-scale intervention as they will return to near-design capacity levels over the next ten years.

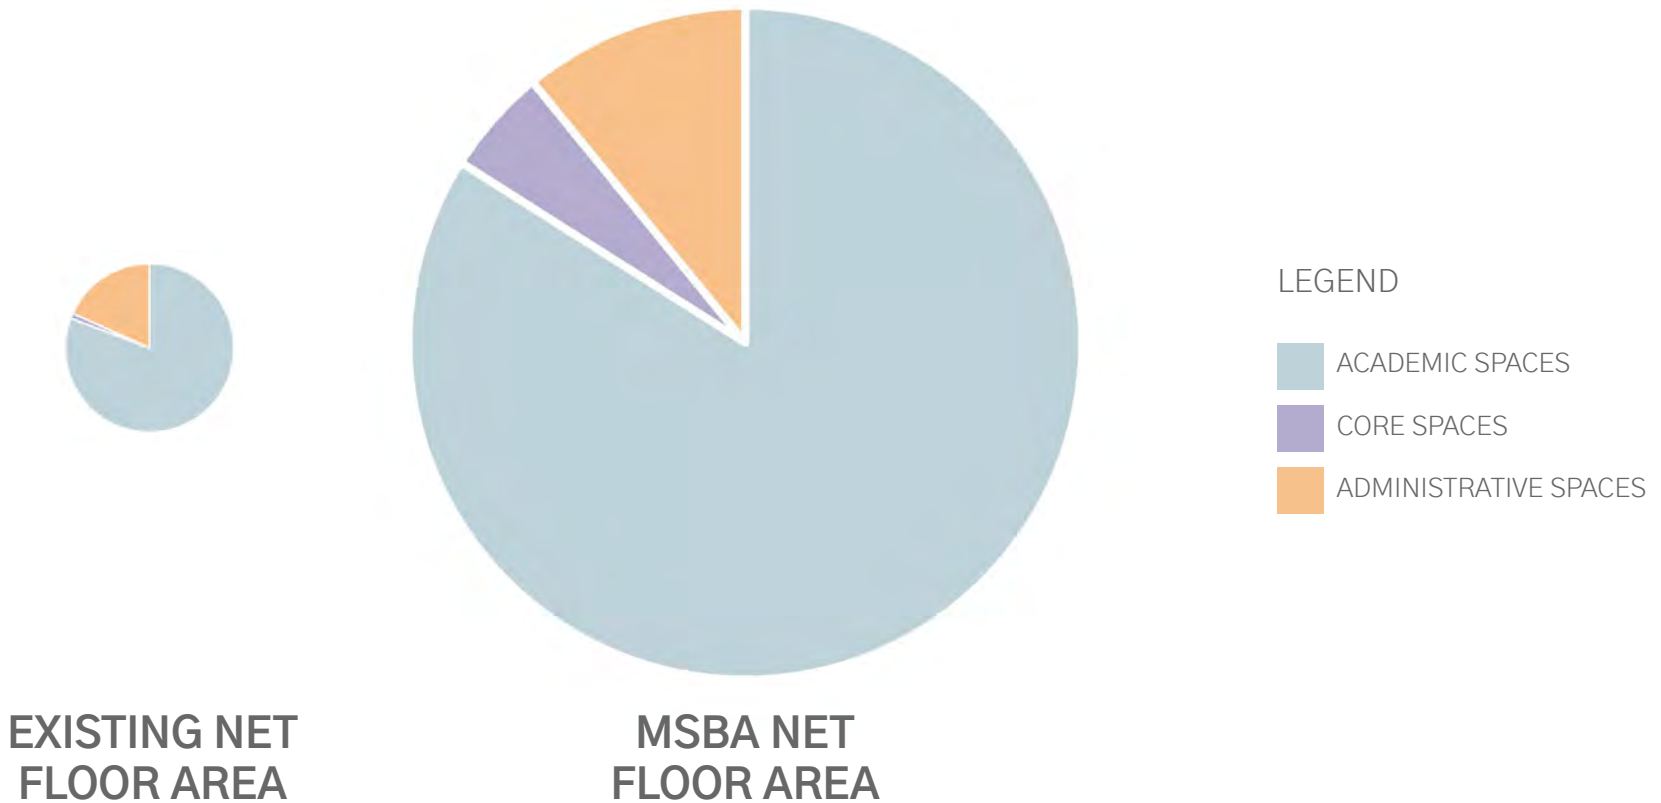
Parker Road Preschool | MSBA Space Summary Template

SPACE TYPE	EXISTING SQFT (NET)	MSBA GUIDELINE SQFT (NET)	DEFICIENCY (GROSS GF =1.5)
CORE ACADEMIC SPACES <small>* Excludes portable classroom square footage.</small>	6,053	32,325	(39,408)
SPECIAL EDUCATION	1,338	3,830	(3,738)
ACADEMIC TOTAL	7,391	36,155	(43,146)
ART & MUSIC	0	0	0
HEALTH & PHYSICAL EDUCATION	0	2,000	(3,000)
MEDIA CENTER	0	0	0
DINING & FOOD SERVICE	92	200	(162)
CORE TOTAL	92	2,200	(3,162)
MEDICAL	176	610	(651)
ADMINISTRATION & GUIDANCE	994	2,097	(1,655)
CUSTODIAL & MAINTENANCE	504	1,982	(2,217)
ADMINISTRATIVE TOTAL	1,674	4,689	(4,523)
TOTAL FLOOR AREA	9,157	43,044	(50,831)

*MSBA guideline square footages calculated based on the 10-year enrollment forecast value: **242 students**
