13 March 2023

Shrewsbury Public Schools Pre-K-12
Capital Inventory & Improvement Study

TABLE OF CONTENTS

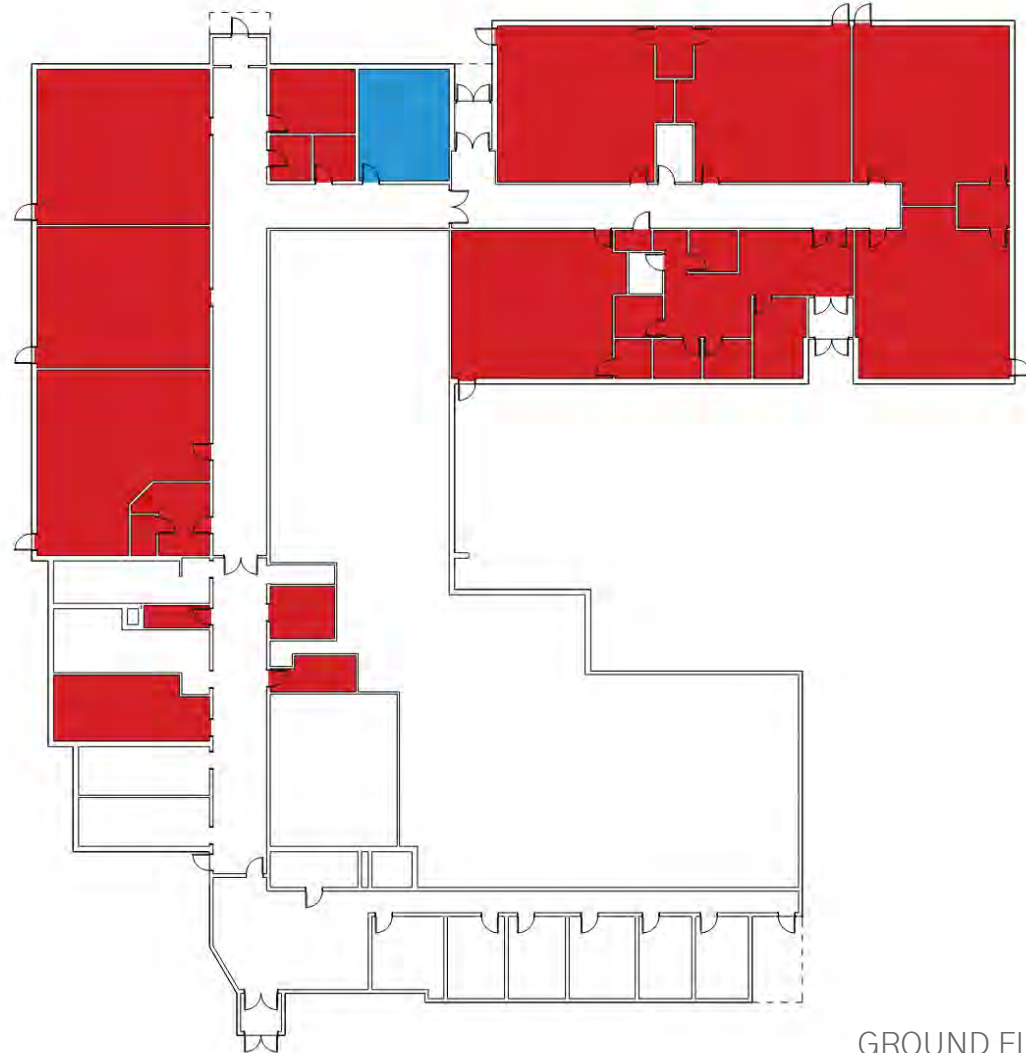
Parker Road Preschool | MSBA Comparison Plans

- The School Committee has verified that preschools do not require the same core area spaces that elementary schools do, as many of these services are provided directly in the classroom. However, in lieu of a full-size gymnasium, a smaller gross motor room should be incorporated, as well as a staff dining area. These values are reflected in the previous chart.
- There is a significant deficiency of space at all levels. These deficiencies, along with the fact that this preschool shares space with a utility company, do not support an addition/renovation option for this school. Options development should focus on new construction.
- Special education needs are greater for the preschool population in Shrewsbury; this should be taken into consideration when developing options.

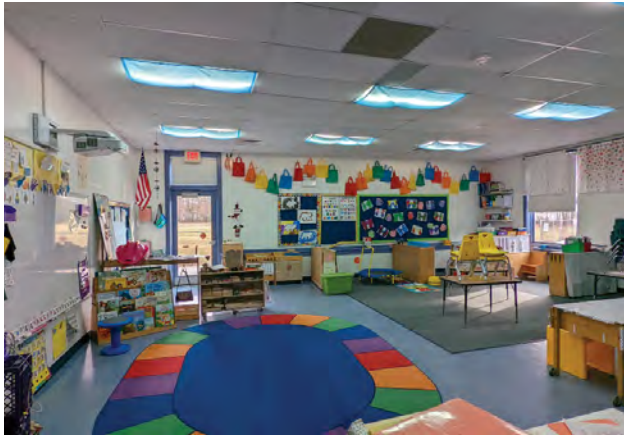
Classrooms are all under the minimum square footage recommended by MSBA

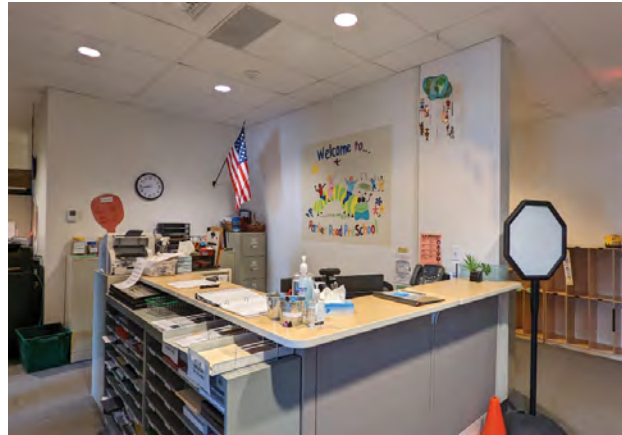
Reception space is undersized but provides good visual access to main entrance

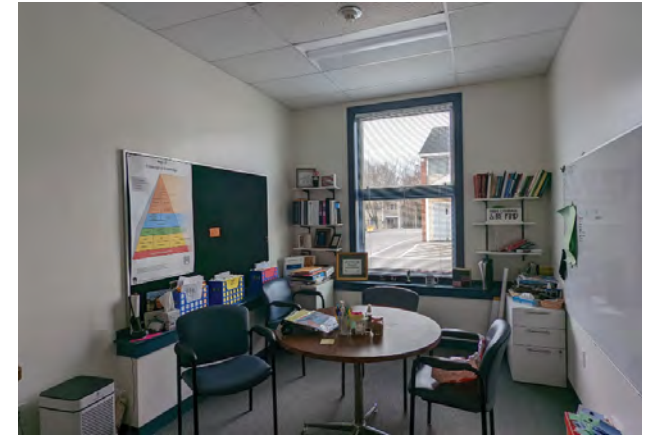
Offices are small; quantity does not meet need; no work rooms provided (copier in hallway)

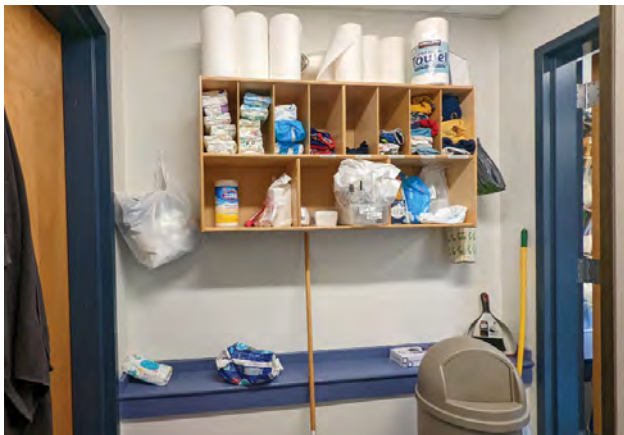
Shared toilet room; inequitable distribution of toilet facilities for classrooms

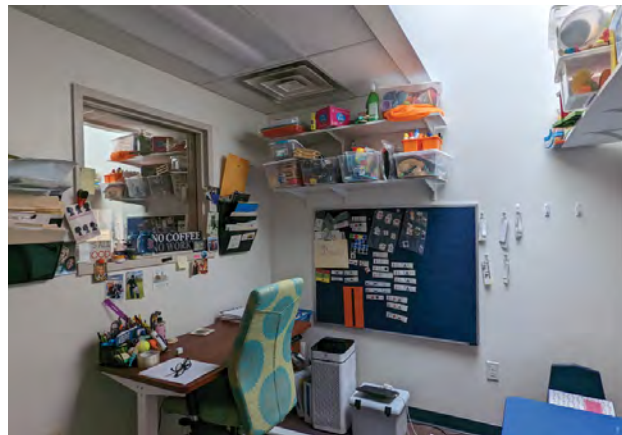
Insufficient special education spaces (1:1 room with observation window to small group room shown)

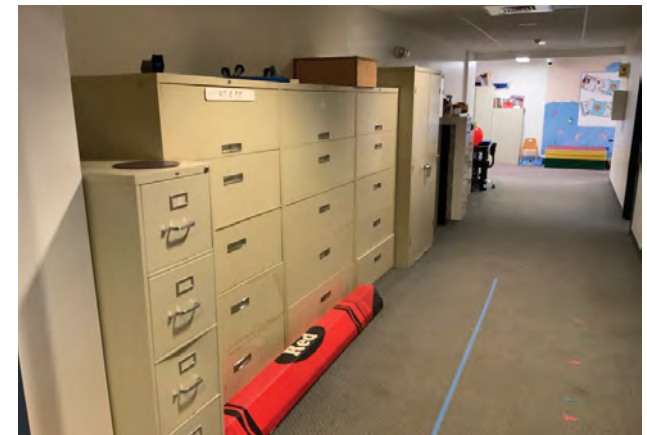
Lack of storage space – storage cabinets line hallways as required

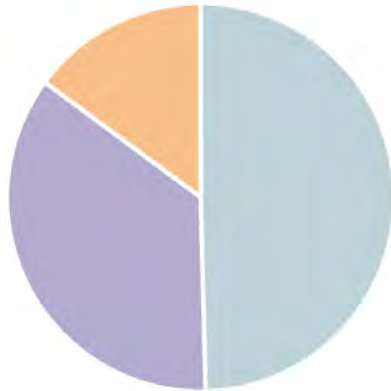
EXISTING NET FLOOR AREA

SPACE TYPE	EXISTING SQFT (NET)	MSBA GUIDELINE SQFT (NET)	DEFICIENCY (GROSS GF = 1.5)
CORE ACADEMIC SPACES <small>* Excludes portable classroom square footage.</small>	12,720	20,600	(11,820)
SPECIAL EDUCATION	2,542	5,455	(4,370)
ACADEMIC TOTAL	15,262	26,055	(16,190)
ART & MUSIC	1,619	2,500	(1,322)
HEALTH & PHYSICAL EDUCATION	4,017	7,650	(5,450)
MEDIA CENTER	1,601	2,020	(629)
DINING & FOOD SERVICE	3,692	5,190	(2,247)
CORE TOTAL	10,929	17,360	(9,647)
MEDICAL	279	610	(497)
ADMINISTRATION & GUIDANCE	3,091	2,015	1,614
CUSTODIAL & MAINTENANCE	1,214	1,900	(1,029)
ADMINISTRATIVE TOTAL	4,584	4,525	89
TOTAL FLOOR AREA	30,775	47,940	(25,748)

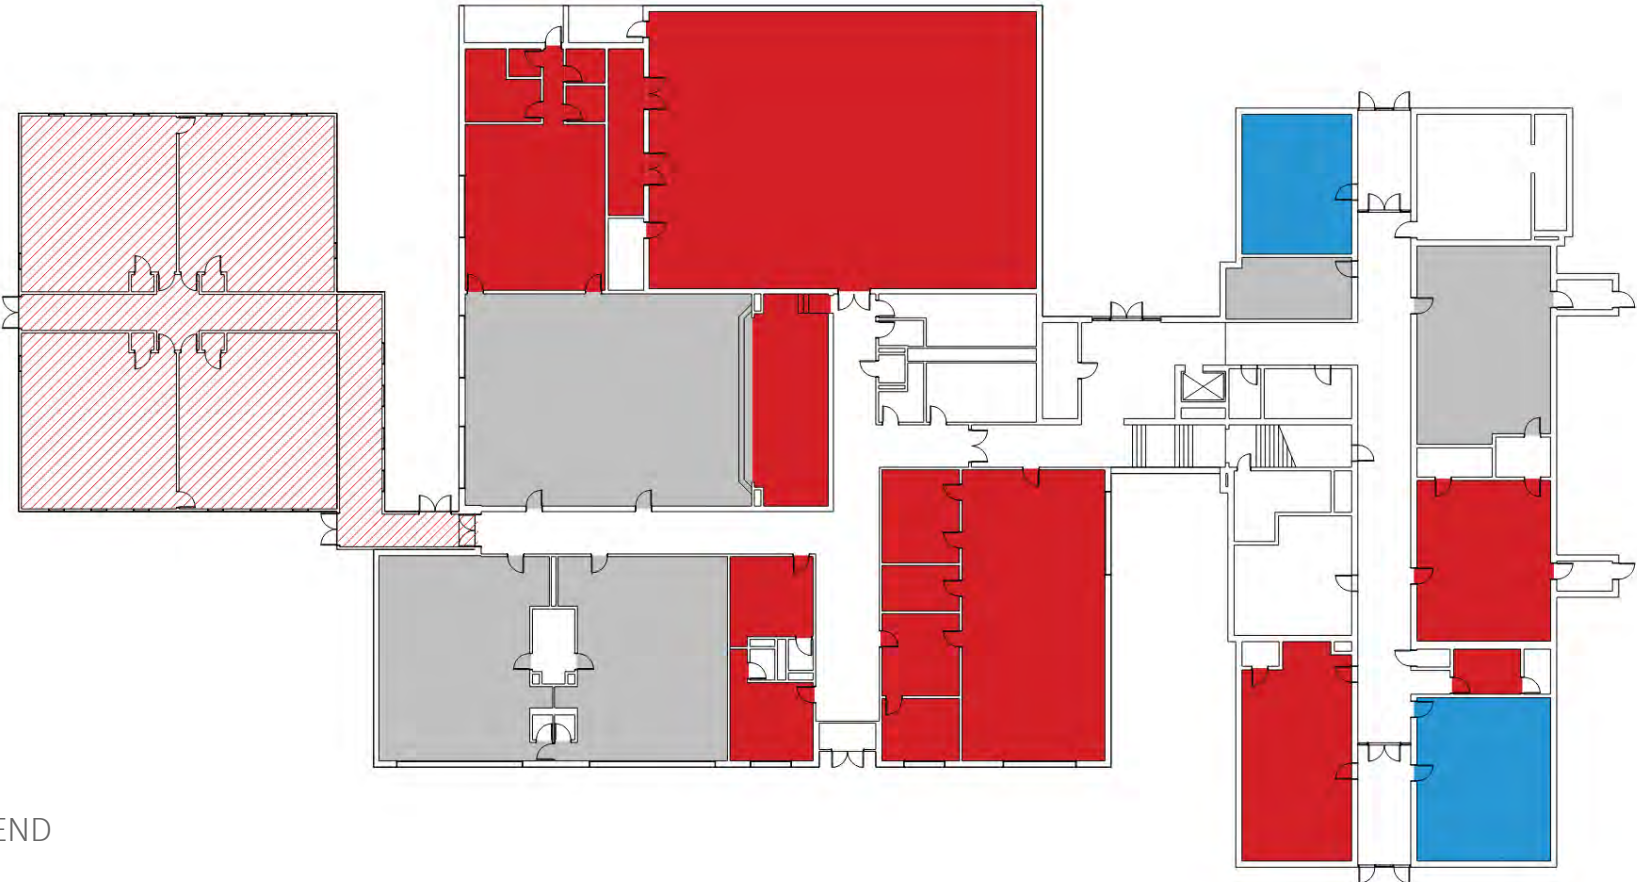
Calvin Coolidge School | MSBA Comparison Plans

- Classrooms (including special education) comprise the greatest deficiency, particularly with removal of portables. This is in alignment with the enrollment/design capacity analysis.
- The existing gymnasium is only about 54% of the square footage recommended by MSBA; similarly, the existing kitchen is about 61%. The cafeteria itself falls just shy of the MSBA value, but reportedly cannot support all families for performances. These spaces comprise the second-largest deficit (behind academic spaces), and will be closely reviewed during options development.
- Administration & guidance spaces are oversized, but medical and custodial spaces are deficient; in lieu of adding square footage, consider reallocating these spaces (if possible) for an improved distribution.

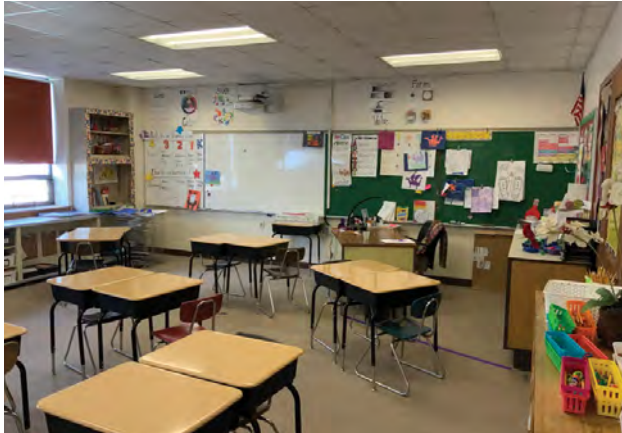
Undersized classroom

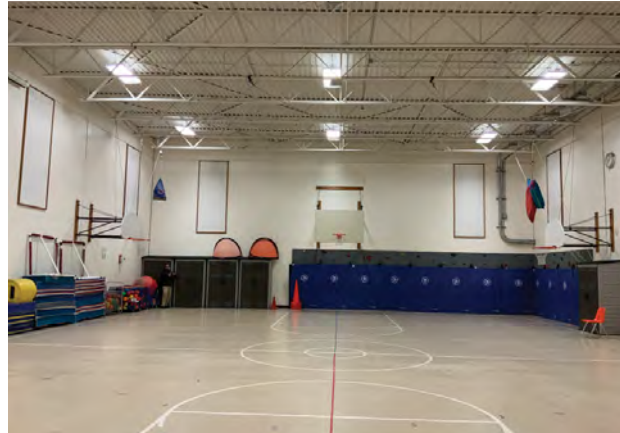
Undersized gymnasium with no spectator seating/bleachers and inadequate storage

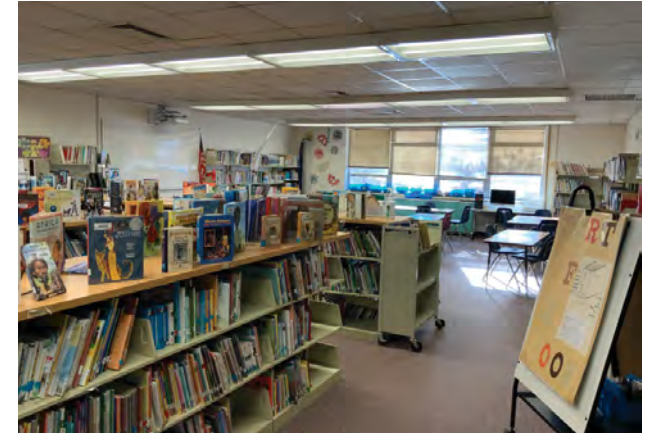
Media center undersized and dated; tables for small groups provided in main space (no quiet areas)

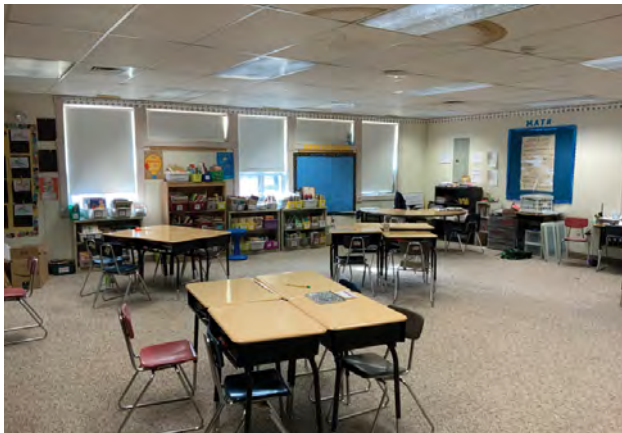
Modular classrooms house undersized kindergarten spaces with no toilet rooms

Kindergarten classrooms are grouped together to the southwest, separate from the rest of the classrooms. Four of the six kindergarten classrooms are portable classrooms. These are undersized and do not have dedicated toilet facilities. The other two kindergarten classrooms are more appropriately sized, and while they do include toilet rooms, those rooms do not meet current guidelines for accessibility.

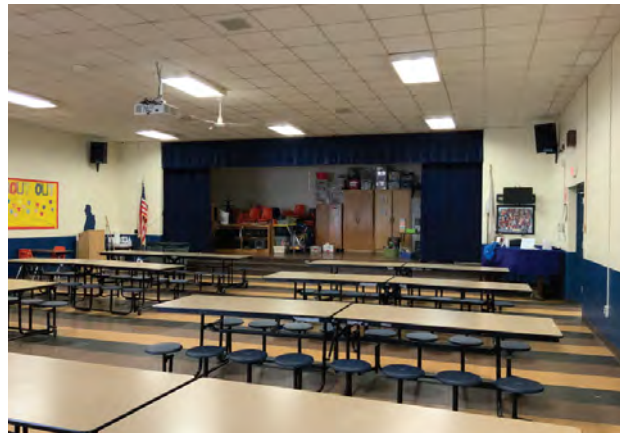
Cafetorium inadequate for performances (too small, acoustic issues); stage non-functional

DINING & FOOD SERVICE	●	○	○	ACOUSTICS AN ISSUE IN CAFETORIUM; STAGE NON-FUNCTIONAL – CURRENTLY USED AS EXTENDED DAY STORAGE; CAFETORIUM SIZE IS INADEQUATE TO HOUSE ALL FAMILIES FOR PERFORMANCES
MEDICAL	●	○	○	COMBINED OFFICE AND EXAM ROOM, WITH NO PRIVACY BETWEEN THE TWO; BATHROOM DOES NOT MEET ACCESSIBILITY STANDARDS
ADMINISTRATION & GUIDANCE	●	●	●	MAIN OFFICE & PRINCIPAL’S OFFICE ADJACENT TO MAIN ENTRANCE; OTHER ADMINISTRATIVE AND GUIDANCE AREAS DISPERSED ON ALL FLOORS
CUSTODIAL & MAINTENANCE	●	○	○	MAIN CUSTODIAL AREA REMOTELY LOCATED FROM LOADING DOCK; LOADING DOCK ACCESSIBLE FROM KITCHEN OR GYMNASIUM ONLY

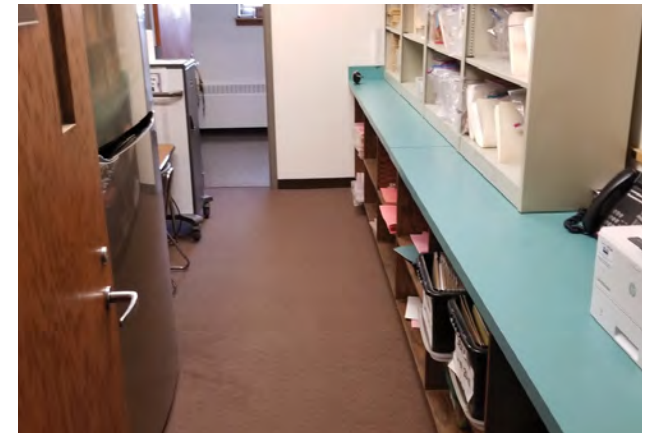
Teacher planning space & restroom on first and third floor; additional shared spaces between classrooms

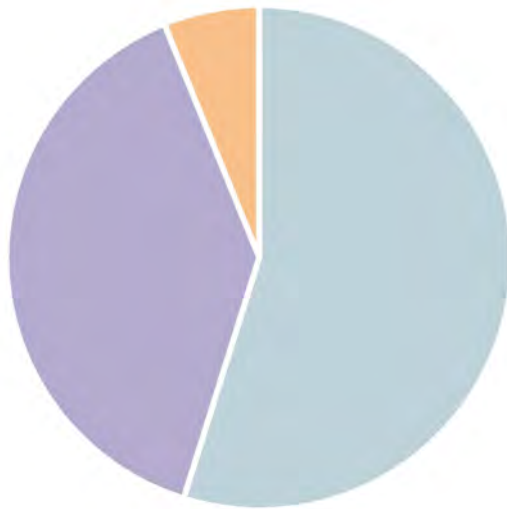
EXISTING NET FLOOR AREA

SPACE TYPE	EXISTING SQFT (NET)	MSBA GUIDELINE SQFT (NET)	DEFICIENCY (GROSS GF = 1.5)
CORE ACADEMIC SPACES <small>* Excludes portable classroom square footage.</small>	28,410	32,475	(6,098)
SPECIAL EDUCATION	4,168	8,210	(6,063)
ACADEMIC TOTAL	32,578	40,685	(12,161)
ART & MUSIC	3,229	2,575	981
HEALTH & PHYSICAL EDUCATION	7,458	7,650	(288)
MEDIA CENTER	2,945	2,965	(30)
DINING & FOOD SERVICE	8,897	7,232	2,498
CORE TOTAL	22,529	20,422	3,161
MEDICAL	394	710	(474)
ADMINISTRATION & GUIDANCE	1,850	2,375	(788)
CUSTODIAL & MAINTENANCE	1,413	2,110	(1,046)
ADMINISTRATIVE TOTAL	3,657	5,195	(2,307)
TOTAL FLOOR AREA	58,764	66,302	(11,307)

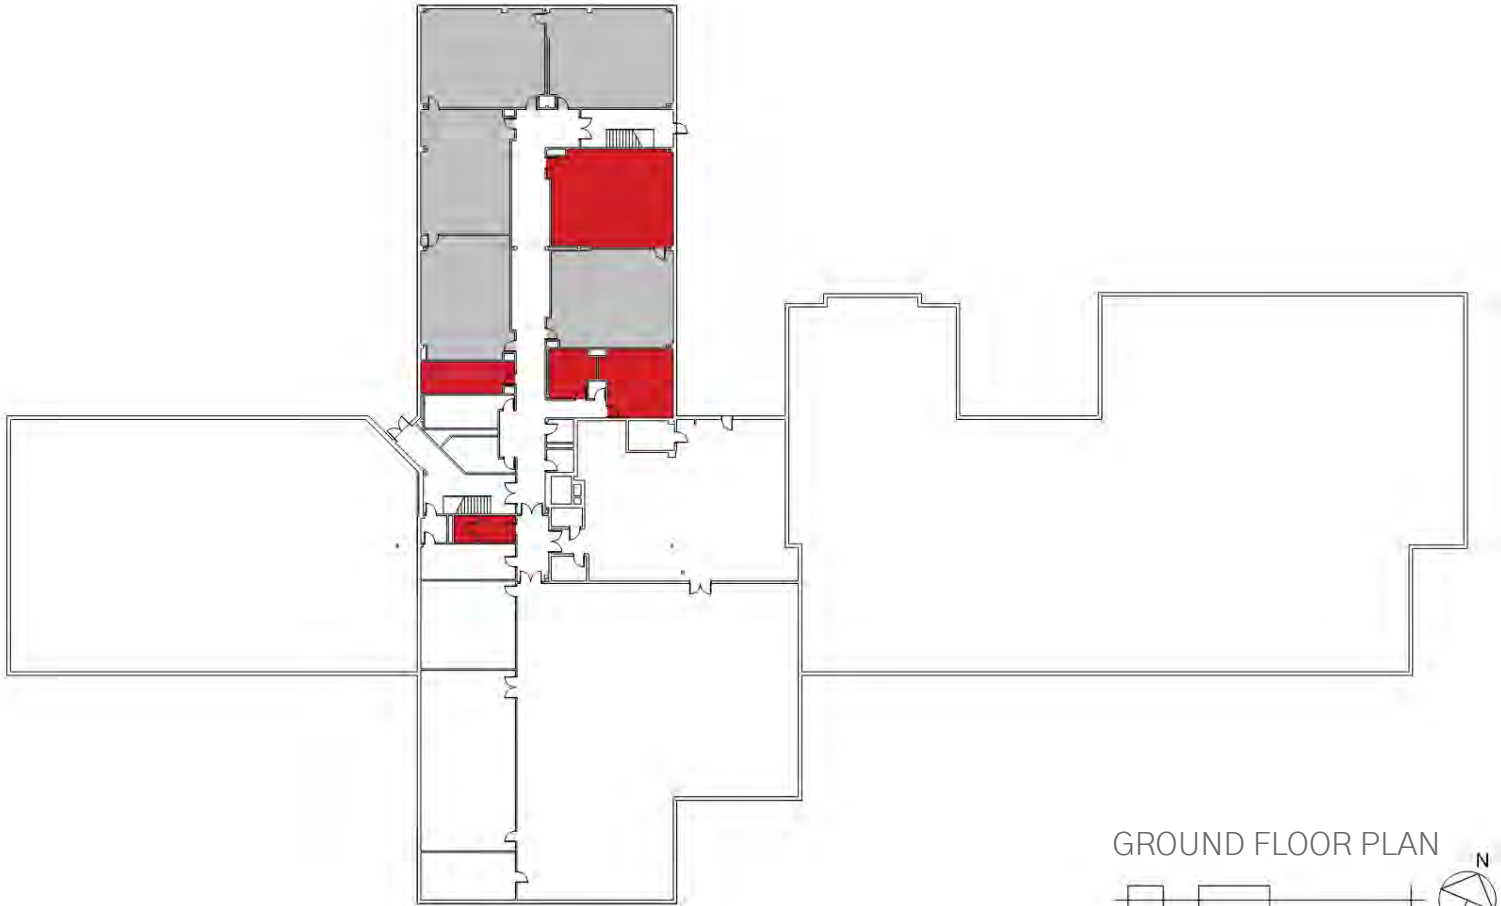
GROUND FLOOR PLAN

- Special education spaces comprise the largest deficit; almost all types of services are provided, but in insufficient sizes and/or quantities to meet the need. This could be alleviated by allocating more of these services to Beal, which has the capacity to adequately support these students. Building expansion is not feasible for this location due to wetlands protections.
- The total academic deficit shown is a bit misleading, as it includes non-classroom spaces like common areas and teacher planning rooms. When comparing just the standard classroom square footage to the MSBA recommendation for this enrollment, Floral actually has a 1,800 square foot excess of classroom space.
- Administration spaces are generally undersized, which contributes to the deficit.

The ground floor houses a large area dedicated to storage for the school department. This could provide future expansion space should the storage be relocated elsewhere; but as it is a windowless area adjacent to the boiler room, careful consideration would be needed as far as what type of space to include here.

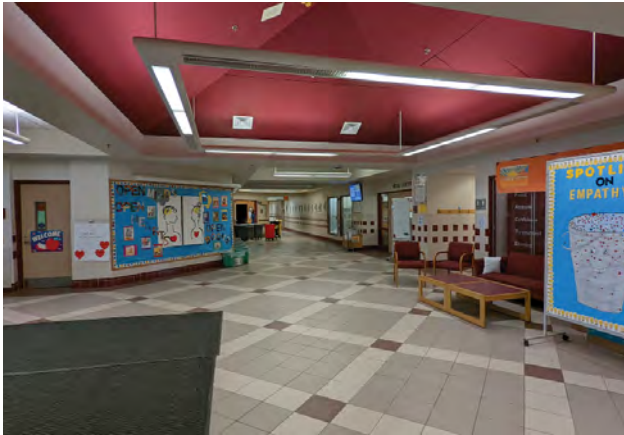
Welcoming lobby with direct access to administration and assembly spaces

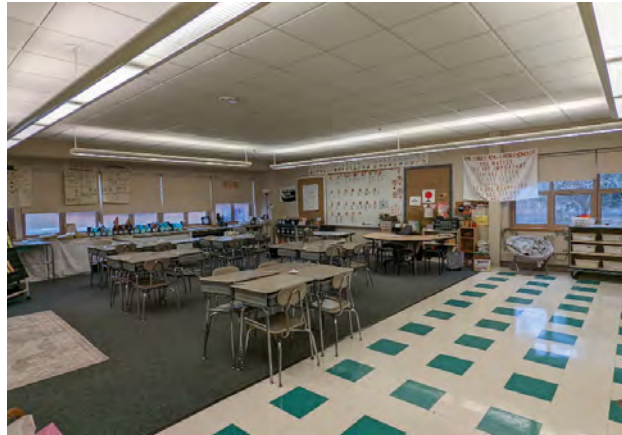
Classrooms are adequately sized, though disparities exist; no dedicated toilets for kindergartens

Past the cafetorium, two classroom wings protrude out to the north and the west. There is an unequal distribution of classroom square footage, but all footprints meet MSBA guidelines for size. Two multi-user and two single-user restrooms are centrally located at the node where the classroom wings meet on all three floors. Special education spaces are also dispersed on all three floors; though the spaces provided are inadequate to address the need. Indeed, the special education deficit comprises the primary need at Floral. Kindergarten spaces are dispersed between the ground and first floors. No kindergarten classroom has a dedicated toilet room.

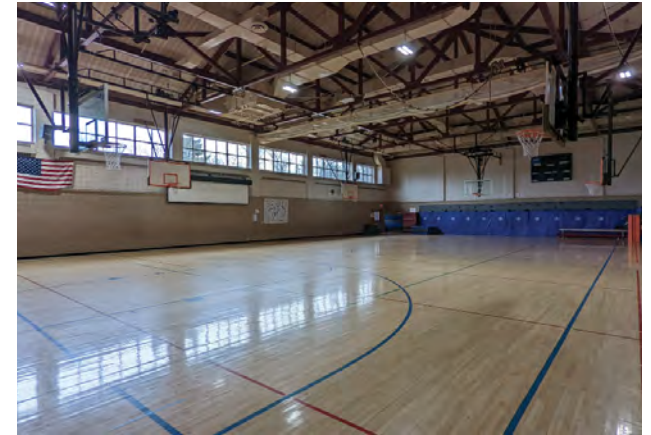
Gymnasium meets requirements, but associated storage and office spaces do not

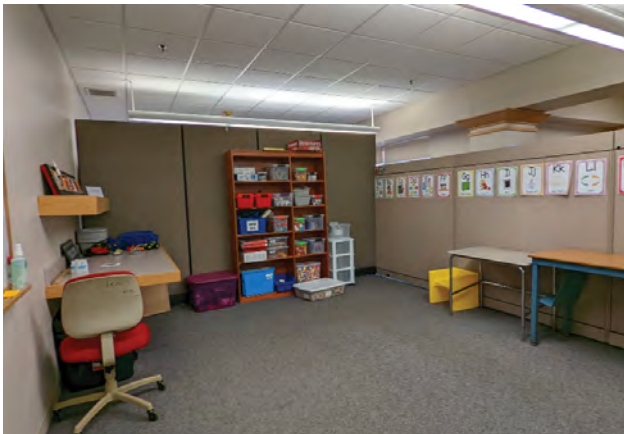
Portion of media center has been reallocated to small group services via movable partitions

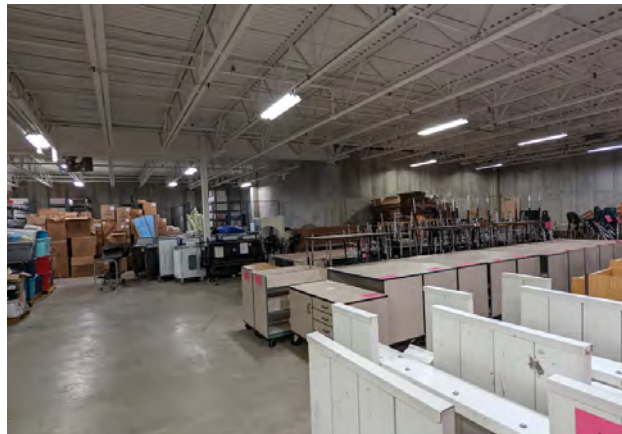
School department storage in basement provides potential opportunity for future school expansion

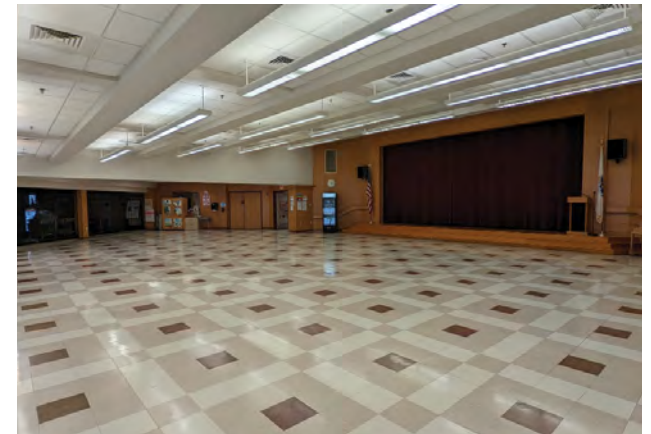
Cafetorium is sized appropriately and well-maintained, as are the kitchen and associated spaces

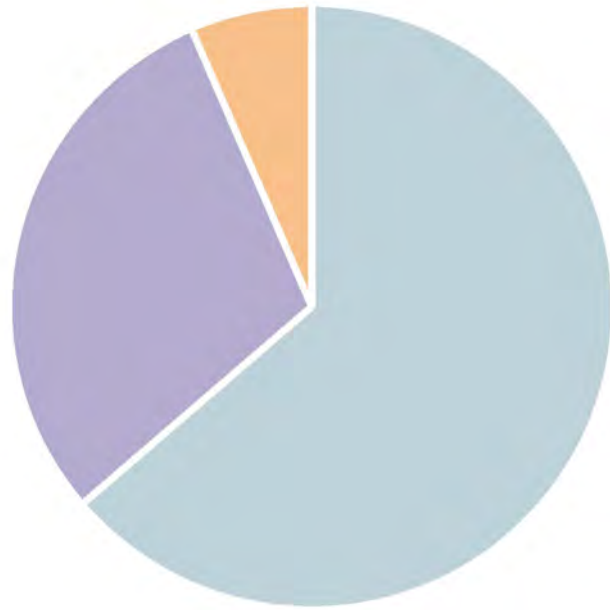
EXISTING NET FLOOR AREA

- Beal was oversized to account for some of the inequities that existed in other parts of the district, as well as to ensure full-day kindergarten would be provided for all eligible Shrewsbury students. Not all classrooms are currently in use at their full capacity, as the enrollment is far below the design capacity.
- Special education spaces account for almost twice the MSBA recommendation for square footage.
- These spatial excesses make Beal a critical component of options development, as it could feasibly act as a swing space for one of the other elementary schools (or even absorb almost an entire population permanently), should there be a need to take a school offline for renovation.

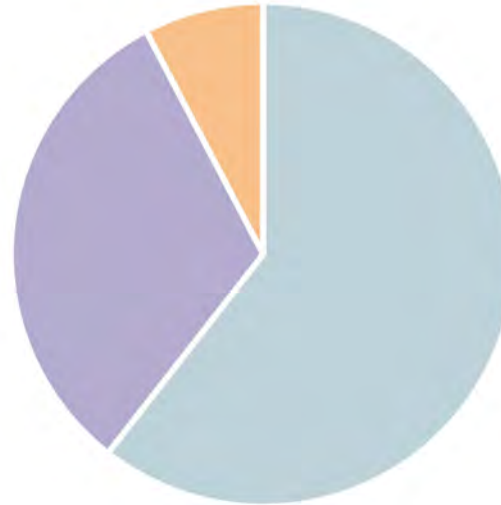
MSBA NET FLOOR AREA

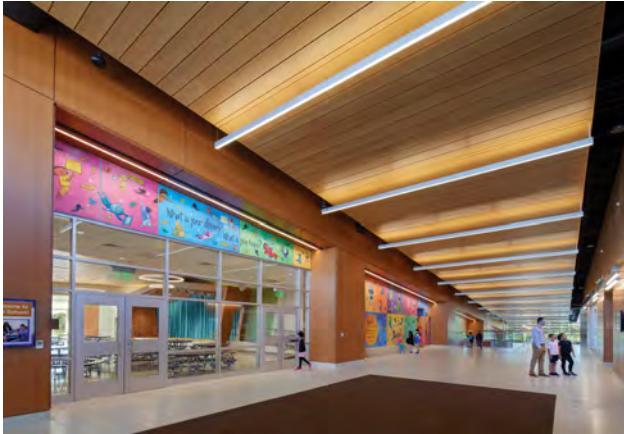
Central spine corridor connects main entrance with all assembly spaces

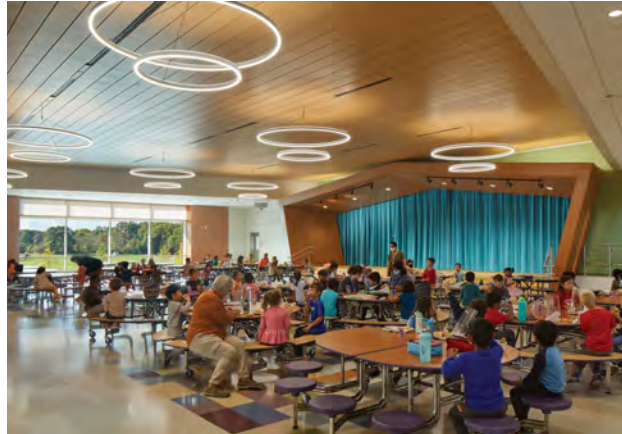
Cafetorium and stage sufficiently sized for all-school meetings as well as lunch periods

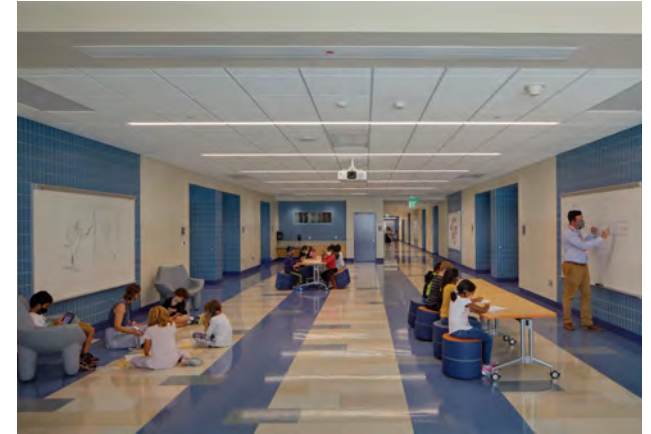
Classrooms arranged in neighborhoods, with common areas for breakout instruction

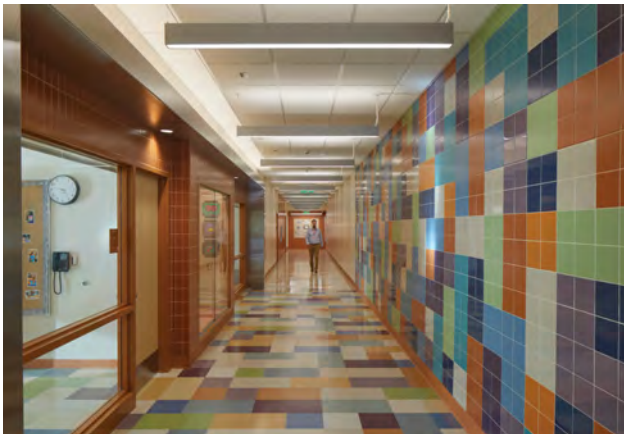
Efficient, well-lit circulation makes navigation easy

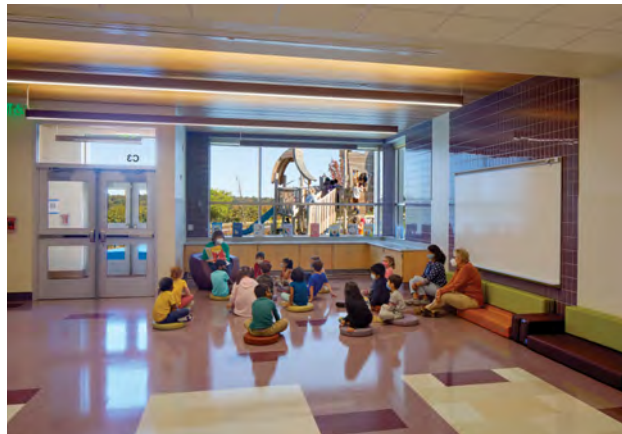
Kindergartens have their own wing and common areas with direct access to playground

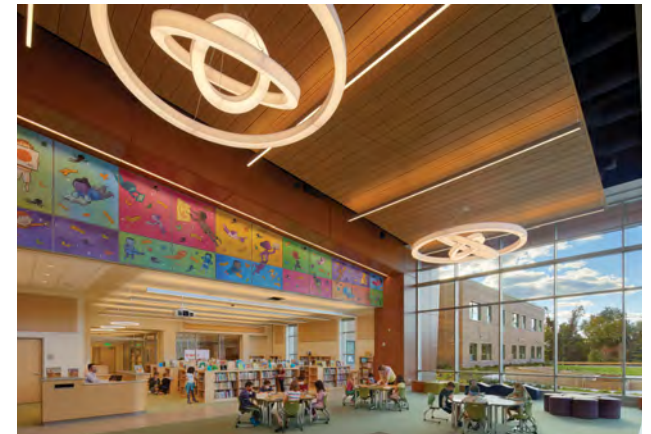
Media center & maker space centrally located at crosspoint of classroom wings

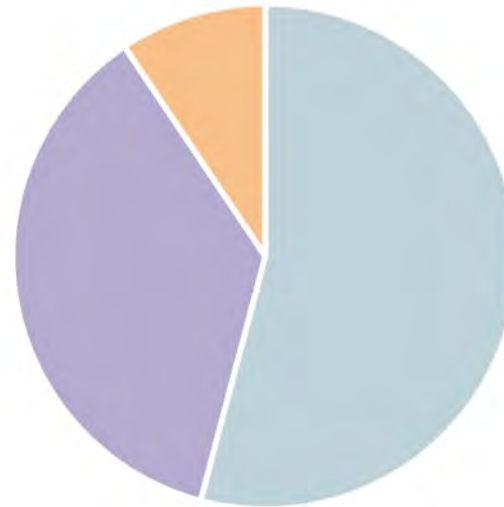
MSBA NET FLOOR AREA

- Generally speaking, all rooms at Spring Street School are quite small compared to MSBA recommendations. This contributes to the deficits across the board.

- The average classroom size is 794 sq ft for general classrooms and 812 for special education classrooms (the MSBA minimum recommendation for both is 900 sq ft). There are also no common spaces, no ESL/ELL classroom, no teacher planning spaces, and no STE room.

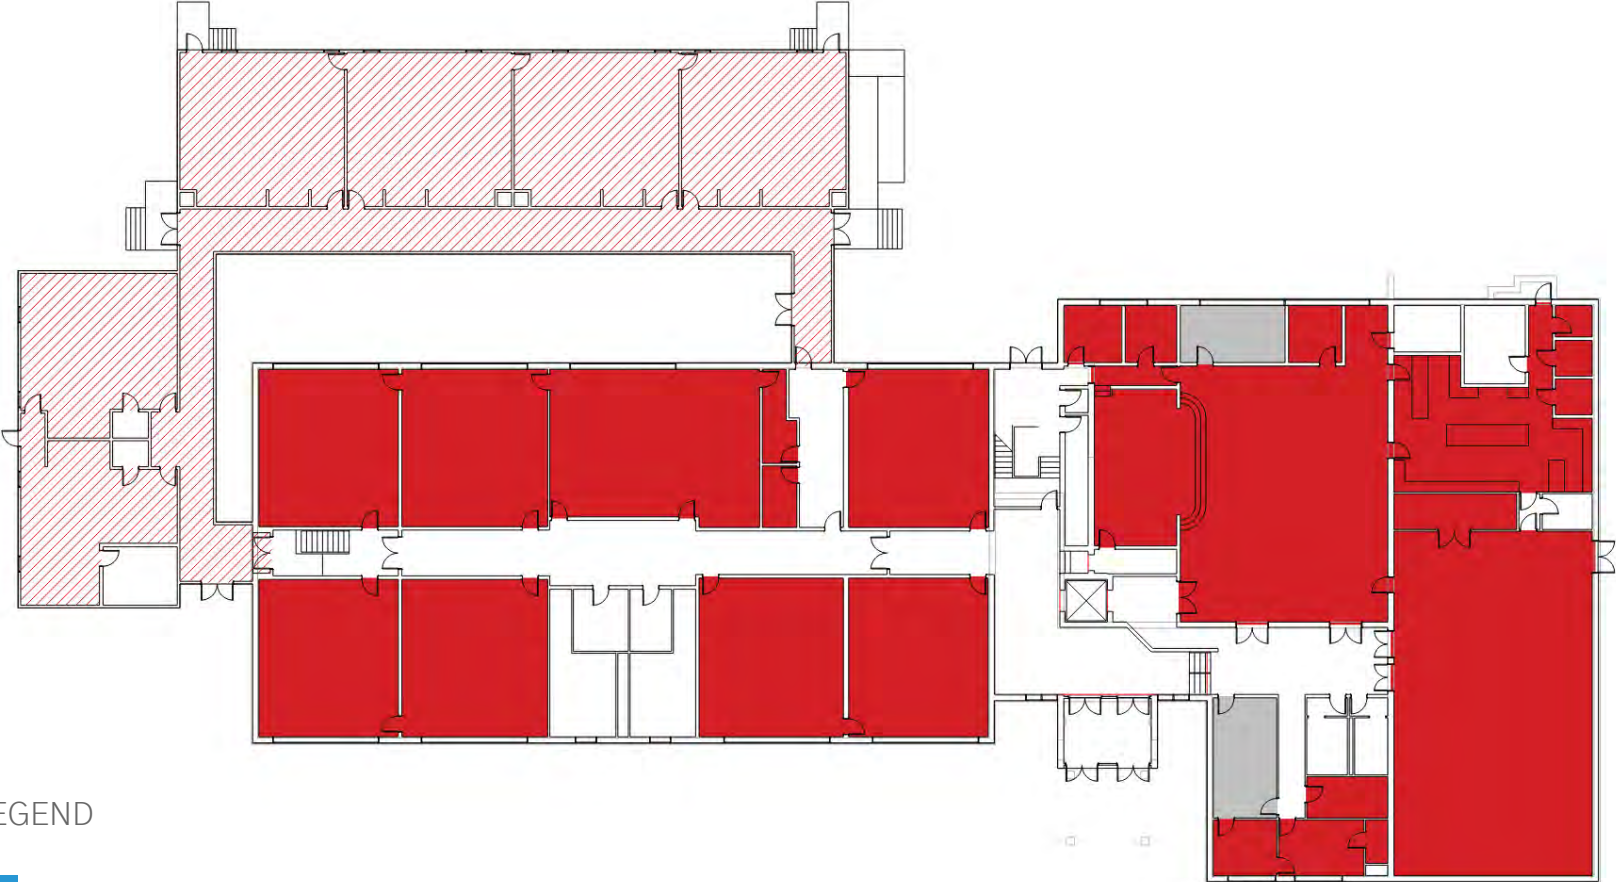
Spring Street School | MSBA Comparison Plans

- 10% OVER MSBA GUIDELINES
- MEETS MSBA GUIDELINES
- 10% UNDER MSBA GUIDELINES
- MODULAR/PORTABLE

- The media center is about 55% of the MSBA recommended size; the gymnasium is about 35%, and the art room is about 81%. (While a music classroom is provided here, it is in a portable classroom, so it has not been included in this analysis.) The stage is 53% of the recommended size; additionally, it is inaccessible (no ramp).

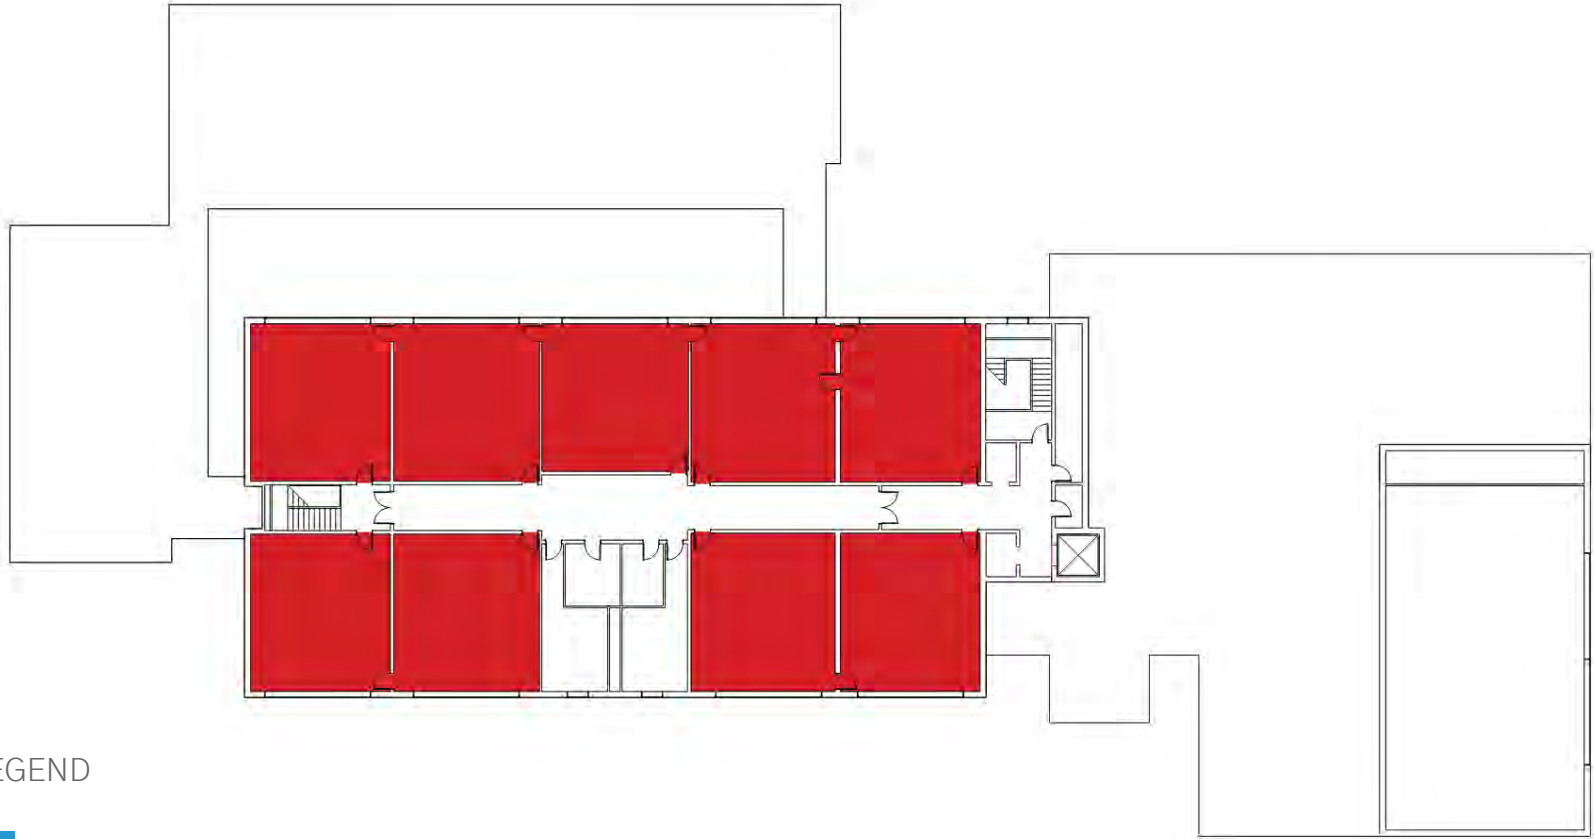
Spring Street School | MSBA Comparison Plans

- 10% OVER MSBA GUIDELINES
- MEETS MSBA GUIDELINES
- 10% UNDER MSBA GUIDELINES
- MODULAR/PORTABLE

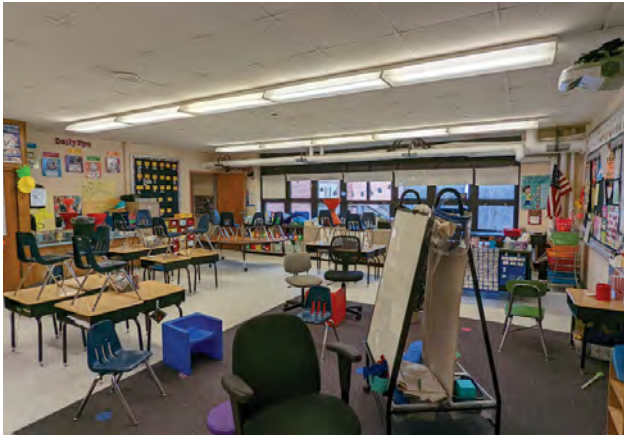
Undersized classrooms with good access to natural light; sinks provided

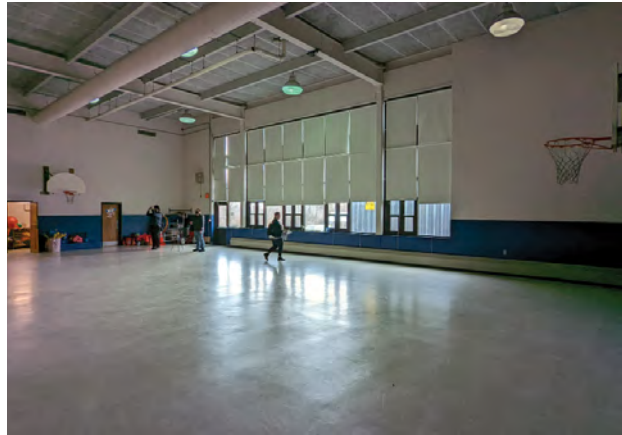
Gymnasium with exterior access and storage room; no bleachers or wall pads; undersized

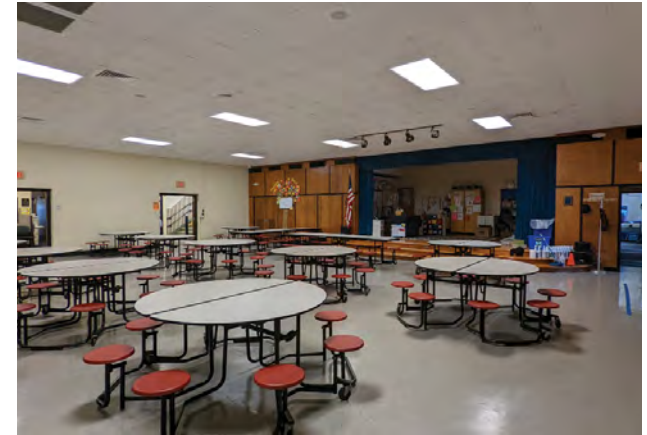
Cafeteria with stage; stage is inaccessible (no ramp, only accessed via stairs)

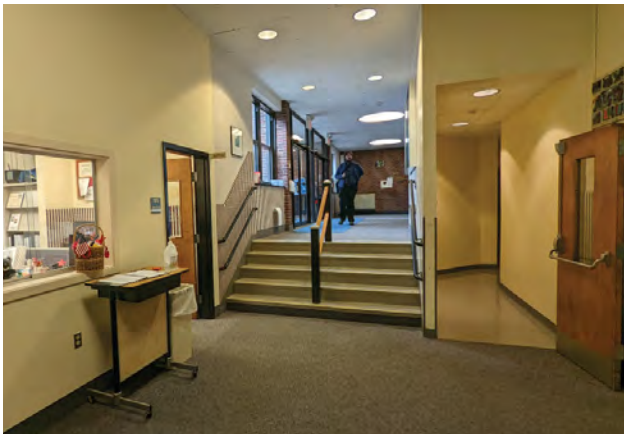
No direct line of sight from school office to main entrance – insecure; elevator corridor to right of stair

The administrative suite is remotely located from the main entrance; there is no direct visual access to the vestibule, nor was any type of controlled entry system observed. This presents a potential security concern.

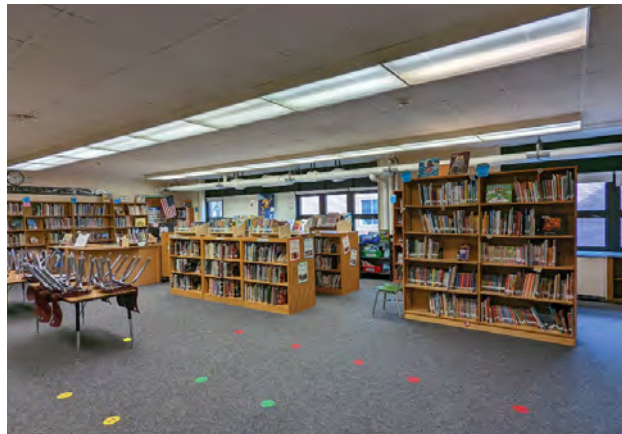
Former classroom re-purposed as media center; undersized

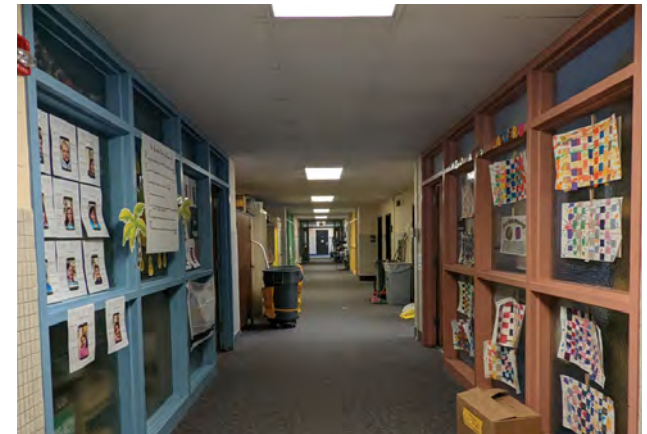
Efficient circulation in classroom wing (both floors); double-loaded corridors with short travel distances

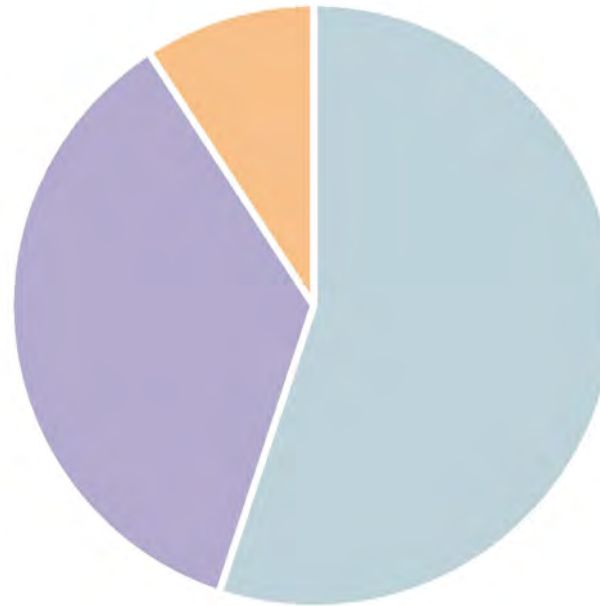
EXISTING NET FLOOR AREA

- The “Triple Threat” cafe-gym-atorium space accounts for the greatest square footage deficiency, followed by classrooms.
- While the classroom deficiency is exacerbated by the removal of about 2,550 square feet of portable classroom space, classrooms would still be only 64% of the square footage needed to meet the enrollment need with the portables included.
- A case can be made for a full academic wing addition, as well as a new gymnasium.

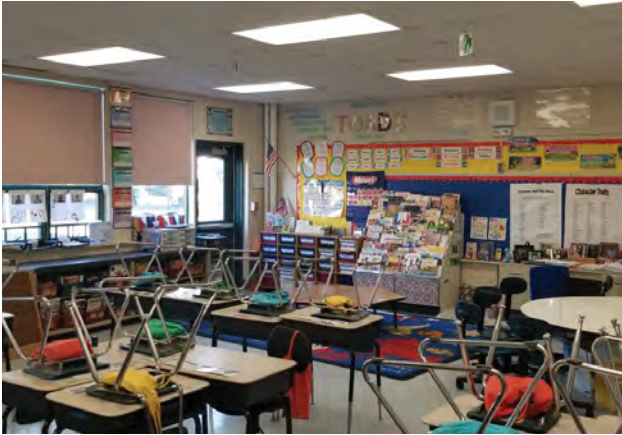
Adequately sized classrooms with good access to natural light

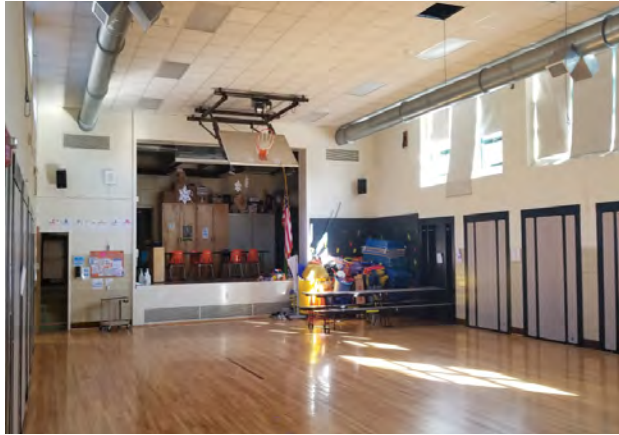
“Triple Threat” space: cafe-gym-atorium

The biggest concern would be that of the cafe-gym-atorium, or “Triple Threat” space. Separating these uses into a cafetorium and gymnasium (with adequate storage space for both) would be the preferred solution for an elementary school. Classrooms are sized appropriately and have good access to natural light; but there are not enough to support the student body population. (This will be exacerbated by the removal of three modular classrooms at the north side of the building.) The generous classroom sizes have been useful in flexibly reallocating space for media center, art, music, reading, and special education uses. An administrative expansion added much needed office space, though it still falls short of the mark overall.

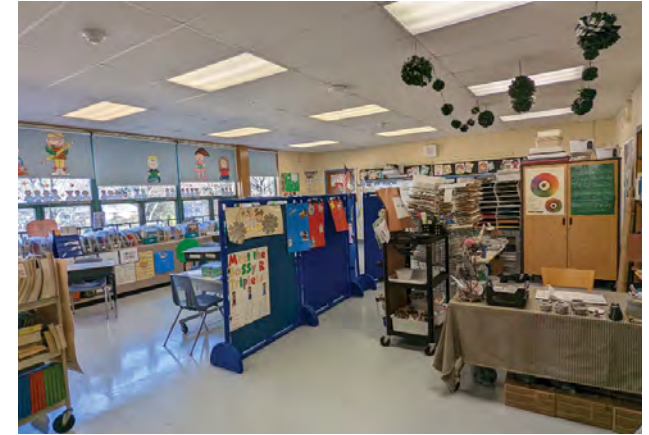
Classroom re-purposed to house art/music/reading

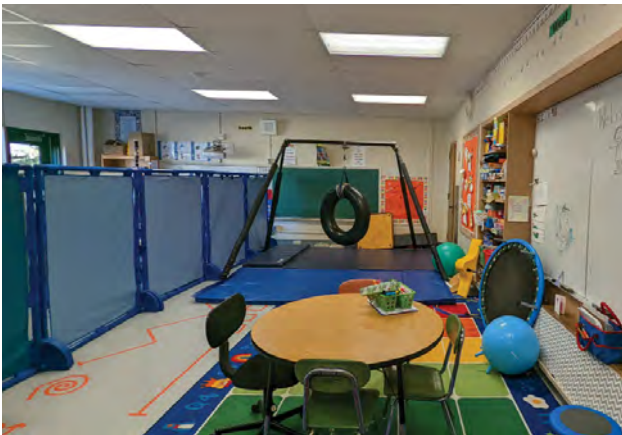
Classroom re-purposed to house various special education programs, including OT/PT

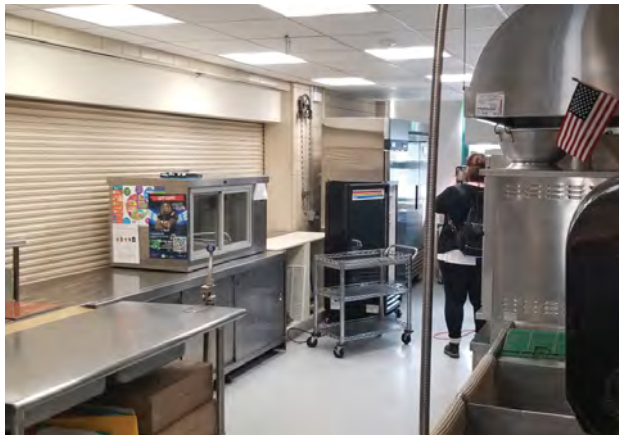
Maxed-out kitchen with limited storage options

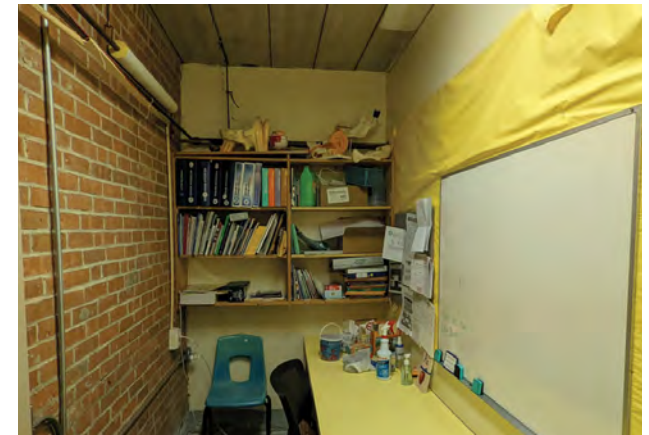
Undersized teacher work room located in basement (no elevator access)
