13 March 2023

Shrewsbury Public Schools Pre-K-12
Capital Inventory & Improvement Study

TABLE OF CONTENTS

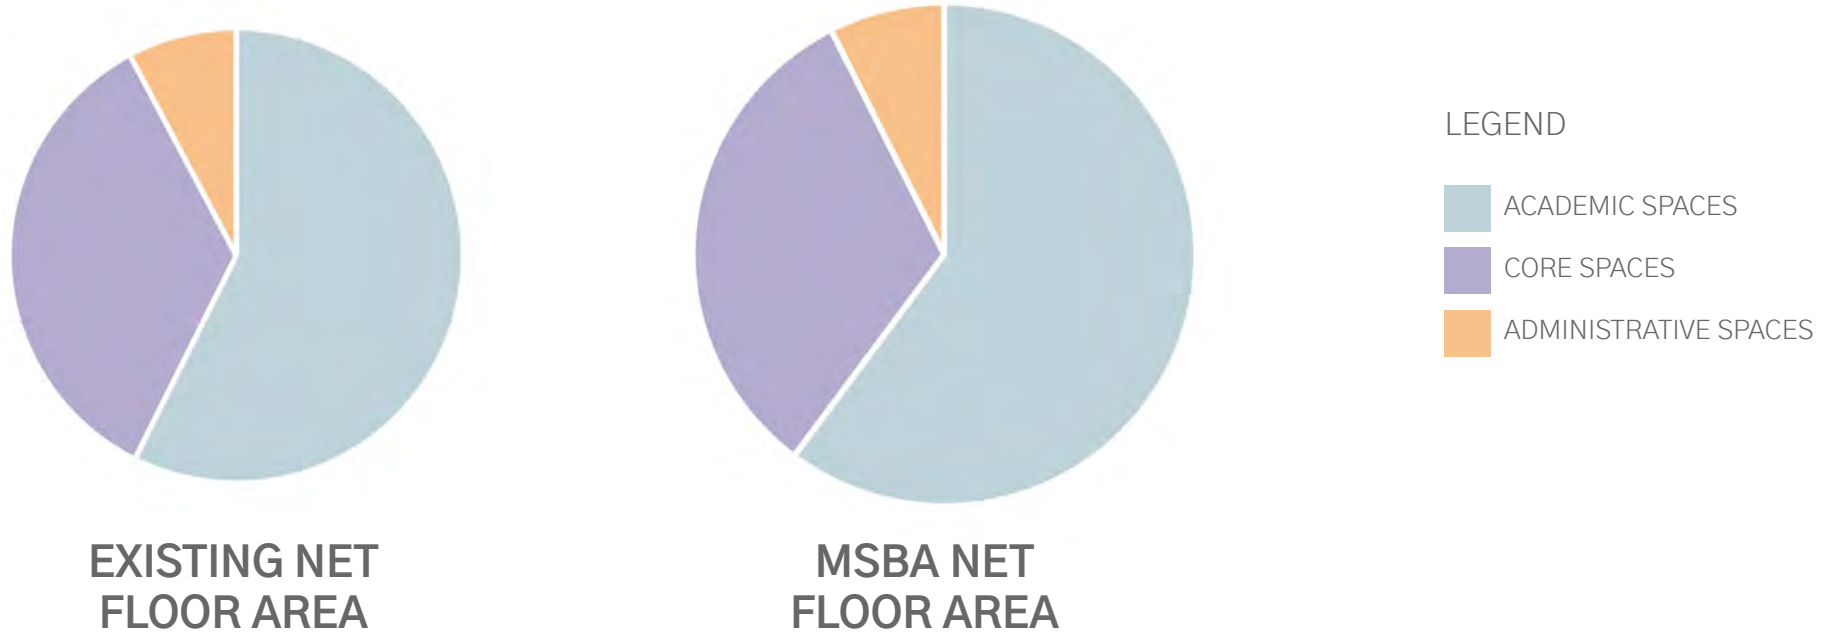
Sherwood Middle School | MSBA Space Summary Template

- The core academic deficiency is purely the result of a lack of special education spaces. In fact, Sherwood has a 13-classroom surplus, when compared to the MSBA space summary template value. The lack of special education spaces can be attributed to the current excess in enrollment (952 students versus a design capacity of 837); as enrollment is forecasted to drop by 132 students over the next ten years, classrooms can be reallocated to make up the difference.
- The media center is undersized but has opportunity for expansion, if desired (there are two classrooms directly adjacent that the media center could expand into).
- There are no technical classrooms currently provided at Sherwood.
- Custodial spaces are lacking; but assuming these facilities can be shared with Oak Middle School, which is directly adjacent and has extensive custodial space, this may be a non-issue.

SPACE TYPE	EXISTING SQFT (NET)	MSBA GUIDELINE SQFT (NET)	DEFICIENCY (GROSS GF = 1.5)
CORE ACADEMIC SPACES <small>* Excludes portable classroom square footage.</small>	44,410	42,150	3,390
SPECIAL EDUCATION	7,211	11,590	(6,569)
ACADEMIC TOTAL	51,621	53,740	(3,179)
ART & MUSIC	5,072	4,800	408
VOCATIONS & TECHNOLOGY	0	0	0
HEALTH & PHYSICAL EDUCATION	12,017	9,750	3,401
MEDIA CENTER	3,246	5,095	(2,774)
DINING & FOOD SERVICE	11,013	10,648	548
CORE TOTAL	31,348	30,293	1,583
MEDICAL	992	910	123
ADMINISTRATION & GUIDANCE	5,223	3,770	2,180
CUSTODIAL & MAINTENANCE	795	2,295	(2,250)
ADMINISTRATIVE TOTAL	7,010	6,975	53
TOTAL FLOOR AREA	89,979	91,008	(1,544)

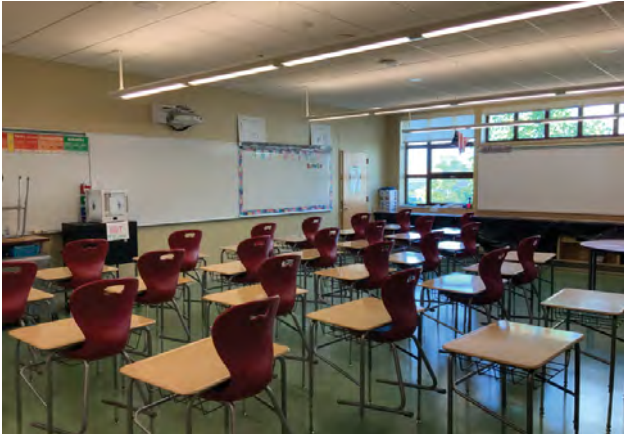
Typical classroom with modern technology, natural light, and flexible furnishings

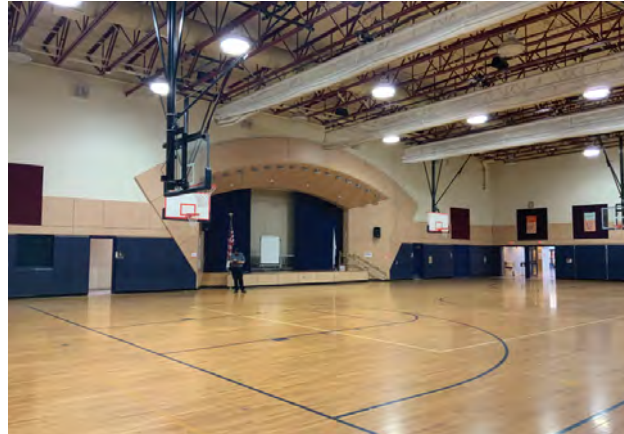
Gymnasium with stage; movable partitions on stage close to create a drama/choral classroom

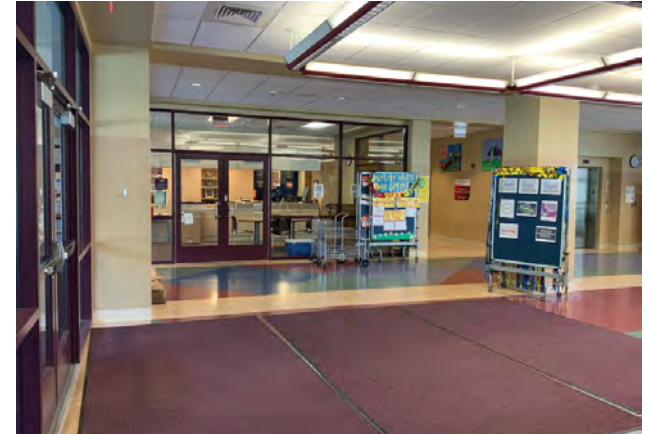
Administrative suite directly adjacent to main entrance with controlled visitor access; optimal layout for security

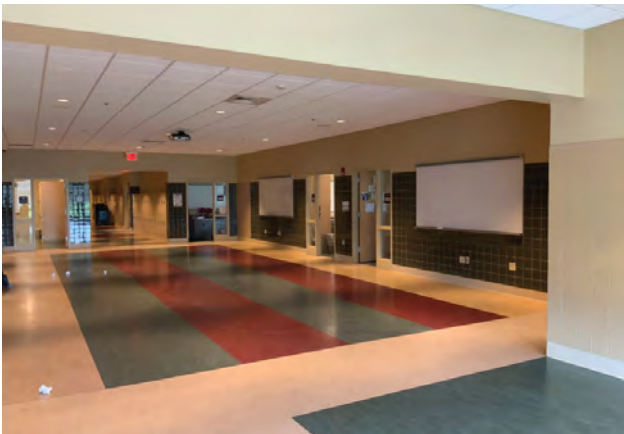
Common areas outside classrooms provide flexible space for breakout sessions or informal instruction

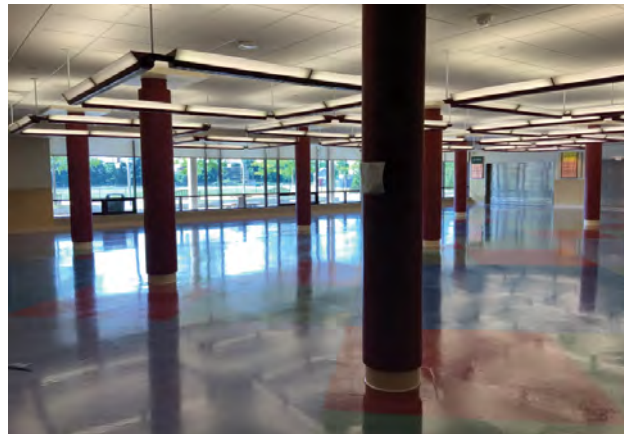
Cafeteria slightly undersized but with good natural light

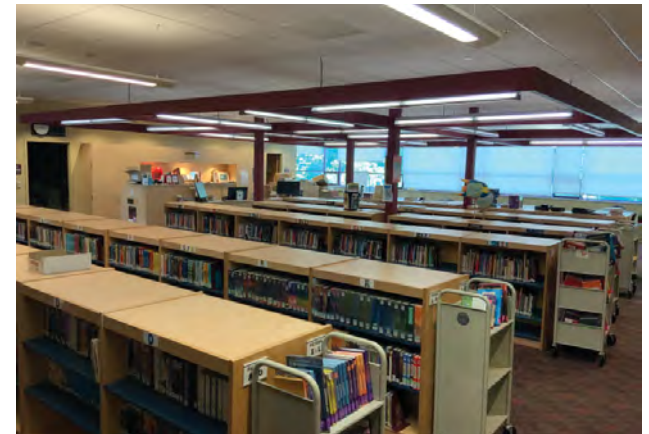
Media center undersized; small maker space cart provided

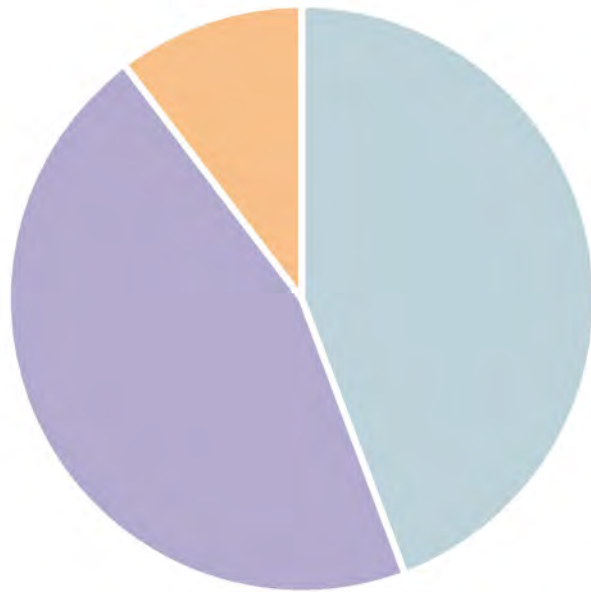
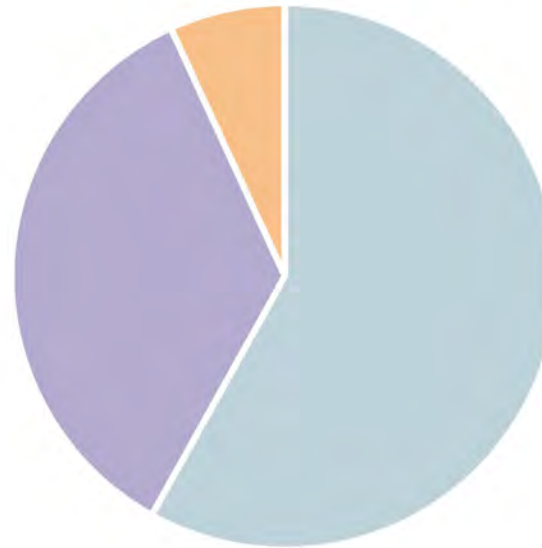
Oak Middle School | MSBA Space Summary Template

EXISTING NET FLOOR AREA

MSBA NET FLOOR AREA

- The core academic deficiency is primarily due to the lack of commons and teacher planning spaces, as well as undersized science classrooms. The quantity of both general and science classrooms is actually greater than the MSBA recommendation; in the case of general classrooms, this leads to a square footage surplus of about 3,800 sq ft. Undersized classrooms and a lack of resource rooms are the primary drivers for the special education deficit.

- Oak's auditorium is not an MSBA requirement for the middle school level; this, along with oversized athletic facilities, accounts for the core spaces surplus. However, the individual deficiencies shown in the chart cannot be ignored because of the overall surplus, as the uses of these spaces are not interchangeable. These deficiencies should be addressed discretely.

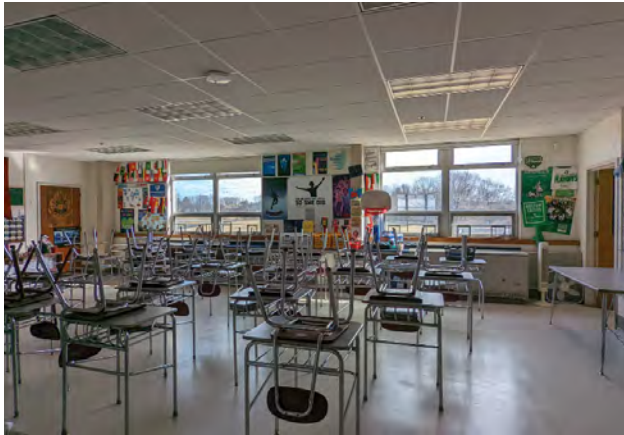
Standard classroom; undersized, but with ample natural light and flexible furnishings

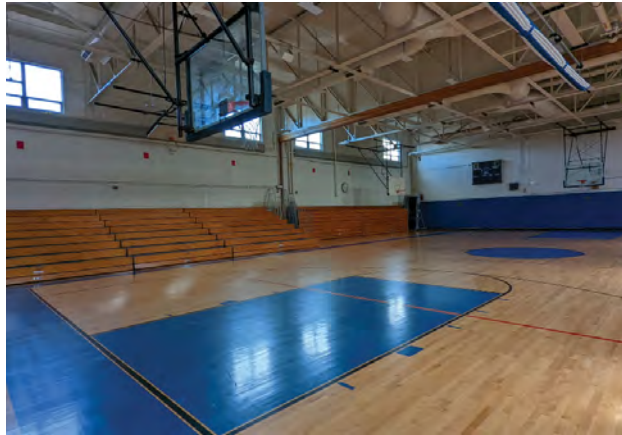
Oversized gymnasium contributes to an overall surplus of physical education spaces

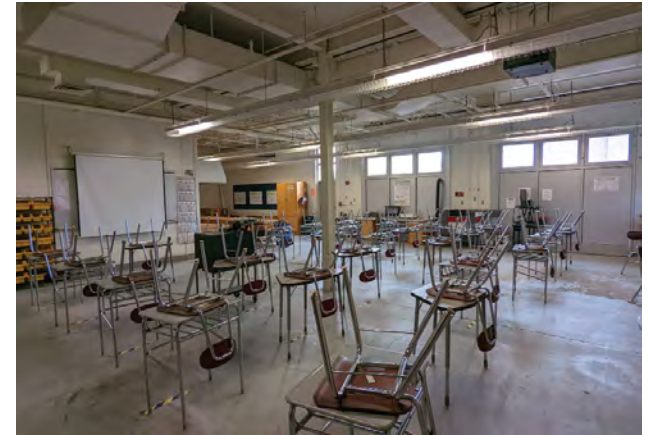
Engineering design classroom; one of two technical classrooms provided

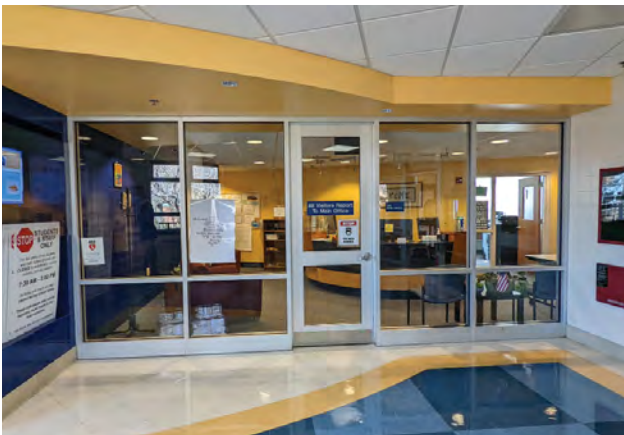
Administration suite directly adjacent to main entrance, with high visibility to greet visitors

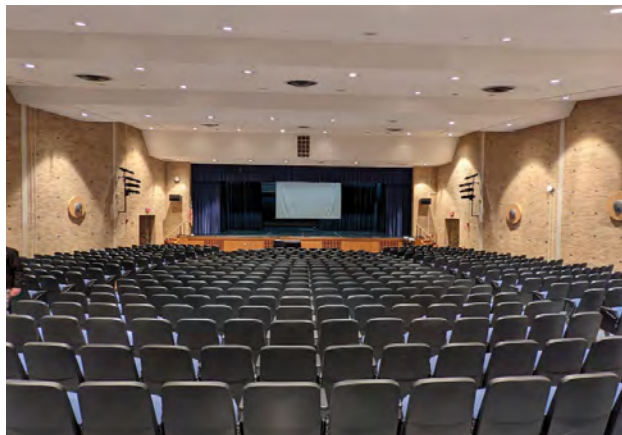
Auditorium primarily responsible for art & music coverage

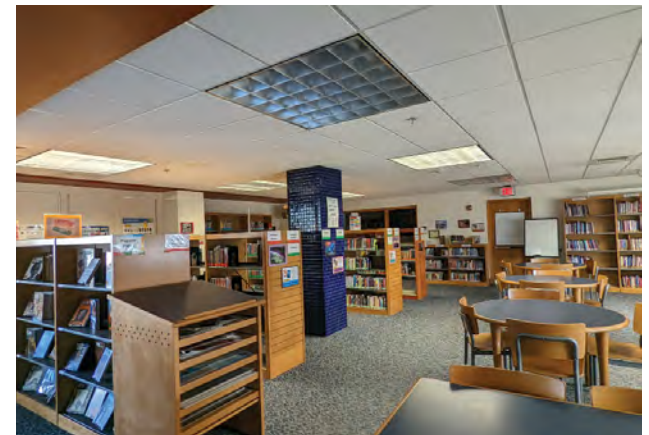
Media center is undersized but opportunities for expansion exist, if desired/required

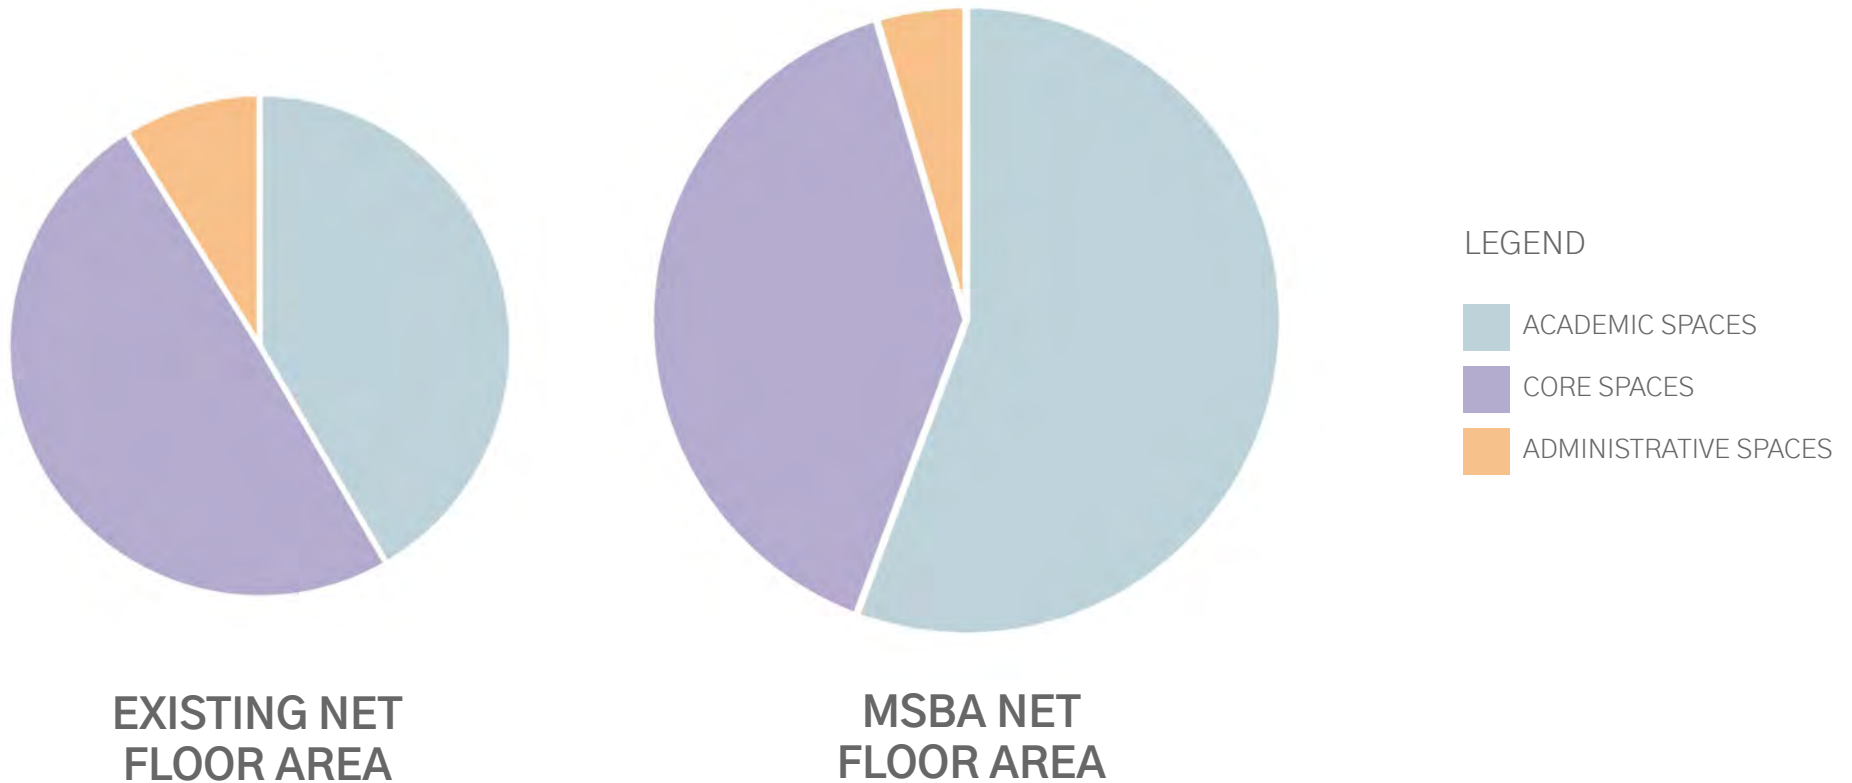
Shrewsbury High School | MSBA Space Summary Template

- Though the overall deficit is less than the academic, the academic and technology deficits should be the driver for any future space planning. The overages in core and administrative spaces do not truly give relief, since the uses are not interchangeable with academic spaces.
- The gymnasium and associated spaces are greatly oversized; but the realities of reducing or reallocating this in any meaningful way for classroom use is not feasible.
- Administration spaces are oversized; consideration could be given to reallocating some of this space for academic use, if appropriate.

SPACE TYPE	EXISTING SQFT (NET)	MSBA GUIDELINE SQFT (NET)	DEFICIENCY (GROSS GF=1.5)
CORE ACADEMIC SPACES <small>* Excludes portable classroom square footage.</small>	73,969	101,535	(41,349)
SPECIAL EDUCATION	9,669	26,160	(24,737)
OTHER (PRE-K SUITE)	1,743	0	2,615
ACADEMIC TOTAL	85,381	127,695	(63,471)
ART & MUSIC	10,395	8,350	3,068
VOCATIONS & TECHNOLOGY	7,722	21,600	(20,817)
HEALTH & PHYSICAL EDUCATION	47,454	26,194	31,890
MEDIA CENTER	9,201	10,831	(2,445)
AUDITORIUM & DRAMA	11,111	10,400	1,067
DINING & FOOD SERVICE	15,628	13,668	2,940
CORE TOTAL	101,511	91,043	15,702
MEDICAL	1,270	1,510	(360)
ADMINISTRATION & GUIDANCE	11,965	6,150	8,723
CUSTODIAL & MAINTENANCE	5,021	2,937	3,126
ADMINISTRATIVE TOTAL	18,256	10,597	11,489
TOTAL FLOOR AREA	205,148	229,335	(36,281)

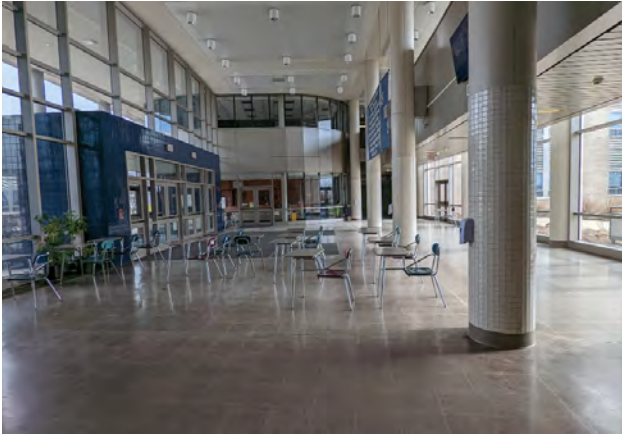
Main entrance opens onto lobby with direct access to “Main Street” corridor; administrative suite is adjacent to vestibule with clear line of sight

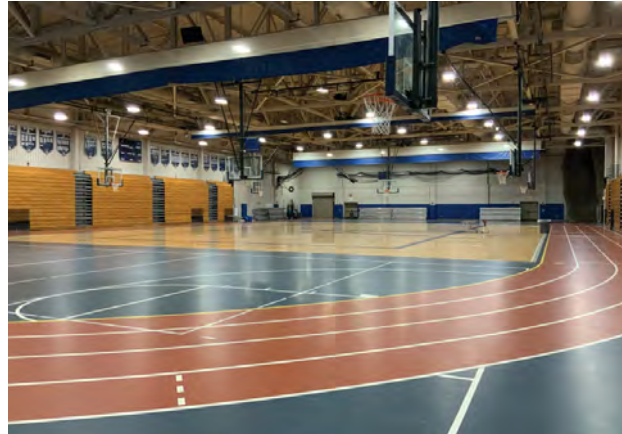
Gymnasium is greatly oversized (indoor track contributes); locker rooms are undersized

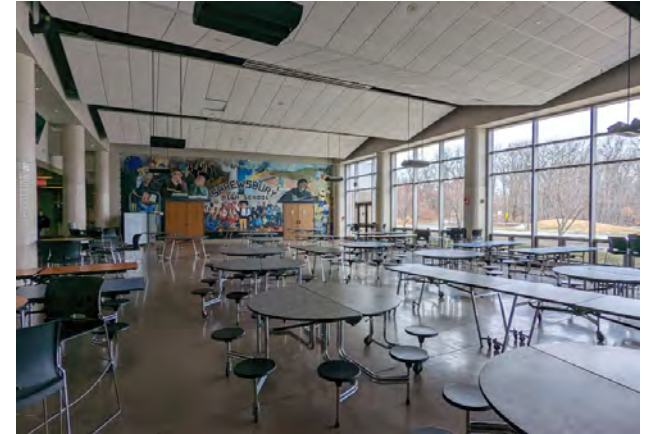
Cafeteria seating area is insufficient/over-crowded; kitchen and servery are adequate

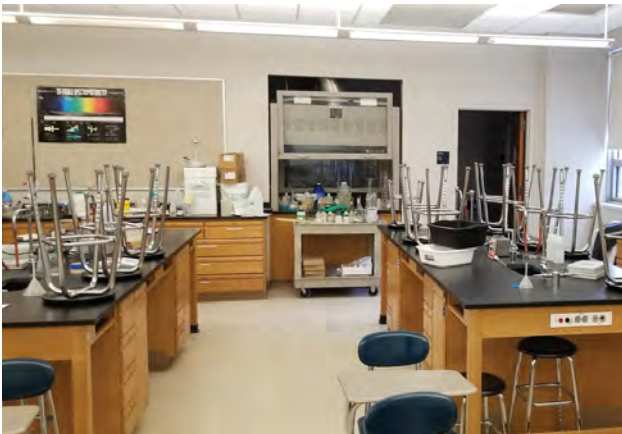
Science labs are undersized and lack quantity needed to serve population

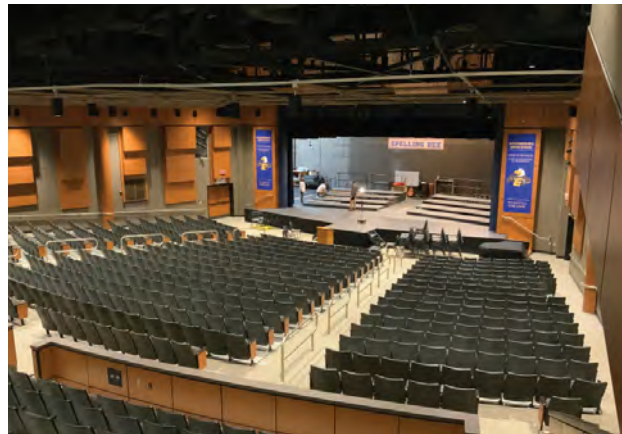
Auditorium is about 89% of the recommended size; the stage is about 82% oversized, however

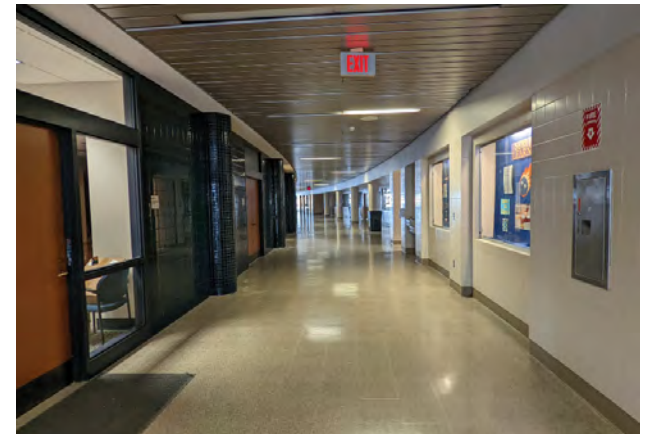
“Main Street” corridor connects all wings to each other on first and second floors

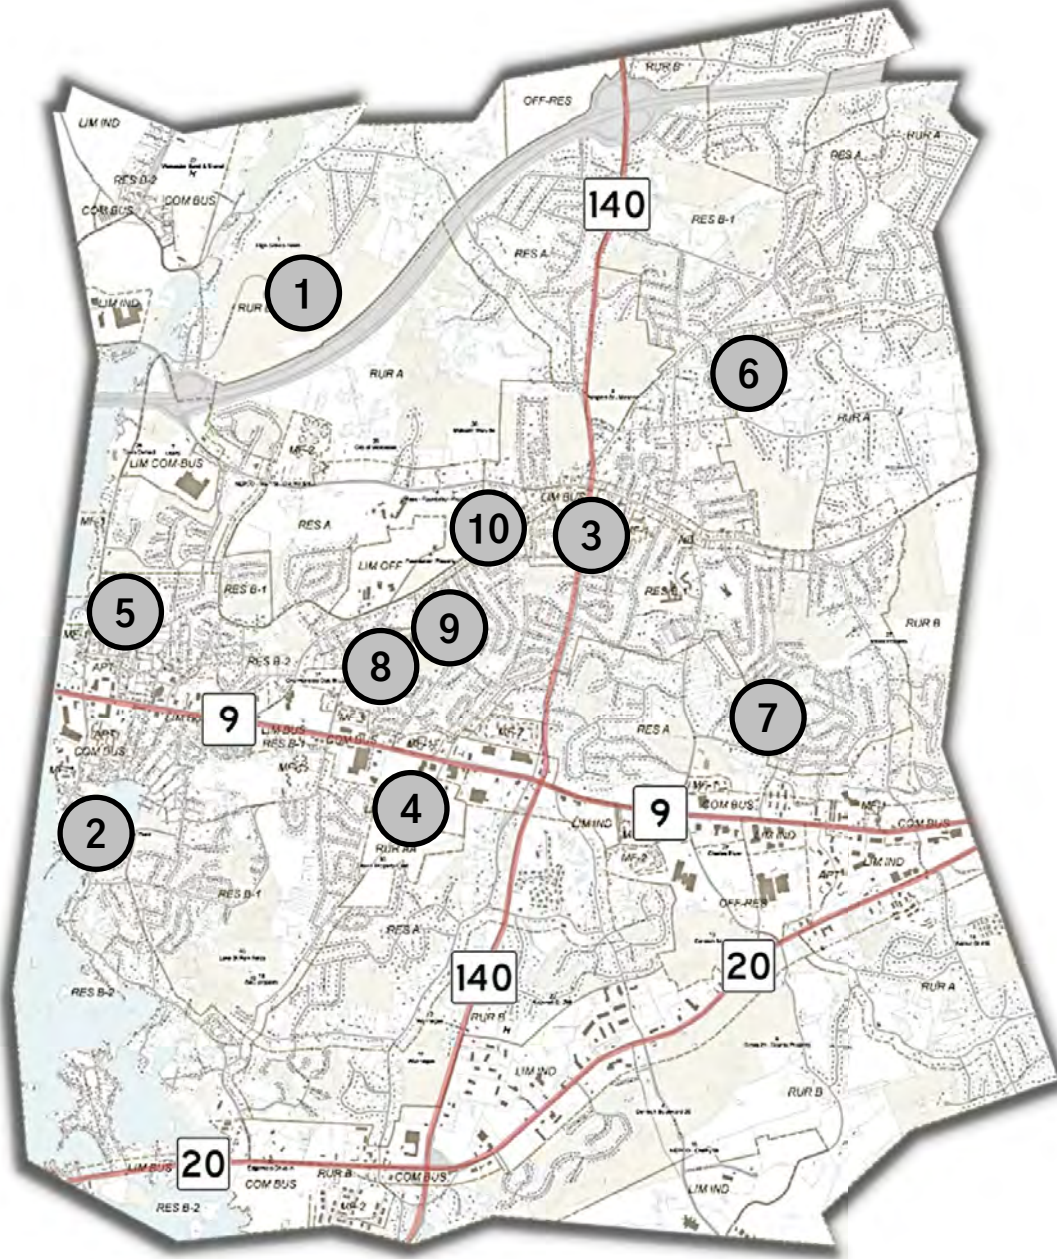
Options | Overall Locus Plan

- ① SHREWSBURY HIGH SCHOOL
- ② CALVIN COOLIDGE SCHOOL
- ③ WALTER J. PATON SCHOOL
- ④ MAJOR HOWARD BEAL SCHOOL
- ⑤ PARKER ROAD PRECHOOL
- ⑥ SPRING STREET SCHOOL
- ⑦ FLORAL STREET SCHOOL
- ⑧ SHERWOOD MIDDLE SCHOOL
- ⑨ OAK MIDDLE SCHOOL
- ⑩ SPS ADMINISTRATION

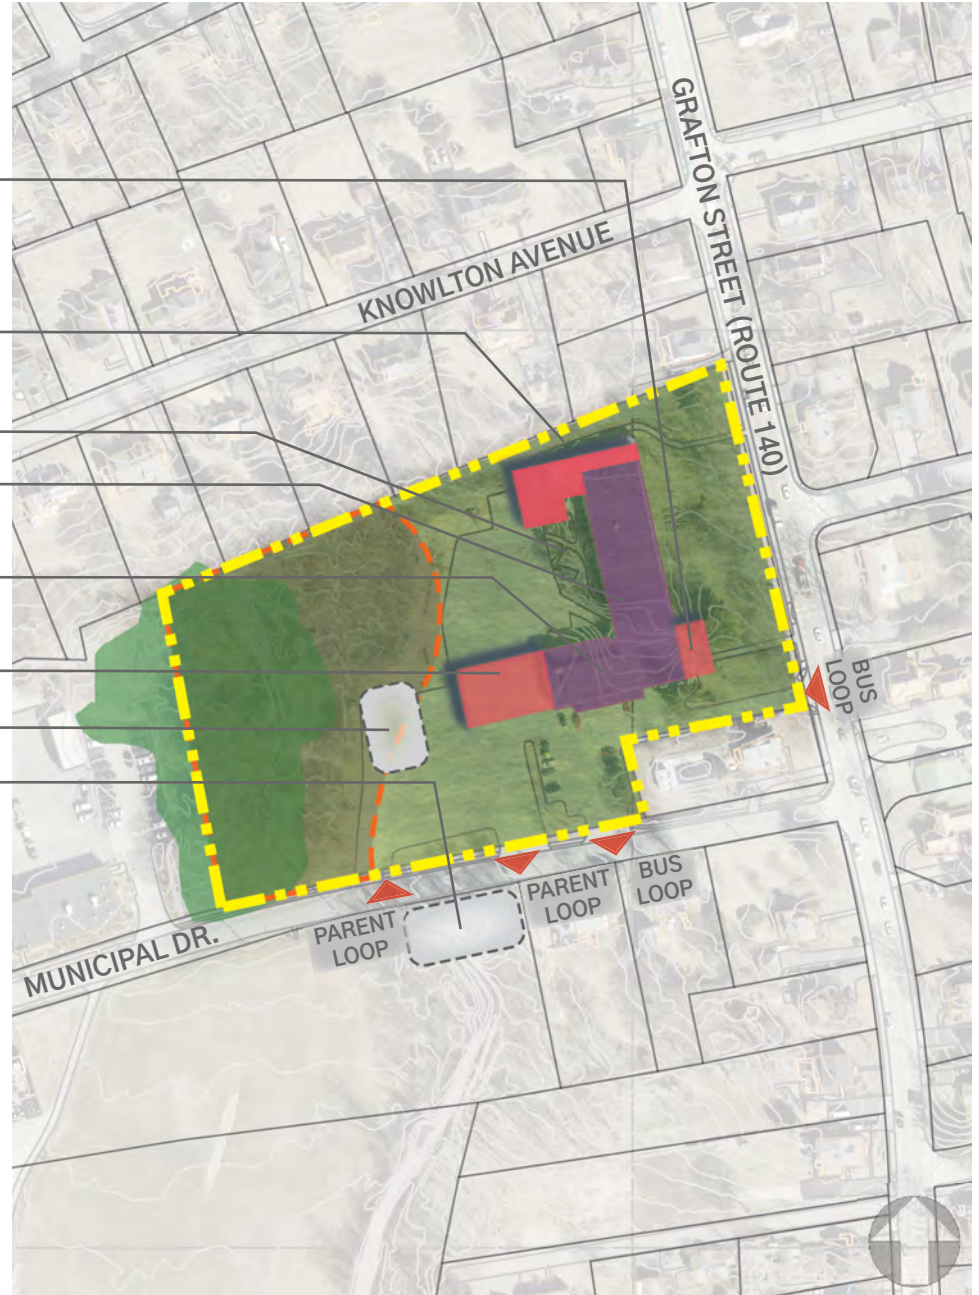
Options | Pre-K Options – Addition/Renovation at Walter J. Paton School

- Expanded administrative suite
- Demolish portable classrooms and replace with new two-story academic wing
- New paved play yard
- Renovate existing academic wing for preschool classrooms with shared restrooms
- Renovate existing cafegymnasium for a new gross motor room
- New single-story classroom wing
- Expanded parking
- Expanded parking option (across Municipal Drive)

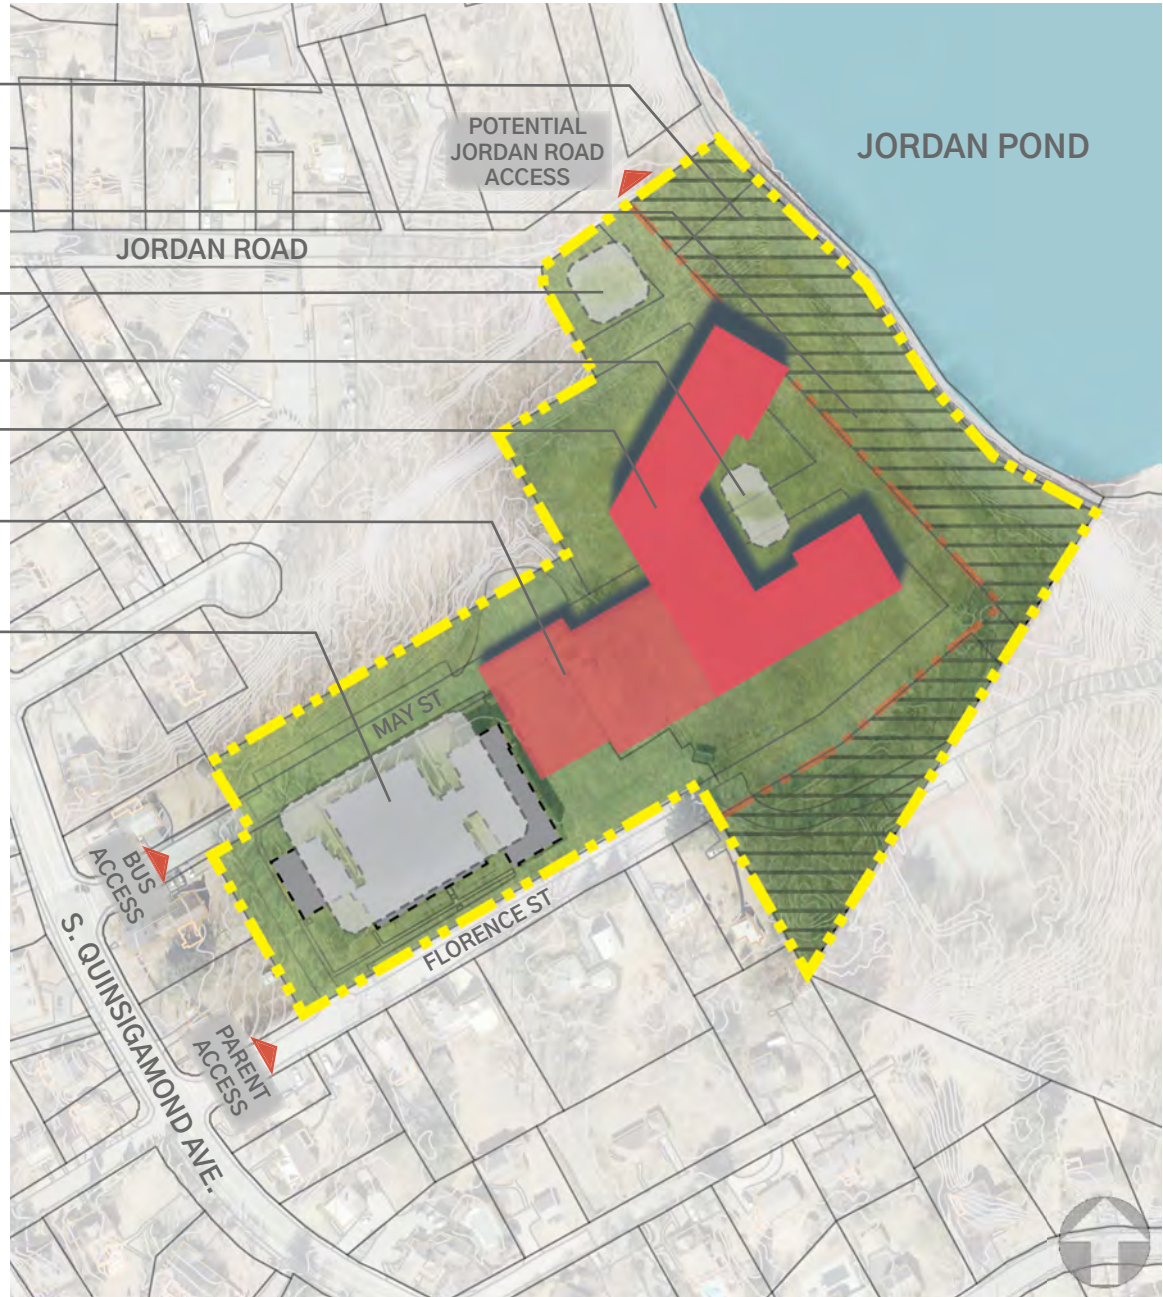
New one-story gymnasium/cafeteria/administrative wing

Demolish school in its entirety; student population to temporarily transfer to Beal during construction; create new expanded parking lot & reconfigured bus turnaround

- New building
- Existing building to be demolished
- Wetlands
- 200' wetlands buffer zone
- Property line
- Vehicular access points

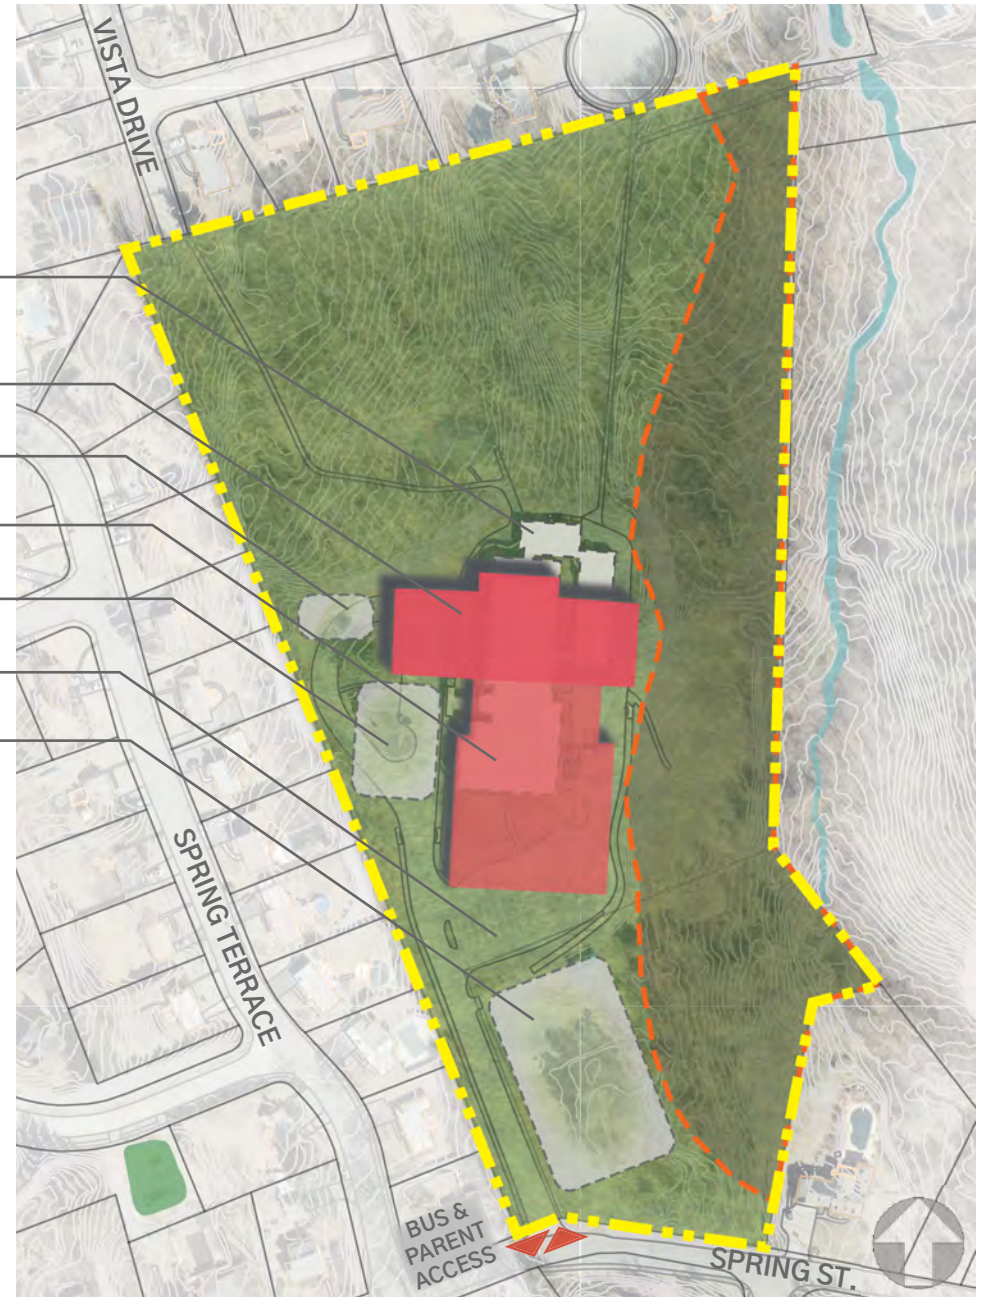
Options | New Construction (600) – Spring Street School Site

- Demolish school in its entirety; student population to temporarily transfer to Beal during construction
- New three-story academic wing addition
- Kindergarten play area
- New one-story gymnasium/cafeteria/administrative wing
- Revise rotary for bus loop
- Relocate play area adjacent to building
- Expand parking lot; parent loop to occur in new lower parking lot
